Paint Stains Under Rapgard

Service Category Vehicle Exterior

Section Paint/Coatings

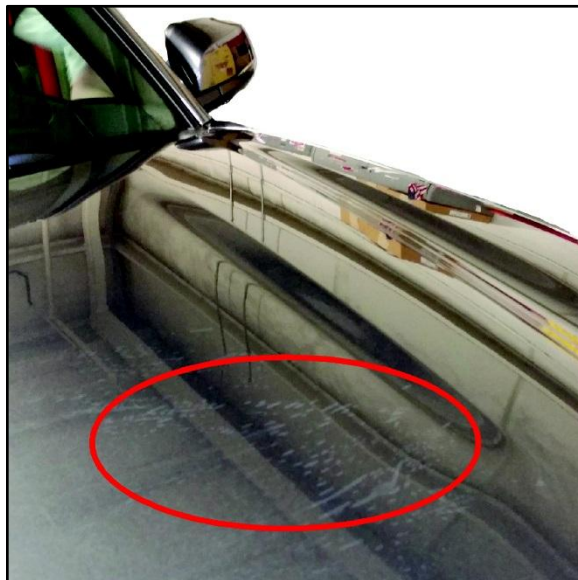
Figure 1.

On some vehicles, when Rapgard™ is removed, the paint may have a stained appearance. These stains appear to be under the clear coat (repainting this area is NOT necessary). The stain patterns are usually under wrinkles in the Rapgard™. These wrinkles sometimes trap water and cause the paint to stain from the trapped moisture, especially on horizontal surfaces, such as the hood, roof, and trunk. Stains can be removed by heating the stained surface to remove the trapped moisture.

1. Use the aluminum foil or damp cloth to cover plastic/rubber parts that are near the stain.
2. Apply heat to the stain using an infrared lamp or heat gun.

Apply heat for 5 – 10 minutes at 158°F – 176°F (70°C – 80°C). Do NOT allow the surface to become hotter than 176°F (80°C). Measure the temperature with a thermometer.

3. After applying heat for 5 minutes, examine the area to determine if the stain has been removed. If the stain still exists, continue to apply heat and re-examine the stain 5 minutes later.
