TECHNICAL INSTRUCTIONS

SPECIAL SERVICE CAMPAIGN H0D

CERTIFICATION LABEL

**CERTAIN 2016 SCION iA
&
2017 TOYOTA YARIS iA**

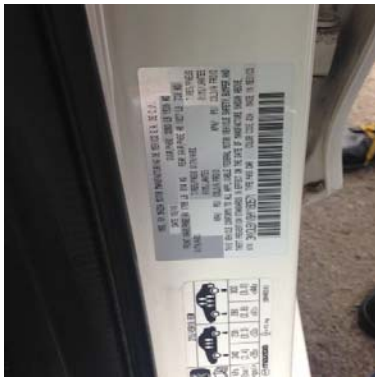
2. LOCATE THE ORIGINAL CERTIFICATION LABEL
 - a. The label is located in the driver's door jamb. Other than the production date, the label should be identical.

The original label **MUST** be removed and the **NEW** label **MUST** be affixed directly to the body. Placing the **NEW** label on top of the old label **IS NOT** acceptable.

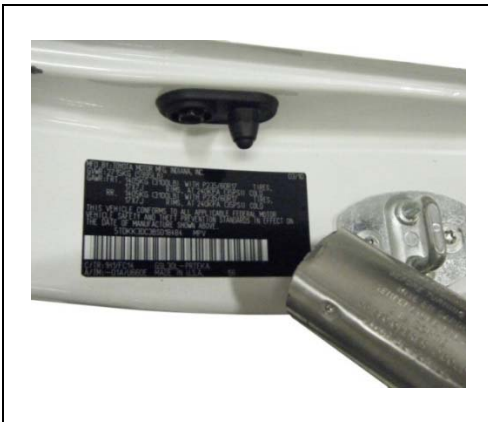
3. REMOVE THE ORIGINAL CERTIFICATION LABEL

- a. Heat the original Certification Label evenly using a heat gun.

- It might take approximately 1 to 2 minutes, depending on the type of heat gun being used, to heat the label sufficiently.

When removing the certification label, use extreme caution to prevent damage to the paint and any other labels.

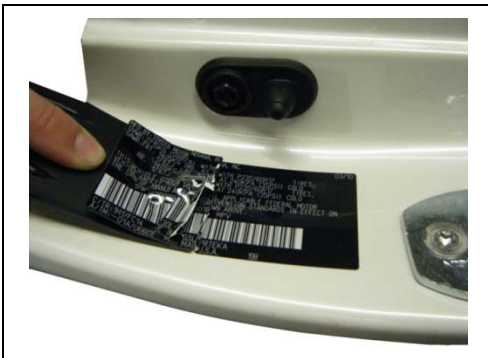
- b. While continuing to apply heat, peel the label using a plastic scraper. Take caution to prevent damaging the paint.

- **DO NOT** use any type of metal scraper to remove the label.
- If the label does not come off in 2 or 3 large pieces, the label may not be heated up enough.

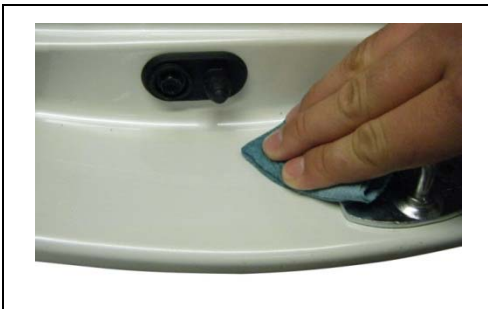
- c. Using 3M General Purpose Adhesive Cleaner (P/N 08984) or equivalent, wipe down the affected area completely to remove all remaining residue of the original Certification Label.

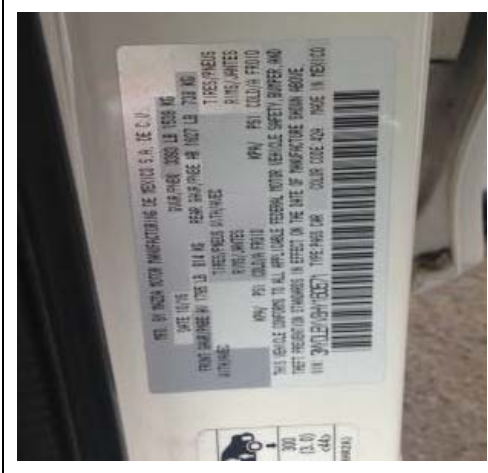
4. INSTALL THE **NEW** CERTIFICATION LABEL

- a. Place the **NEW** certification label on the panel in the same location as the original label.

NOTE: Confirm there are no bubbles or creases when installing the **NEW** label.

The original label *MUST* be removed and the **NEW label *MUST* be affixed directly to the body. Placing the **NEW** label on top of the original label *IS NOT* acceptable.**

- Verify the **NEW** Certification Label has good adhesion to the vehicle door jamb
- Verify the **NEW** Certification Label has been completely pressed into place so that it can't be removed.
