# HVAC Evaporator Drain Hose Clogged Due to Insect Intrusion

## HVAC Evaporator Drain Hose Clogged Due to Insect Intrusion

March 8, 2017 Rev1:

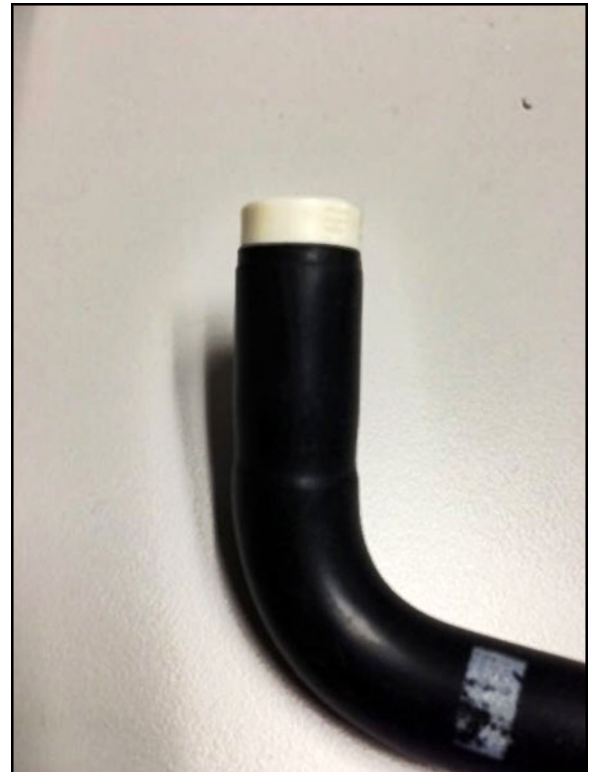
1. Follow the instructions provided in the Safety Requirements for Handling the ARINIX® Tip (Connector, Water Hose) section of this bulletin.
2. Locate the HVAC Evaporator Drain Hose.
3. Following the vehicle specific Repair Manual, remove the HVAC Evaporator Drain Hose.
4. Put on all necessary PPE and install the ARINIX® Tip (Connector, Water Hose) into the NEW HVAC Evaporator Drain Hose listed in the Parts Information section of this bulletin.
5. When installing the ARINIX® Tip, verify it is fully seated in the HVAC Evaporator Drain Hose as shown in Figure 1.
6. Following the vehicle specific Repair Manual, install the HVAC Evaporator Drain Hose.

1. Follow the instructions provided in the Safety Requirements for Handling the ARINIX® Tip (Connector, Water Hose) section of this bulletin.
2. Locate the HVAC Evaporator Drain Hose.
3. Following the vehicle specific Repair Manual, remove the HVAC Evaporator Drain Hose.
4. Put on all necessary PPE and install the ARINIX® Tip into the original HVAC Evaporator Drain Hose listed in the Parts Information section of this bulletin.
5. When installing the ARINIX® Tip, verify it is fully seated in the HVAC Evaporator Drain Hose as shown in Figure 1.
6. Following the vehicle specific Repair Manual, install the HVAC Evaporator Drain Hose.

6. When installing the ARINIX® Tip, verify it is fully seated in the HVAC Evaporator Drain Hose as shown in Figure 1.
7. Following the vehicle specific Repair Manual, install the HVAC Evaporator Drain Hose.

1. Follow the instructions provided in the Safety Requirements for Handling the ARINIX® Tip (Connector, Water Hose) section of this bulletin.
2. Locate the HVAC Evaporator Drain Hose
3. Following the vehicle specific Repair Manual, remove the HVAC Evaporator Drain Hose.
4. Before installing the ARINIX® Tip (Connector, Water Hose) into the original HVAC Evaporator Drain Hose, the end of the hose needs to be cut perpendicular as shown in Figure 2.
5. Put on all necessary PPE and install the ARINIX® Tip into the original HVAC Evaporator Drain Hose listed in the Parts Information section of this bulletin.
6. When installing the ARINIX® Tip, verify it is fully seated in the HVAC Evaporator Drain Hose as shown in Figure 1.
7. Following the vehicle specific Repair Manual, install the HVAC Evaporator Drain Hose.

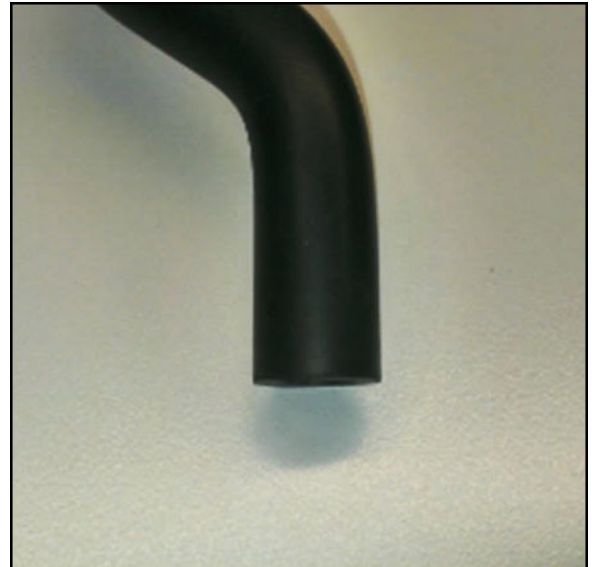
1. Follow the instructions provided in the Safety Requirements for Handling the ARINIX® Tip (Connector, Water Hose) section of this bulletin.
2. Locate the HVAC Evaporator Drain Hose.
3. Following the vehicle specific Repair Manual, remove the HVAC Evaporator Drain Hose.
4. Before installing the ARINIX® Tip (Connector, Water Hose) into the NEW HVAC Evaporator Drain Hose, the end of the hose needs to be cut perpendicular as shown in Figure 2.
