Service Category	General		
Section	Pre-Delivery Service	Market USA	Lexus Supports ASE Certification

YEAR(S)	MODEL(S)	ADDITIONAL INFORMATION	
2018	GX460

Some 2018 model year GX 460 vehicles are equipped with a compass in the rear view mirror. Use the following procedure to complete initial calibration of the compass during Pre-Delivery Service (PDS).

L-SB-0141-17

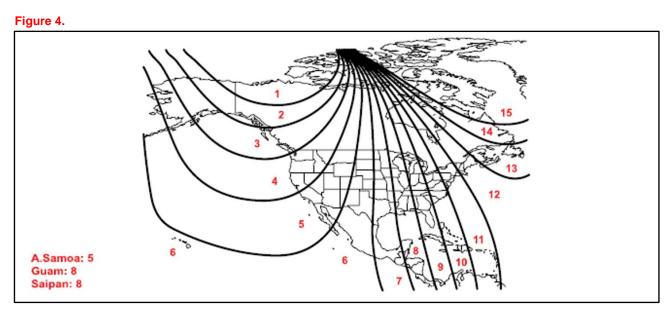
See the map for zone reference.

Push and hold the "N" switch for approximately 6 seconds until the zone number (1 – 15) appears on the display. Then push the switch to select the number of the zone where the vehicle is located.
