Spot Corrosion on B-Pillar and/or C-Pillar

Service Category Vehicle Exterior

Section Paint/Coatings

YEAR(S)	MODEL(S)	ADDITIONAL INFORMATION
2012 - 2015	Tacoma	WMI(s): 3TM, 5TF

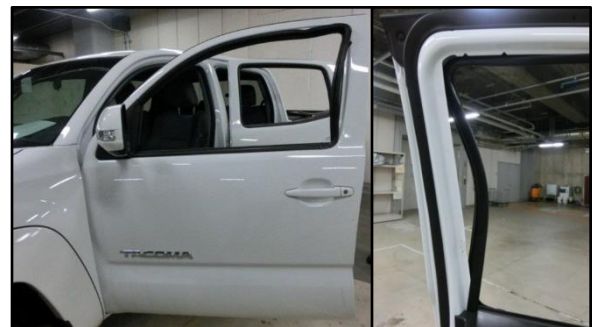
Figure 1.

2. Open the window and partially remove the door glass run as shown.

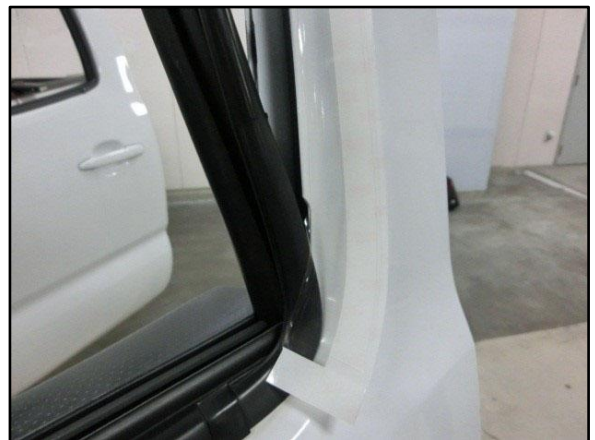
Figure 4.

7. Attach the front half of the paint protective film to the door. Align the position markers on the paint protective film with the position markers on the door as shown in step 4.

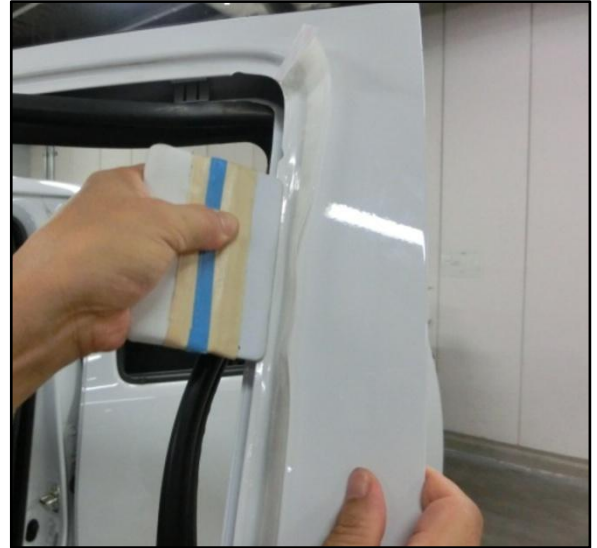
Figure 5.

8. Remove ALL water and air bubbles trapped under the paint protective film using a plastic spatula or similar tool.

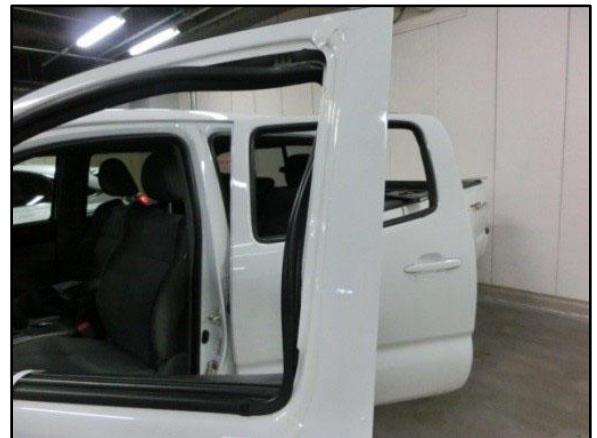
Figure 6.

9. Remove the remaining backing paper.
10. Apply water to the newly exposed paint protective film to make sure that the film can be adjusted during installation.
11. Attach the remaining paint protective film to the door. Remove ALL water and air bubbles by using a plastic spatula or a similar tool.

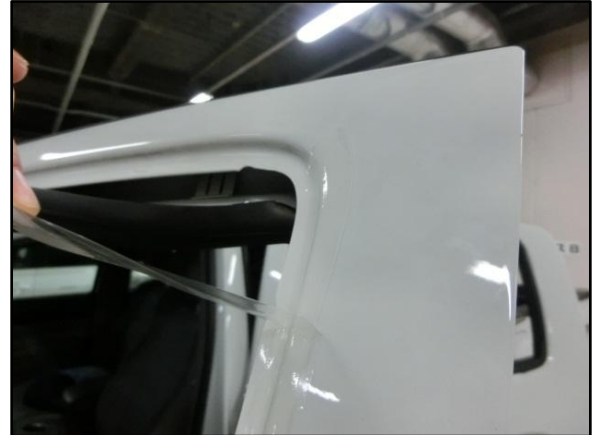
Figure 7.

12. Remove the backing film from the top surface of the paint protective film.
