Outside Door Handle Sticking

YEAR(S)	MODEL(S)	ADDITIONAL INFORMATION
2008 - 2015	Sequoia	
2007 - 2015	Tundra

Some 2007 – 2015 model year Tundra and 2008 – 2015 model year Sequoia vehicles may exhibit an abnormal feeling, dragging, or sticking when using the outside door handle. Follow the Repair Procedure in this bulletin to address this condition.

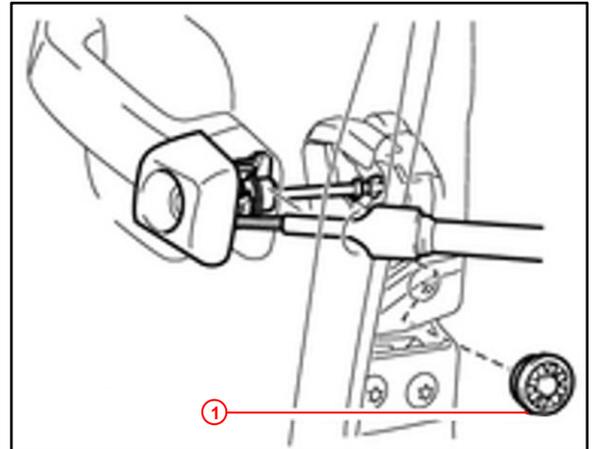
Figure 1. WITH Lock Cylinder

1. Remove the outside door handle cover.
 - A. Remove the hole plug.
 - B. Using a T30 Torx wrench, loosen the screw and remove the front door outside handle cover and the door lock key cylinder (if equipped) as a unit.

1	Hole Plug
----------	------------------

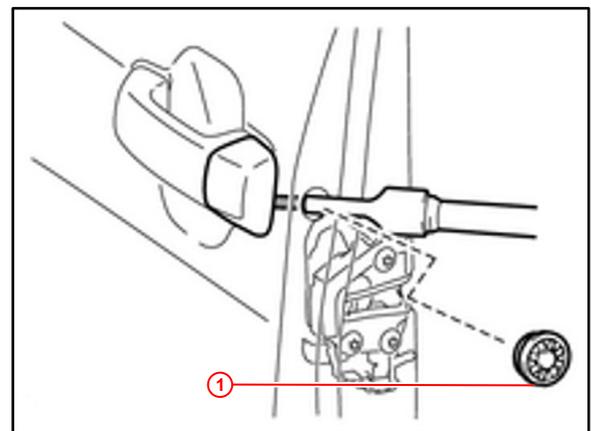
Figure 2. WITHOUT Lock Cylinder

1	Hole Plug
----------	------------------

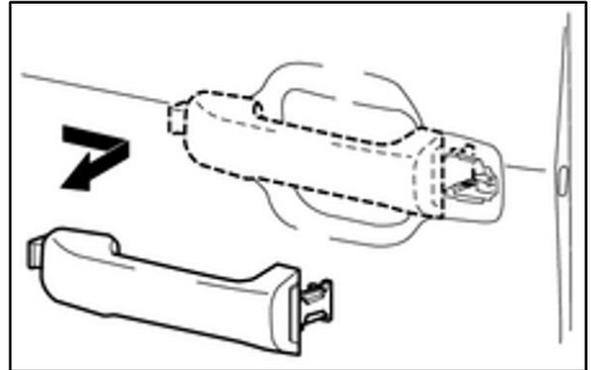
Figure 3.

2. Remove the outside door handle assembly by sliding and pulling it in the direction indicated by the arrow as shown.

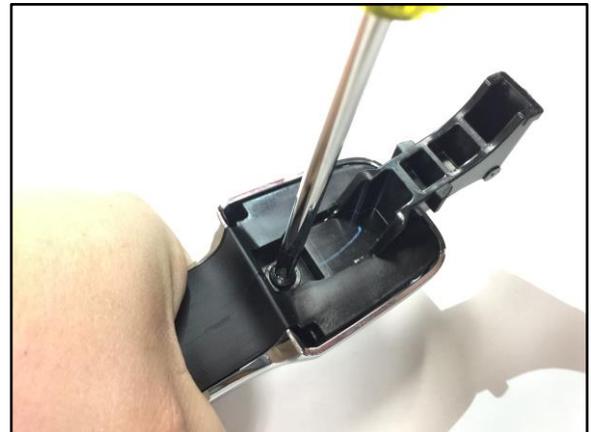
Figure 4.

3. Disassemble the outside door handle.
 - A. Remove the screw from the outside door handle assembly previously removed from the vehicle.

- The screw is secured using thread locking compound. When attempting to remove the screw, use a high quality, #2 Phillips screwdriver, with an undamaged tip.
- To minimize slipping and to reduce the risk of stripping the screw head, apply firm inward pressure while turning the screw.

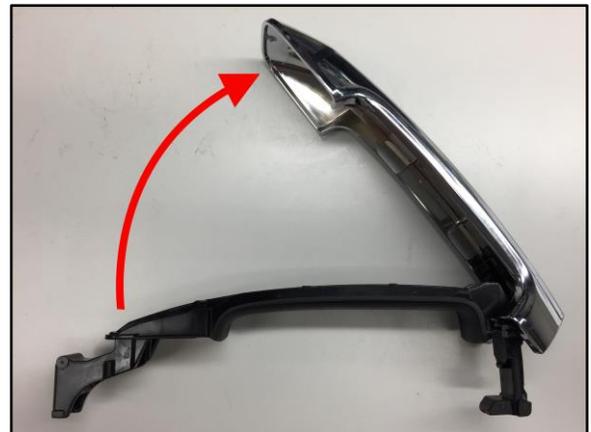
Figure 5.

- B. Remove the door handle inner from the outside door handle outer cover by rotating it in the direction indicated by the arrow as shown and discard the outside door handle inner.

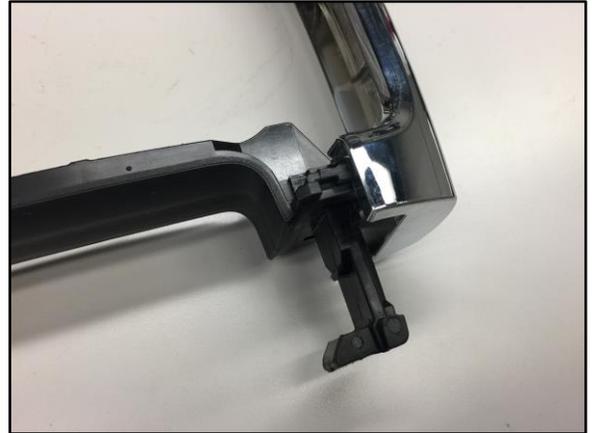
Figure 6.

4. Reassemble the outside door handle.
 - A. Install the NEW door handle inner to the OLD outside door handle cover by engaging the two tabs.

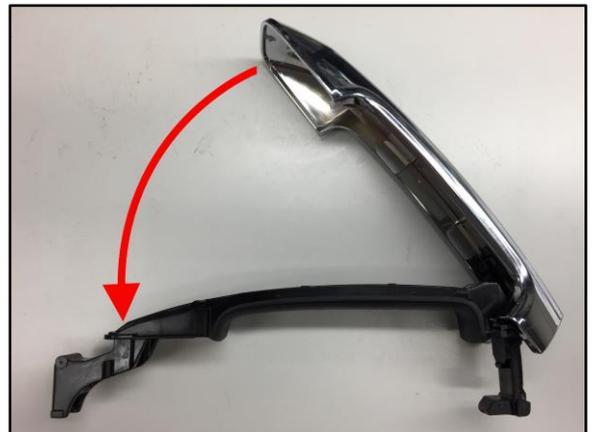
Figure 7.

- B. Seat the cover by rotating in the direction indicated by the arrow as shown.

- C. Apply thread locking compound to the threads of the screw.
 - D. Install the screw in the outside door handle.
Torque: 2.6 N*m (26.5 kgf*cm, 23 in*lbf)

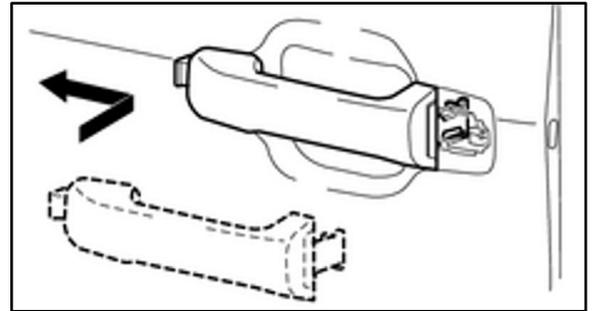
Figure 8.

5. Install the outside door handle assembly by pushing it in the direction of the arrow as shown.

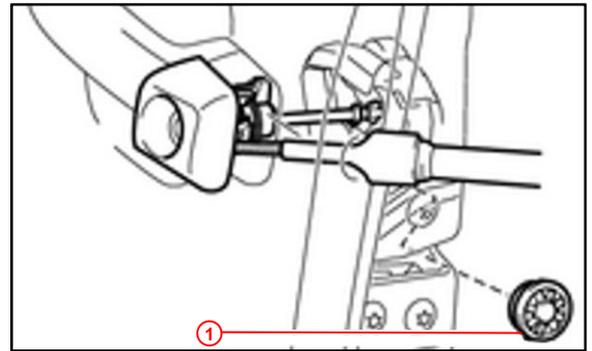
Figure 9. WITH Lock Cylinder

6. Install the outside handle cover.
 - A. Using a T30 Torx socket, install the outside handle cover and the door lock key cylinder (if equipped) as a unit.
Torque: 4.0 N*m (41 kgf*cm, 35 in*lbf)

1	Hole Plug
---	-----------

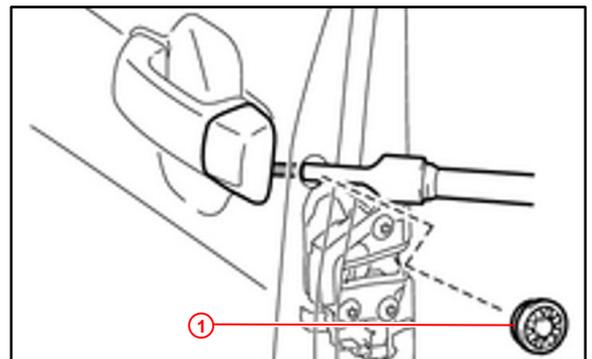
Figure 10. WITHOUT Lock Cylinder

- B. Install the hole plug.

1	Hole Plug
---	-----------
