Tailgate Cable Stay Length Too Long - Verification Procedure

Vehicle Exterior

MY14-18 Tundra

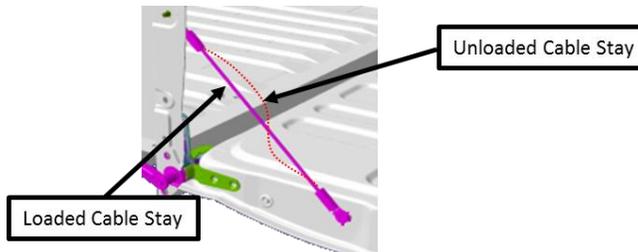
Some customers may experience Tailgate Cable Stay slack appearance. Tailgate Cable Stays are designed to have some slack when the Tailgate does not have a load applied, this is due to Tailgate loading requirements.

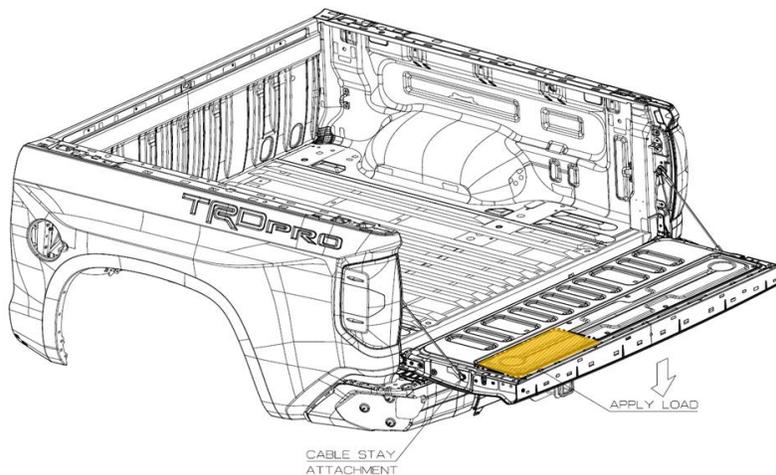
To confirm if Tailgate Cable Stay length is OK - load the Tailgate in the area shown (on the side with slack/loose condition) with load of ≥ 23 lbs. (use Seatbelt Sensor Weight SST 00002-09077-01).

If Cable Stay has no slack/looseness, please inform customer part is OK and functions as intended.
