# Technical Service Bulletin

## PSS 91 Top view camera setting changes to graphic view intermittently after startup

91 17 61 2049414/1 November 15, 2017.

Model(s)	Year	VIN Range	Vehicle-Specific Equipment
A4, A5, Q5, and Q7	2018	All	With front and rear view camera system and two side cameras

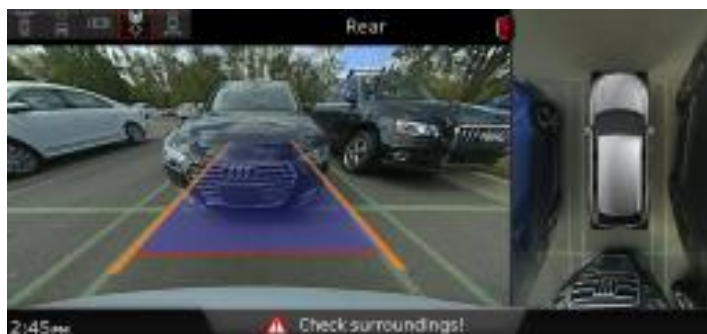
When the reversing camera is active showing the Top view camera to the right, the display changes intermittently at startup from camera view to graphic view. Compare the images to the right (Figure 1 and 2).

Figure 1. Correct camera view.

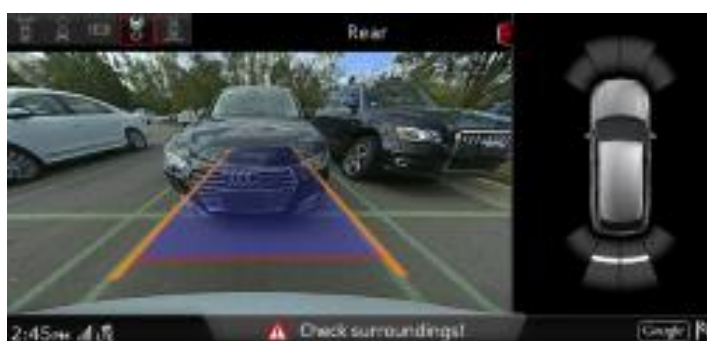
Figure 2. Incorrect graphic view.

The condition is caused by a software concern in the MMI (information control module 1, J794 (address word 005F)).

The condition above can also be caused by known hardware/software issue in the rearview camera system control module, J772 (address word 006C). Reference the following TSB's before submitting a PSS entry:

- TSB 2047730: *90 Top view camera does not load - no communication.*
  - TSB 2048517: *90 Top view camera image: only park aid lines displayed.*
1. If the aforementioned TSB's do not apply to the customer's concern, then please explain to the customer that a solution is forthcoming and that no repairs are necessary at this point. Do not replace any components for this condition since this will not resolve the customer's concern.
  2. Create a PSS record in the PSS application through the Pending Service Solutions (PSS) link in iAudi (under *Related Links >> Service*), or through the Technical Assistance page in Elsa.
