Knocking Noise From Vacuum Pump

Service Category Engine/Hybrid System

Section Engine Mechanical

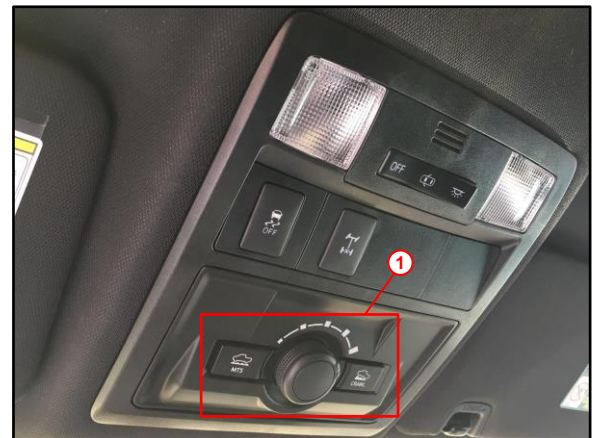
Figure 1. Overhead Console in Vehicle With Crawl Control

- If the vehicle is a Tacoma, is it equipped with crawl control?
 - YES** — This bulletin does NOT apply. Continue diagnosis using the applicable Repair Manual.
 - NO** — Continue to step 2.

1 Crawl Control – This Service Bulletin is Not Applicable
