Service Bulletin

Bulletin No.: 17-NA-247

Subject: Information on Traces of EGR Cooler Housing Actuator Exhaust Residue Seen in Colder Climates

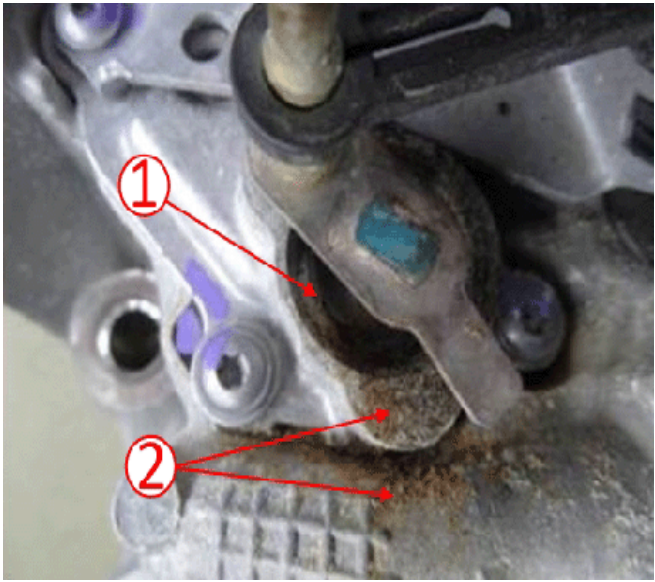
<p style="text-align: right;">4841052</p> <p>Some customers may comment that exhaust residue (2) can be seen condensing onto the aluminum housing of the EGR assembly, making it appear as if the bypass actuator arm seal (1) has failed.</p>
Information	<p>Note: Do Not replace the EGR assembly for this condition.</p> <p>This is normal operation and will not affect the function of the EGR cooler assembly.</p>
