# Service Bulletin

Bulletin No.: 17-NA-320

**Subject: Information on Outside Door Handle or Lock Cylinder Cover Loose, Falling Off**

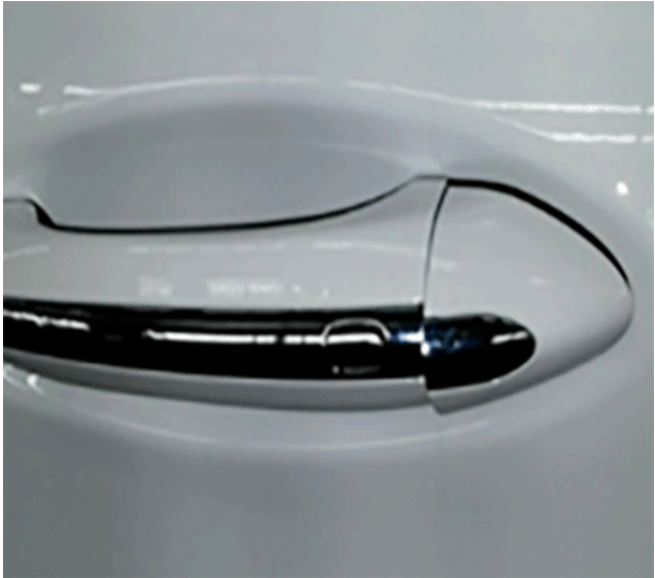
</div> <p style="text-align: right; font-size: small;">4876194</p> <ol style="list-style-type: none"> <li>1. Door handle bracket fracture due to the door lock cylinder cover assembly not being fully seated during assembly.</li> <li>2. Fastener not being torqued to proper specification.</li> </ol>
