## Rear passenger compartment entertainment display: The switch-on button on the display is nonfunctional

| Topic number | LI82.60-P-067457 |
| Validity | Model series 222 with code 808 and 864. |

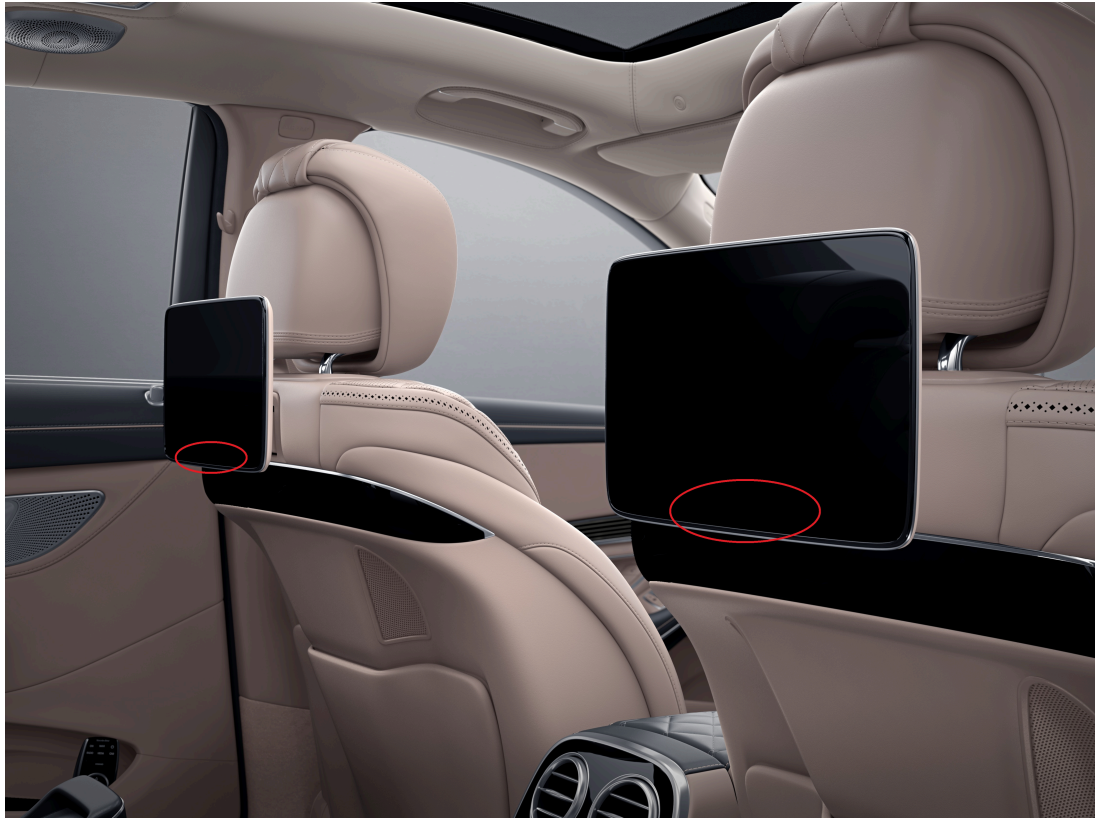
A.jpg:

The switch-on button of the rear passenger compartment entertainment display (see attachment A - red marking) might be nonfunctional. The rear passenger compartment entertainment display can be switched on and off and operated using remote control.

Possibly conductivity of the display glass increased meaning that the finger is no longer detected. Currently, only one of the two subsuppliers is affected.

Replace rear passenger compartment entertainment display. In doing so, note that both displays must be replaced! For the new object numbers to be used, look under Parts.

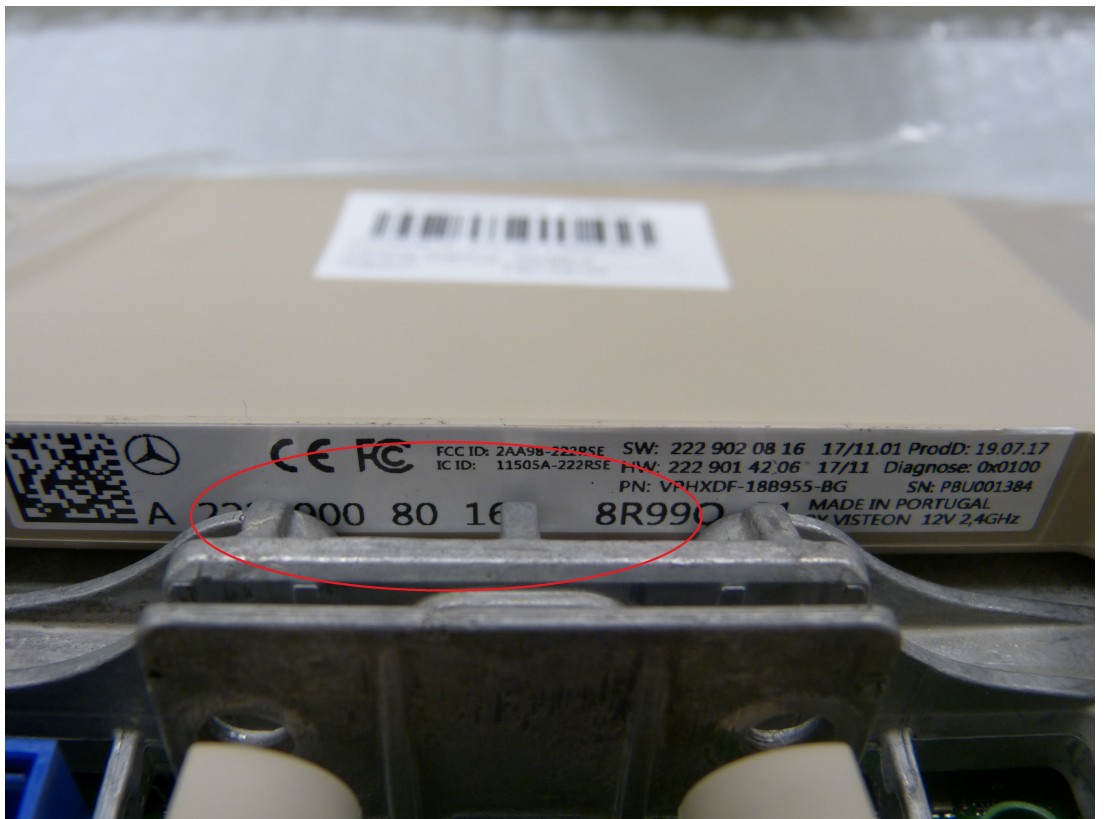
B.jpg:

- A222 900 80 16 7P98 (Magma gray color)

- A222 900 80 16 8R99 (Color: silk beige)

The part numbers can be read off the display (see attachment B - red marking).
