## Indicator lamp of A/C button in front climate control operating unit inoperative

| Topic number | LI83.30-P-067427 |
| Function group | 83.30 Air conditioning |
| Validity | Model series 205, 213, 238, 253 |

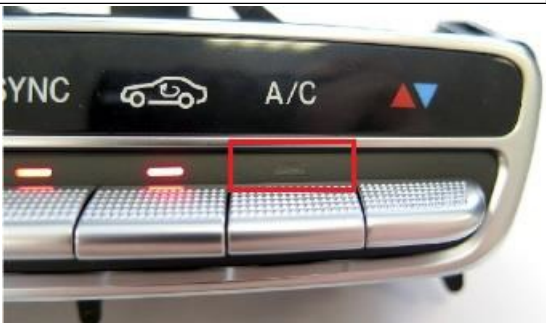
A.jpg:

The indicator lamp of the A/C button in the operating unit of the front climate control is inoperative, although the air conditioning system is switched on. The air conditioning system functions correctly.

The LED in the A/C control panel may be damaged.

Replace the A/C control panel.
