# Customer Satisfaction Program

## 17407 Vehicle Build Incompatible with LPO Accessory Spoiler

Reference Number: N172128790

Release Date: November 2017  
Revision: 00

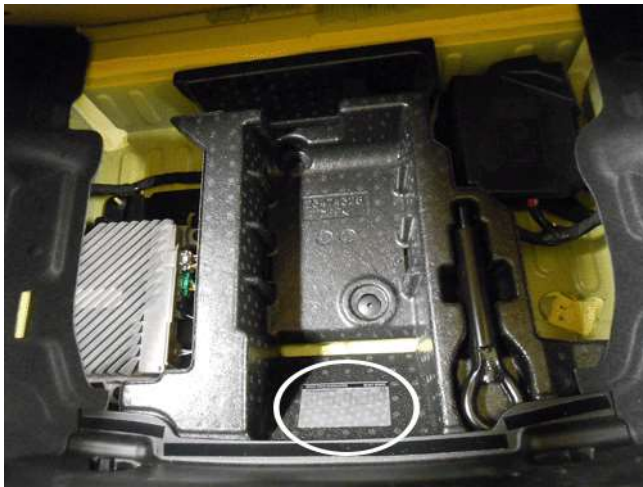
4890968

4. On the vehicle's SPID label, use a black permanent marker to cross off the accessory spoiler RPO that is not installed on the vehicle (5V5 or 5ZU). The SPID label is located in the trunk under the rear compartment floor panel trim. Refer to *Rear Compartment Floor Panel Trim Replacement* in SI.

1. Inspect the current Monroney window label for listing a LPO accessory spoiler.
  - If an accessory spoiler (RPO 5V5 or 5ZU) is listed, proceed to step 2.
  - If no LPO accessory spoiler is listed on the Monroney window label, proceed to step 4.
2. Carefully remove the factory installed label from the vehicle's window. Discard this label.
3. Carefully affix the replacement label to the vehicle's window.

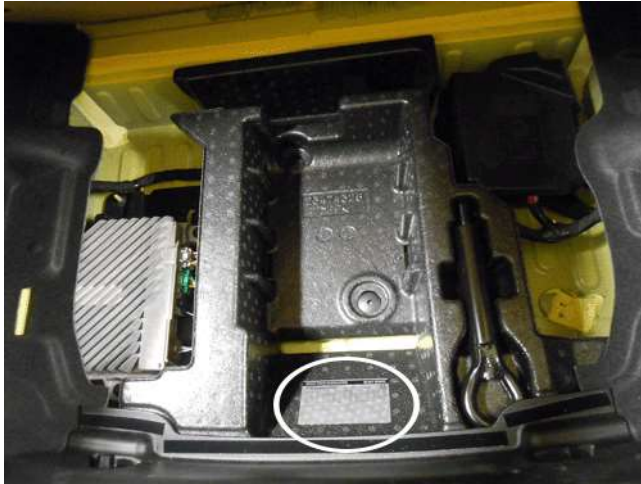
4890968

4. On the vehicle's SPID label, use a black permanent marker to cross off the accessory spoiler RPO that is not installed on the vehicle (5V5 or 5ZU). The SPID label is located in the trunk under the rear compartment floor panel trim. Refer to *Rear Compartment Floor Panel Trim Replacement* in SI.
