Coolant / Vacuum / Temperature fault codes - Check Engine Light with DTCs P003313, P0299FA, P0299FB, P226100, P261F71, P012800, and P012809

Topic number	LI07.09-N-063338
Version	7
Design group	07.09 Vacuum system
Date	01-10-2017
Validity	OM651
Reason for change	added cause and picture
Reason for block

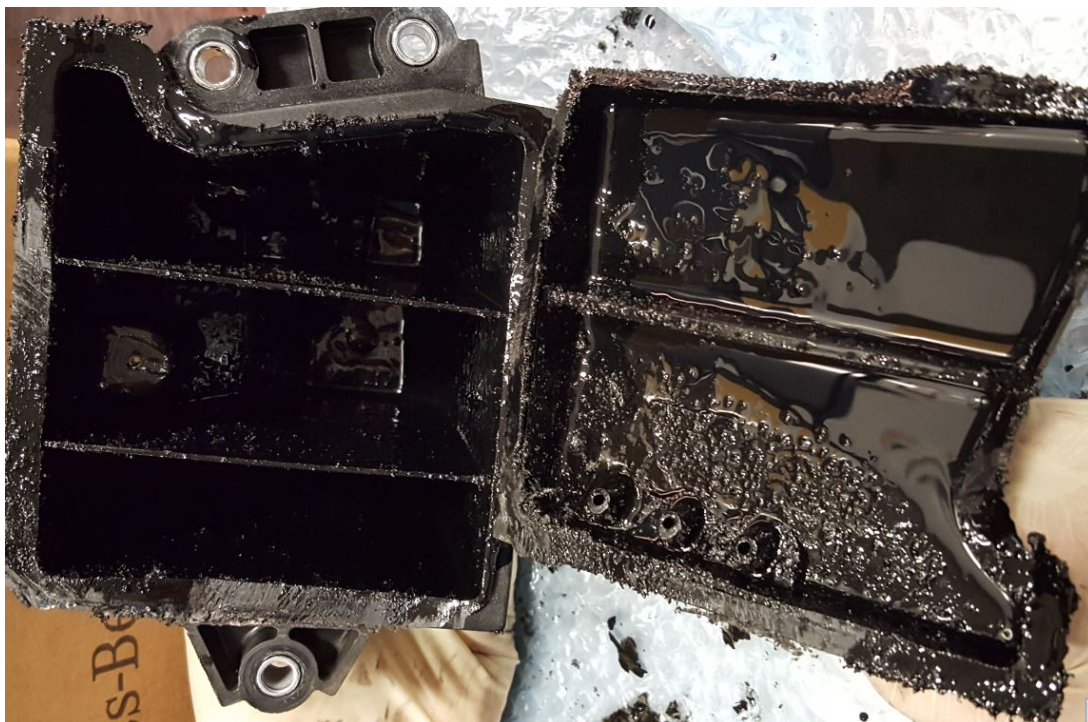
Vac Reservoir w oil.JPG:

Vac Reservoir w oil.JPG	Vacuum Reservoir with oil contamination
Brake Booster with oil.JPG	Brake booster with oil contamination
water pump impeller.JPG	Damaged water pump impeller

5 - If oil contamination is found in the vacuum system replace the vacuum pump, vacuum reservoir, brake booster and clean the vacuum lines.
