## Noise on instrument panel cover at top on model series 213

| Topic number | LI68.10-P-064592 |
| Validity | Model series 213 up to production date 04.07.2016 |

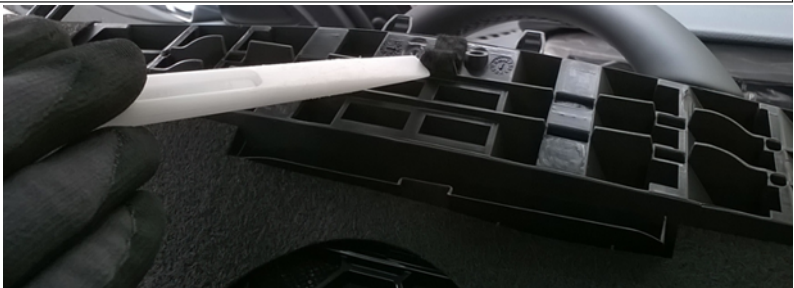
Abdeckung Instrumen-  
tentafel oben Pic.1.JPG:

| Attachments | |
|---|---|
| Abdeckung Instrumententafel oben Pic.1.JPG | A rib is located at this point on the component. A 10x2x25 mm piece of felt must be fitted over this rib. |

Cut felt to size 10X25 mm.

Apply felt to marked area (Pic. 1).

| Operation numbers/damage codes | | | | |
|---|---|---|---|---|
| 68-0000 | APPLY FELT TO INSTRUMENT PANEL COVER | 002 | 68300 36 | Apply felt to marked points (Pic.1) |

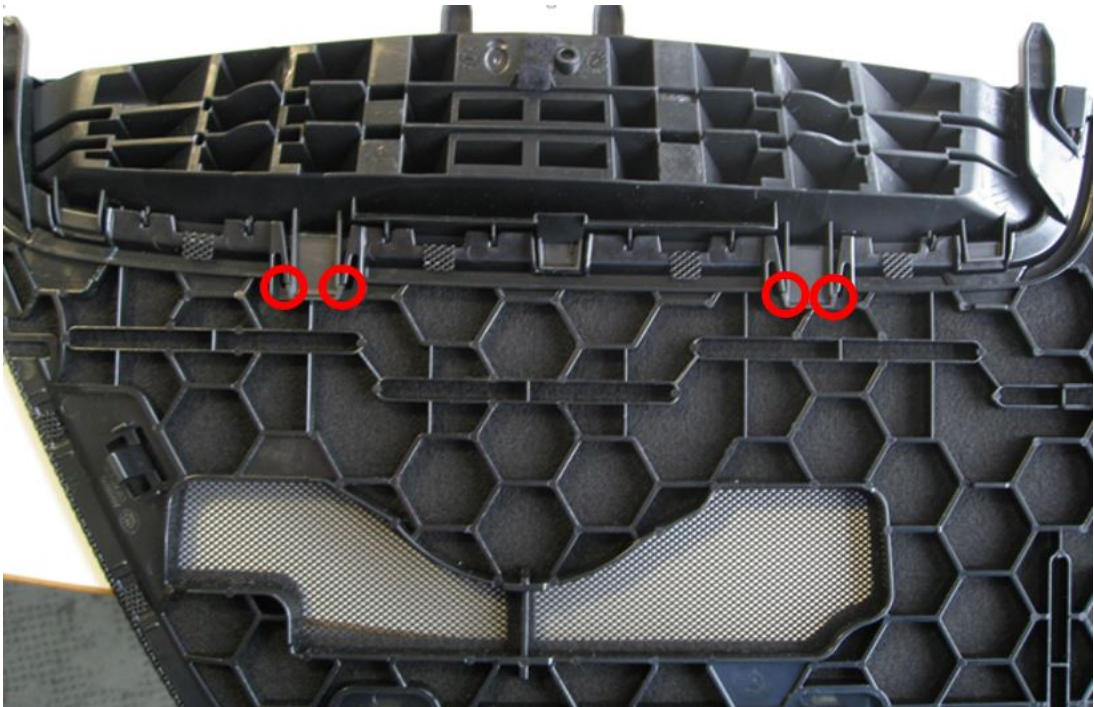
Abdeckung Instrumen-  
tentafel oben Pic.2.JPG:

| Attachments | |
|---|---|
| Abdeckung Instrumententafel oben Pic.2.JPG | Apply coating of Krytox to these points |

Apply light coating of Krytox A000 989 36 60 to clip contact areas (Pic. 2).

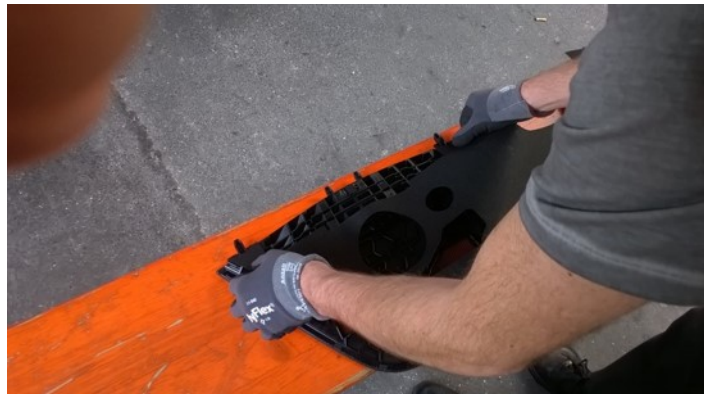
Abdeckung Instrumen-  
tentafel oben Pic.3.JPG:

| Attachments | |
|---|---|
| Abdeckung Instrumententafel oben Pic.3.JPG | Attach front non-woven cloth to shackles on centerfill grid |

Mount non-woven cloth (Pic. 3, 4 and 5).

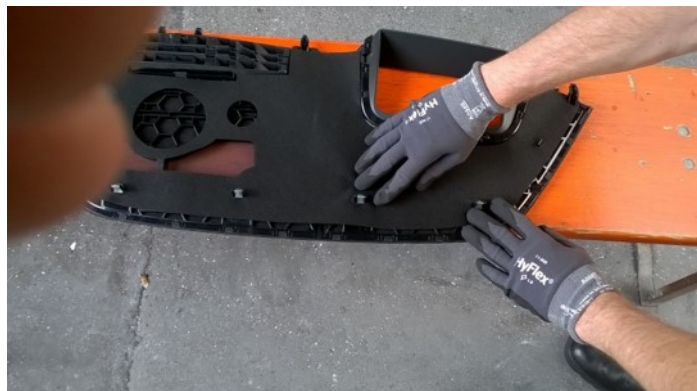
Abdeckung Instrumen-  
tentafel oben Pic.4.JPG:

| Attachments | |
|---|---|
| Abdeckung Instrumententafel oben Pic.4.JPG | Fix non-woven cloth into place on metal clamps |

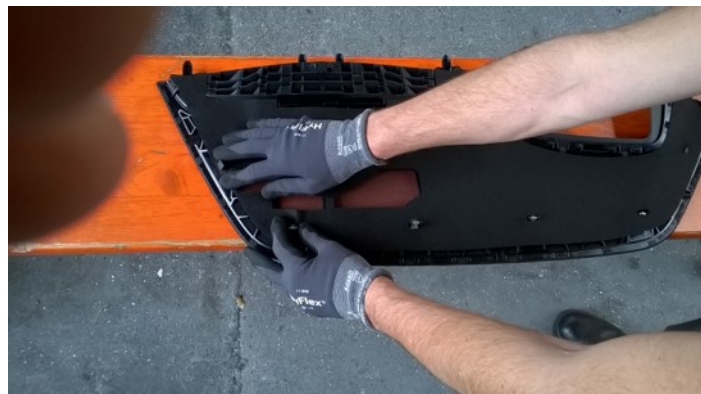
Abdeckung Instrumen-  
tentafel oben Pic.5.JPG:

| Attachments | |
|---|---|
| Abdeckung Instrumententafel oben Pic.5.JPG | Make sure that the opening in the area of the catch hooks was correctly mounted |
