Service Bulletin

Subject: Operating Tips for Hands Free Liftgate

This Bulletin replaces PIT5472A. Please discard PIT5472A.

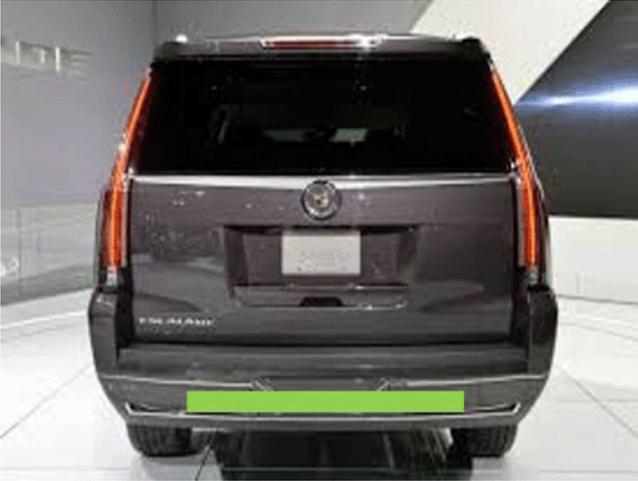
Important: Models: Cadillac Escalade, Chevrolet Suburban, Tahoe, and GMC Yukon

- Best operation will occur when the foot kick is conducted at the direct center of the kick zone. See illustrations above for models kick zone.

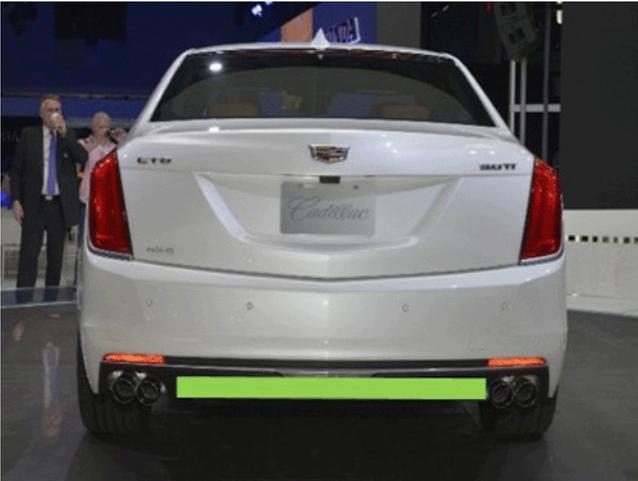
Important: Models: Cadillac CT6

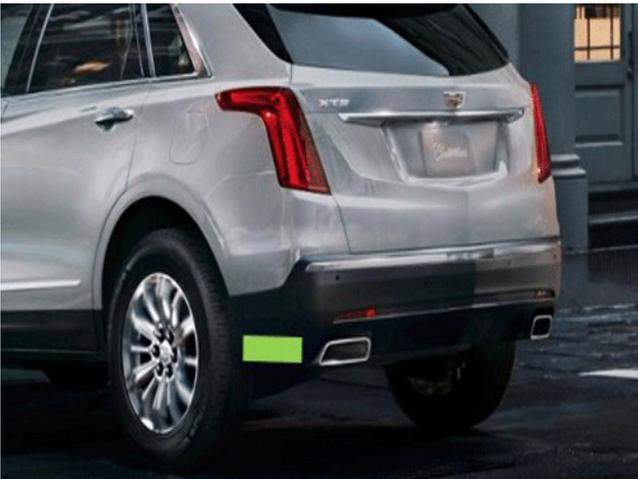
Important: Models: Cadillac XT5 and GM Acadia

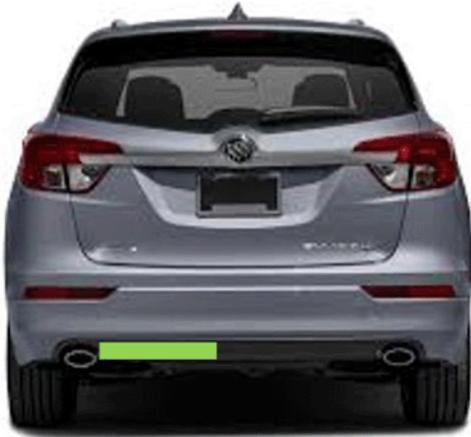
Important: Models: Buick Enclave, Envision, Chevrolet Traverse, Equinox, and GMC Terrain

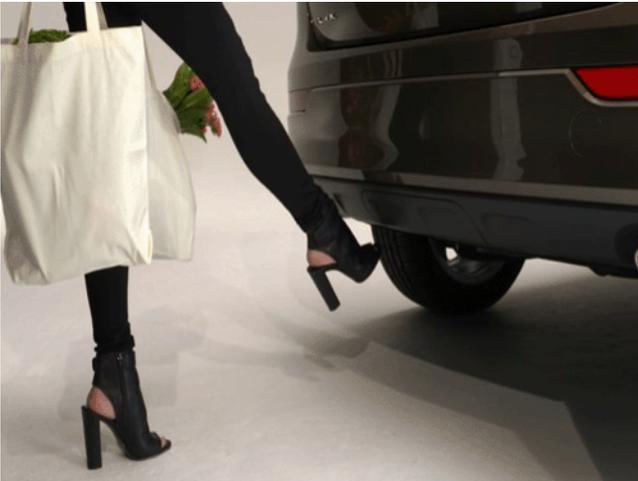
- To operate, kick your foot straight up in one swift motion under the center of the rear bumper, then pull it back. There are two antenna's located in the rear bumper fascia which both must be triggered for the system to detect a kick. During the kick, your foot and shin must come within 6.5 inches (16.5 cm) of the rear fascia for both antenna's to be triggered and detect the kick.
- Speed of kick should be 1 second or less.

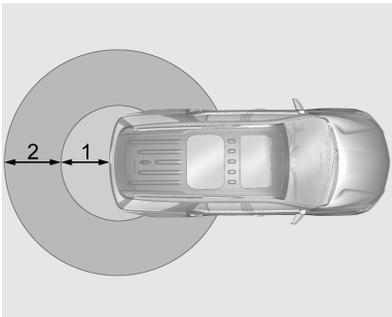
If equipped with this feature, a vehicle logo will be projected for one minute onto the ground near the rear bumper when an RKE transmitter is detected within approximately 2 m (6 ft).

- 1 m (3 ft) Hands-Free Operation Detection Zone
- 2 m (6 ft) Projected Logo Detection Zone

The projected logo shows where the kicking motion is to take place.
