# Preliminary Information

PIC6273A Shifter assembly missing cover for BTSI - cover is serviceable do not replace entire assembly

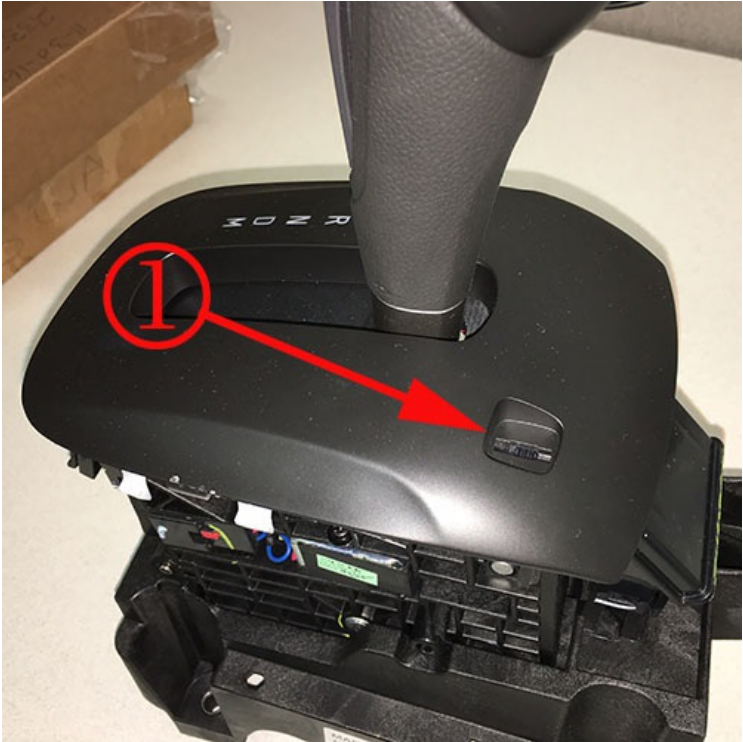
Brand:	Model:	Model Years:	VIN:		Engine:	Transmissions:
			from	to		
Buick	Encore	2013 - 2017	All	All	All	All
Chevrolet	Trax	2013 - 2017	All	All	All	All
Involved Region or Country		North America				
Additional Options (RPO)		N/A				
Condition		The BTSI cover is missing				
Cause		The BTSI cover may be missing or may break when removing the cover to test the shift interlock solenoid.

Do not replace the transmission shift control. The BTSI override cover is serviceable.  
#1 in first image is missing BTSI cover and second image is call out in the parts catalog.

Correction:
