# Service Bulletin

**Subject:** Spray-in Bed Liner General Information and Repair Procedures

**Models:** 2013-2014 Chevrolet Silverado HD 2500/3500 Series  
2014 Chevrolet Silverado 1500  
2015-2017 Chevrolet Colorado, Silverado  
2013-2014 GMC Sierra HD 2500/3500 Series  
2014 GMC Sierra 1500  
2015-2017 GMC Canyon, Sierra  
Equipped with Spray-in Bed Liner (RPO CGN, PDL)

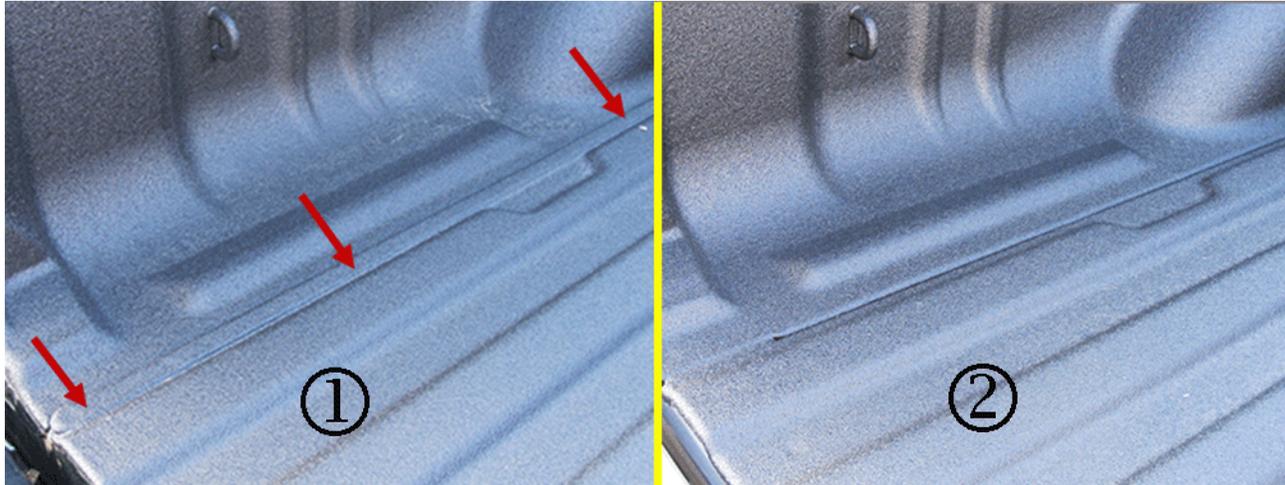
The photos below show the areas that are covered by the spray-in bed liner. These should be used as a guideline when making any repairs or answering customer questions concerning bed liner coverage areas.

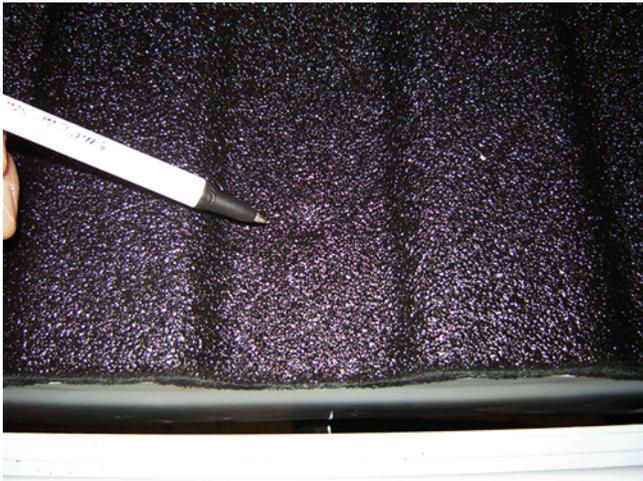
Because the bed liner material is sprayed on evenly, any variation in the bed such as seam sealer or spot welds in the sheet metal will show underneath the spray on coating. This is an expected condition. The coating does not completely fill in these variations.

**Spot weld under bed liner example**
