Service Bulletin

Subject: Heated Seat Back Inoperative When Pressing Seat Back Only Switch

Brand:	Model:	Model Year:		VIN:		Engine:	Transmission:
		from	to	from	to		
Chevrolet	Impala (VIN 1)	2016	2016			All	All

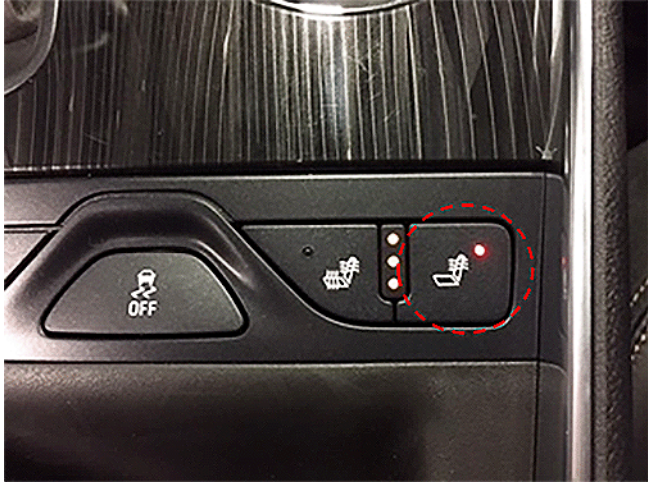
<p>Some customers may comment that the heated seat back is inoperative when pressing the seat back only switch.</p>
Cause	The cause of the condition may be that the proper combination of several of the seat components weren't released correctly for the vehicle.
Correction	Replace the cushion and seat back wiring harnesses in BOTH front seats, replace the seat heater control module in the passenger seat, add a jumper harness circuit to the main body wiring harness and reprogram the BCM following the Service Procedure below.

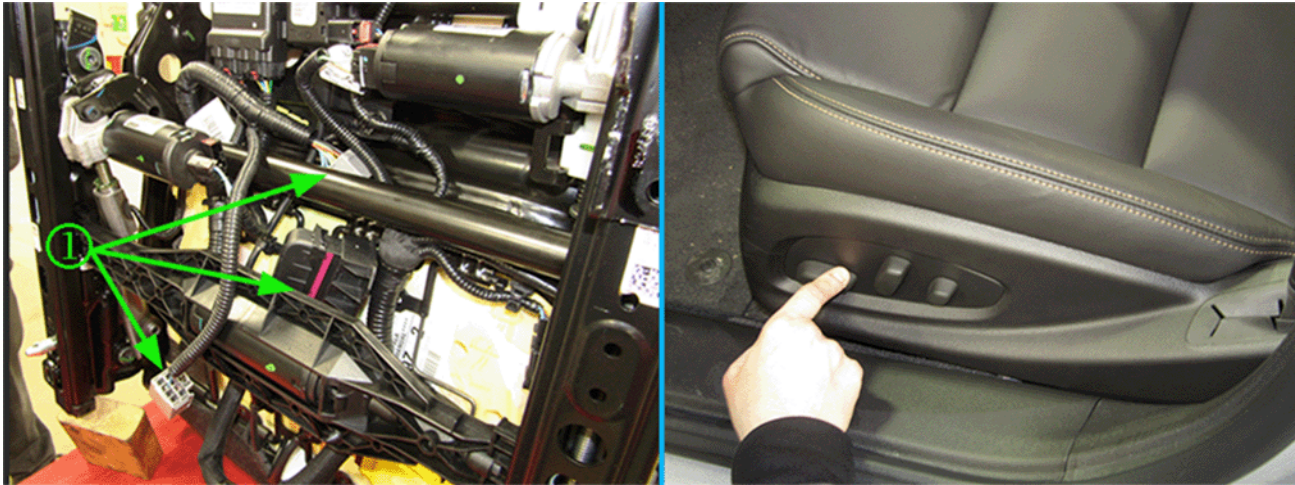
Important: In order to obtain clearance for the seat cushion harnesses connectors (1), the seat cushion height must be approximately mid-position. Prior to disconnecting the wiring harness, power the cushion height to mid-position.

1. Remove the driver and passenger seats. Refer to *Driver or Passenger Seat Removal and Installation* in SI.

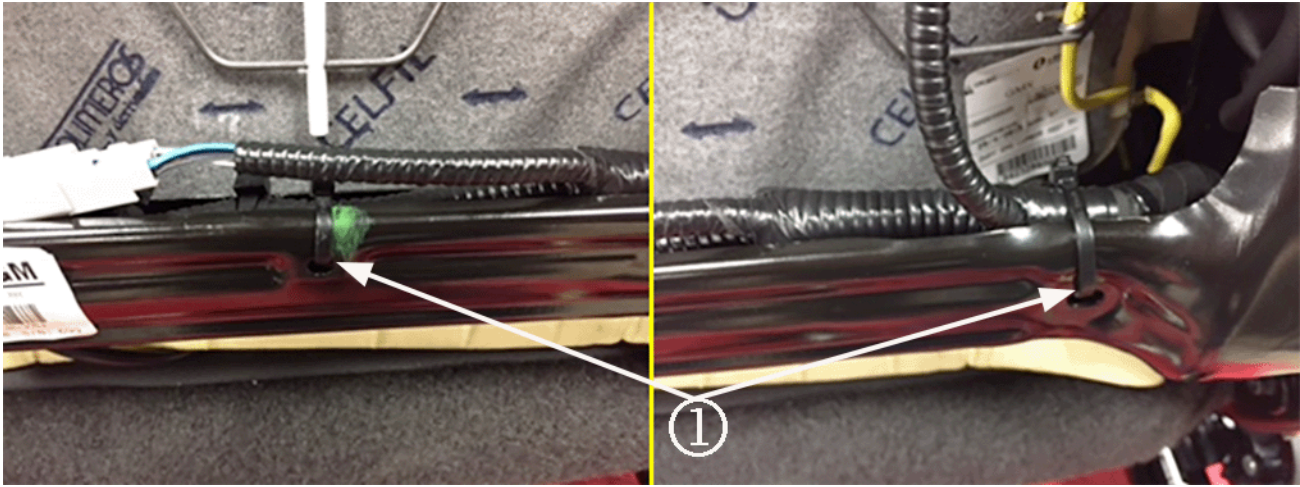
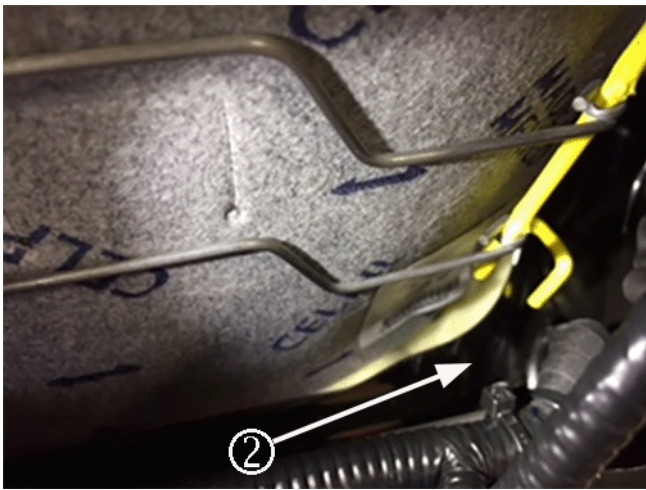
Important: When securing the **seat back wiring harness** along the bottom of the seat frame, add two tie straps (1) to help pull the harness tighter to the frame. This will allow more clearance (2) to the SIR harness in the lower corner.
