# Preliminary Information

PIC6273 Shifter assembly missing cover for BTSI - cover is serviceable do not replace entire assembly

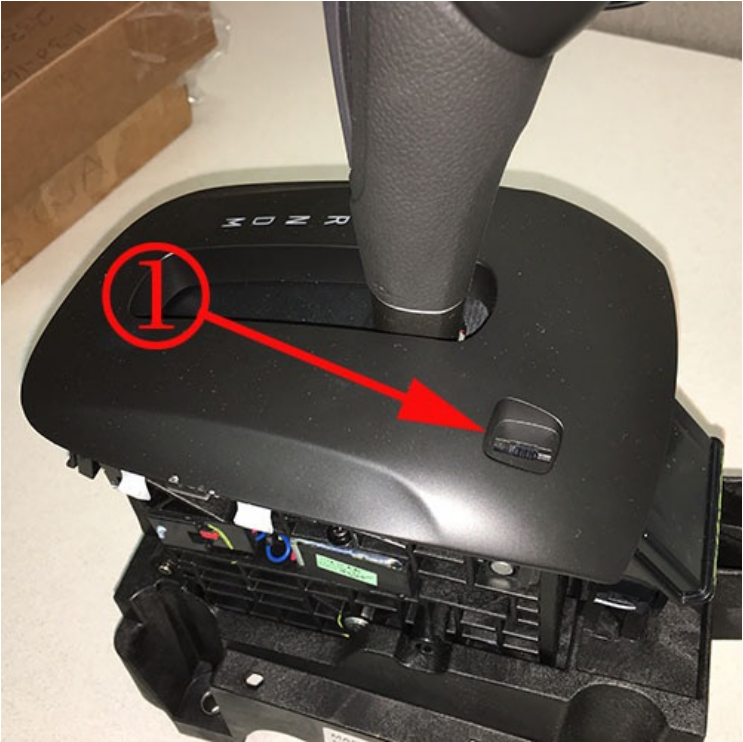
Brand:	Model:	Model Years:	VIN:		Engine:	Transmissions:
			from	to		
Buick	Encore	2013 - 2017	All	All	All	All
Chevrolet	Trax	2013 - 2017	All	All	All	All
Involved Region or Country	North America					
Additional Options (RPO)	N/A					
Condition	The BTSI cover is missing					
Cause	The BTSI cover may be missing or may break when removing the cover to test the shift interlock solenoid.

Correction:  
Do not replace the transmission shift control. The BTSI override cover is serviceable.  
#1 in first image is missing BTSI cover and second image is call out in the parts catalog.
