**NUMBER:** 23-029-17

Dimpled Driver Side Front Leather Heated Seat

2015 - 2017 (JK) Jeep Wrangler

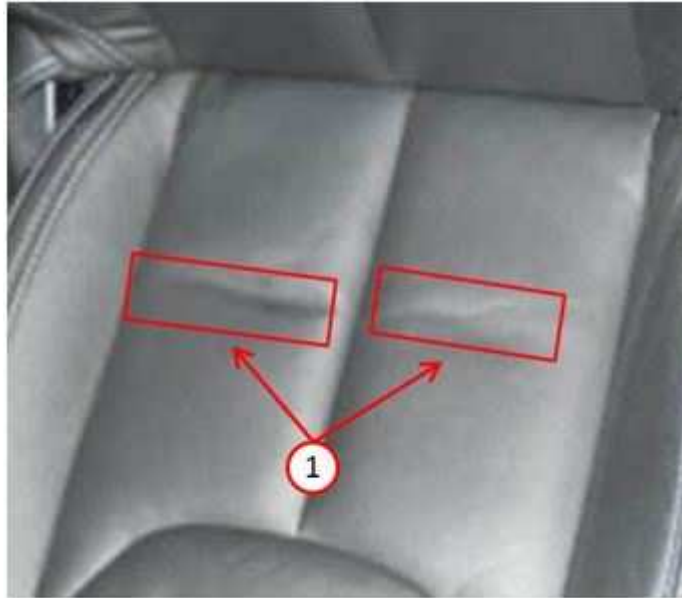
**Fig. 1**  
**Dimple Location On Leather Seats**

The customer may describe, the driver's front leather seat has dimples in the seat bottom. The dimples are caused by openings in the heated seat element, see (Fig. 1) .

1 - Dimples

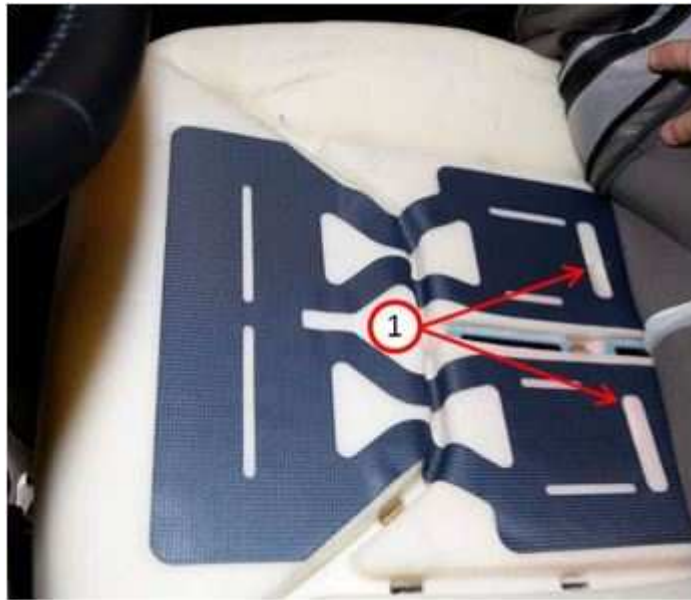
**Fig. 2**  
**Location To Install Patches**

1 - Opening in heater element

1. Remove the driver's seat cover. Refer to the detailed service procedures available in DealerCONNECT> TechCONNECT under: Service Info>23 - Body/Seats/Cover, Seat Cushion, Front/Removal .
2. Locate the area on the heated seat element to install the patches, see (Fig. 2) .

**NOTE: Ensure that the heater element is free of debris that may prevent patch from properly adhering to heater mat.**

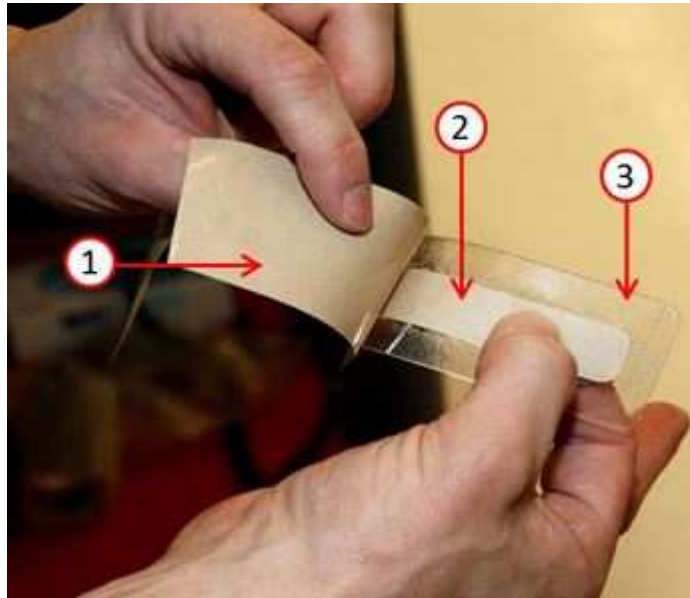
**Fig. 3**  
**Center Backing On Patch**

- 1 - Outer backing
  - 2 - Center backing
  - 3 - Adhesive
-

4. Remove outer backing from patch. Do not remove the center backing from the patch, see (Fig. 3) .
