**NUMBER:** 07-004-17 REV. A

Coolant Hose Retainer Clip Replacement

This bulletin involves replacing a coolant hose retainer clip with a new style clip.

2017 (GA) Alfa Romeo Giulia

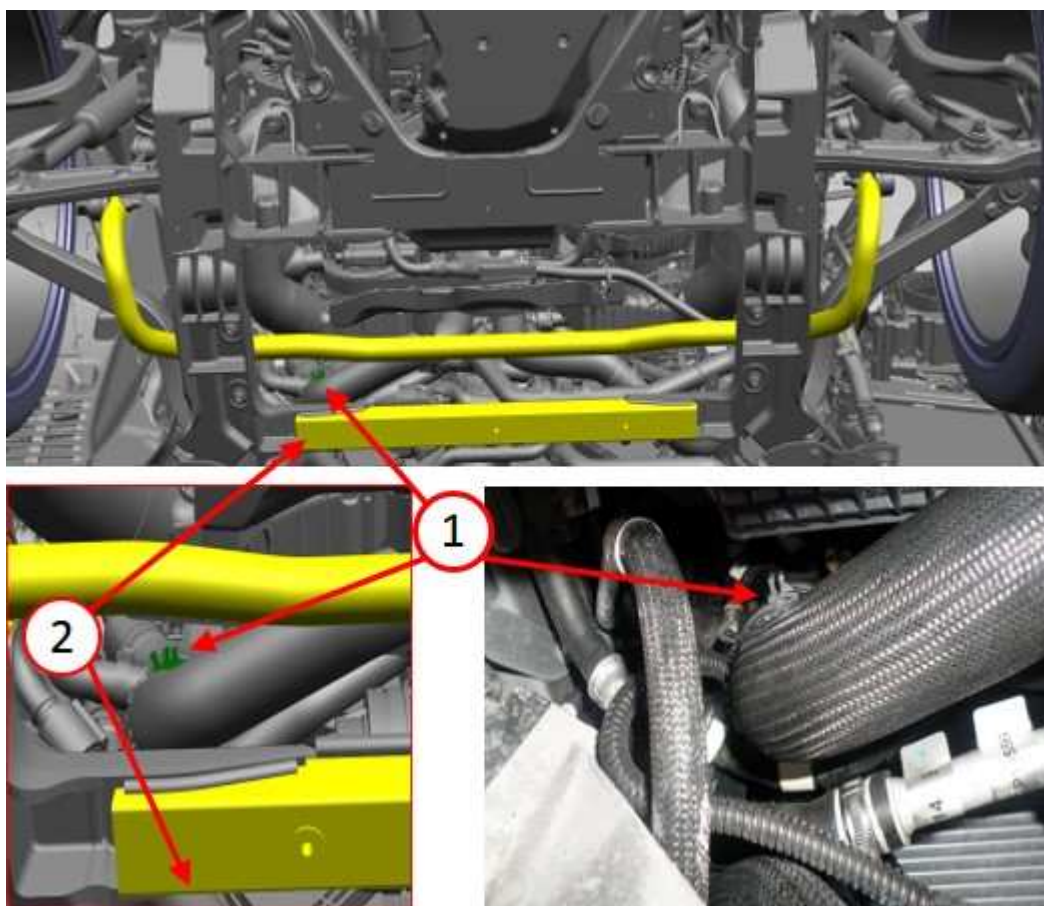
Fig. 1

2. Locate the coolant hose retainer clip in the left front, just behind the radiator, see (Fig. 1) and (Fig. 2) .

Location of Coolant Hose Retainer Clip

- 1 - Retainer Clip
  - 2 - Front of Vehicle
-

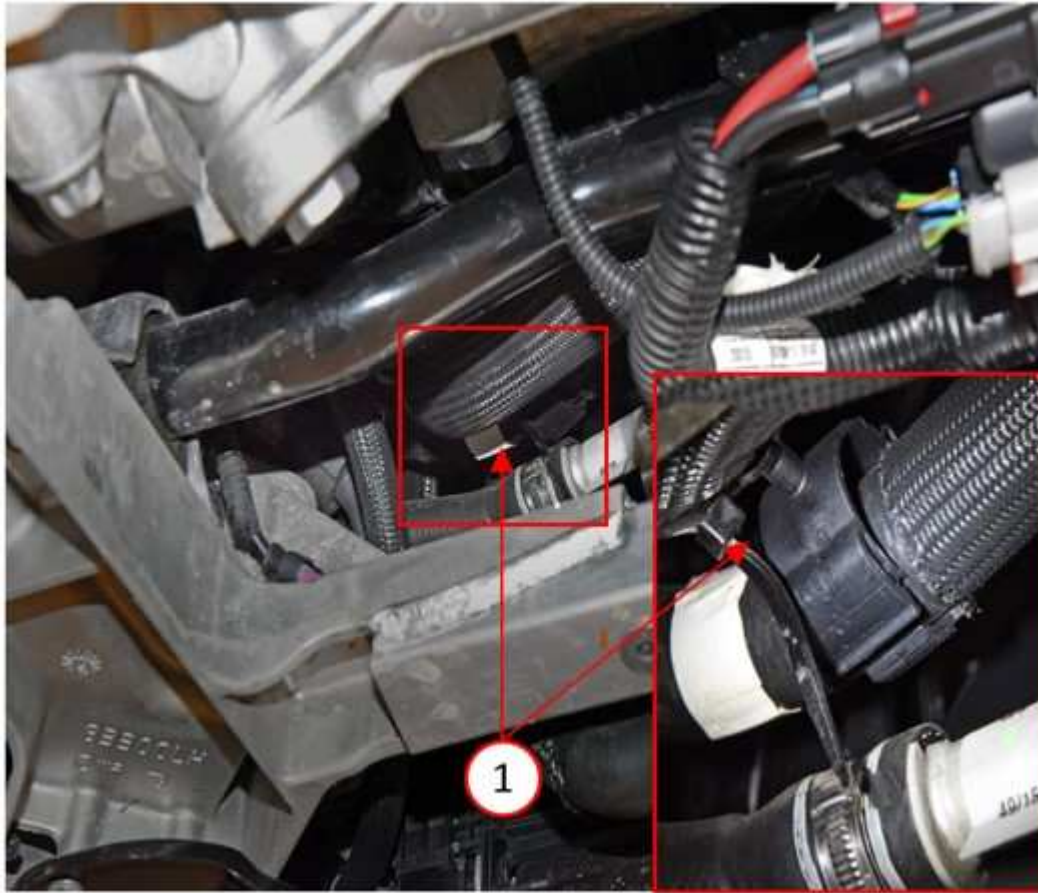
**Fig. 2**  
**Location of Retainer Clip**

1 - Retainer Clip

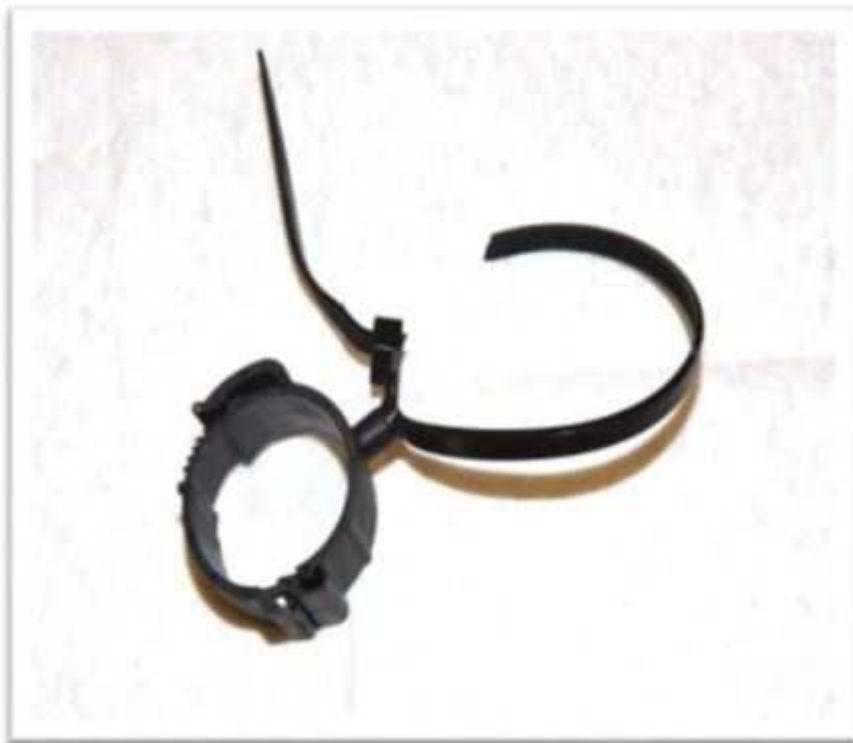
**Fig. 3**  
**Old Style Retainer Clip**

3. Remove and discard the old style retaining clip from the coolant hose, see (Fig. 3) .
