Service Bulletin

Bulletin No.: 17-NA-076

Subject: Information on Diesel Exhaust Fluid (DEF) Leaking Past Filler Cap

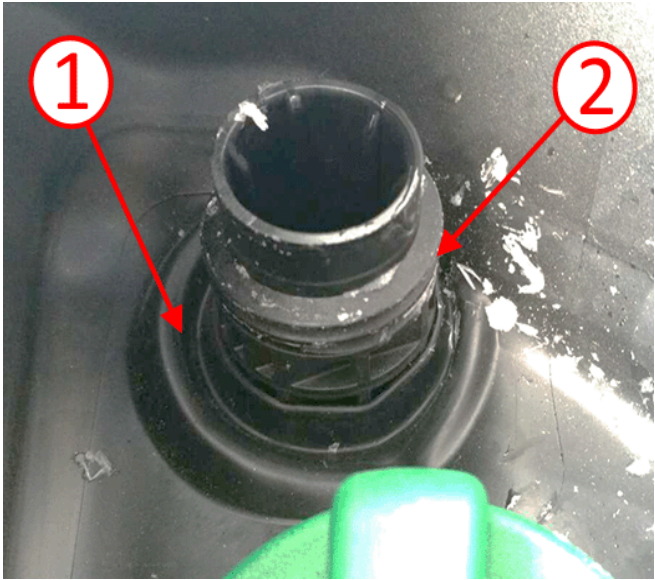
Involved Region or Country	North America
Condition	<p>Some customers may comment on one or more of the following conditions:</p> <ul style="list-style-type: none"> • DEF leaking at the filler pipe. • DEF filler cap doesn't install completely/properly.
Cause	<div style="text-align: center;"> </div> <p style="text-align: right; font-size: small;">4732593</p> <p>This condition may be caused by the grommet (1) in the fuel housing expanded around the DEF filler pipe cap threads (2).</p>

<p style="text-align: right; margin-top: 10px;">4732670</p>
<p>Position the grommet (1) away from the DEF filler cap threads (2).</p>
