Service Bulletin

Bulletin No.: 17-NA-349

Subject: Front and Rear Fascia Paint Mismatch, Color Sandy Ridge Metallic

Brand:	Model:	Model Year:		Date Breakpoint:		Engine:	Transmission:
		from	to	from	to		
Chevrolet	Equinox	2018	2018	April 17, 2017	May 12, 2017	All	All

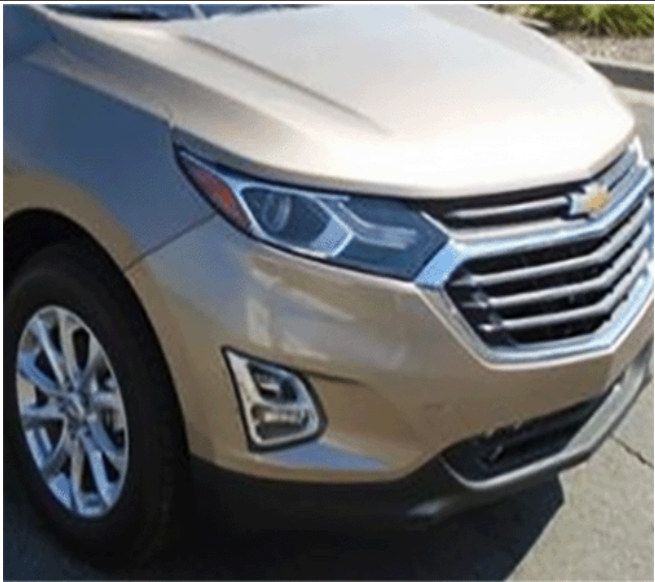
<p style="text-align: right; font-size: small;">4891581</p> <p>Some customers may comment on seeing that the front and rear fascia color does not match the color of the body. The mismatch is most noticeable in low light conditions or when the vehicle is indoors.</p>
Cause	The cause of the condition may be a paint variation when applied at the assembly plant.
Correction	<p>Important: Refer to the latest revision of the GM Approved Refinish Materials book to identify the paint systems you may use that have been engineered to meet GM standards.</p> <p>The latest revision of the GM Approved Refinish Materials booklet is located on the Genuine GM Parts website at www.genuinegmparts.com.</p> <p>Apply correct color and clear coat to fascias, then blend fenders and liftgate/quarter panels to match, following the service Procedure below.</p>
