Service Bulletin

Bulletin No.: 17-NA-397

Subject: Fuel Tank Scrapes and/or Gouges

Brand:	Model:	Model Year:		VIN:		Engine:	Transmission:
		from	to	from	to		
Chevrolet	Camaro	2018	2018			All	All

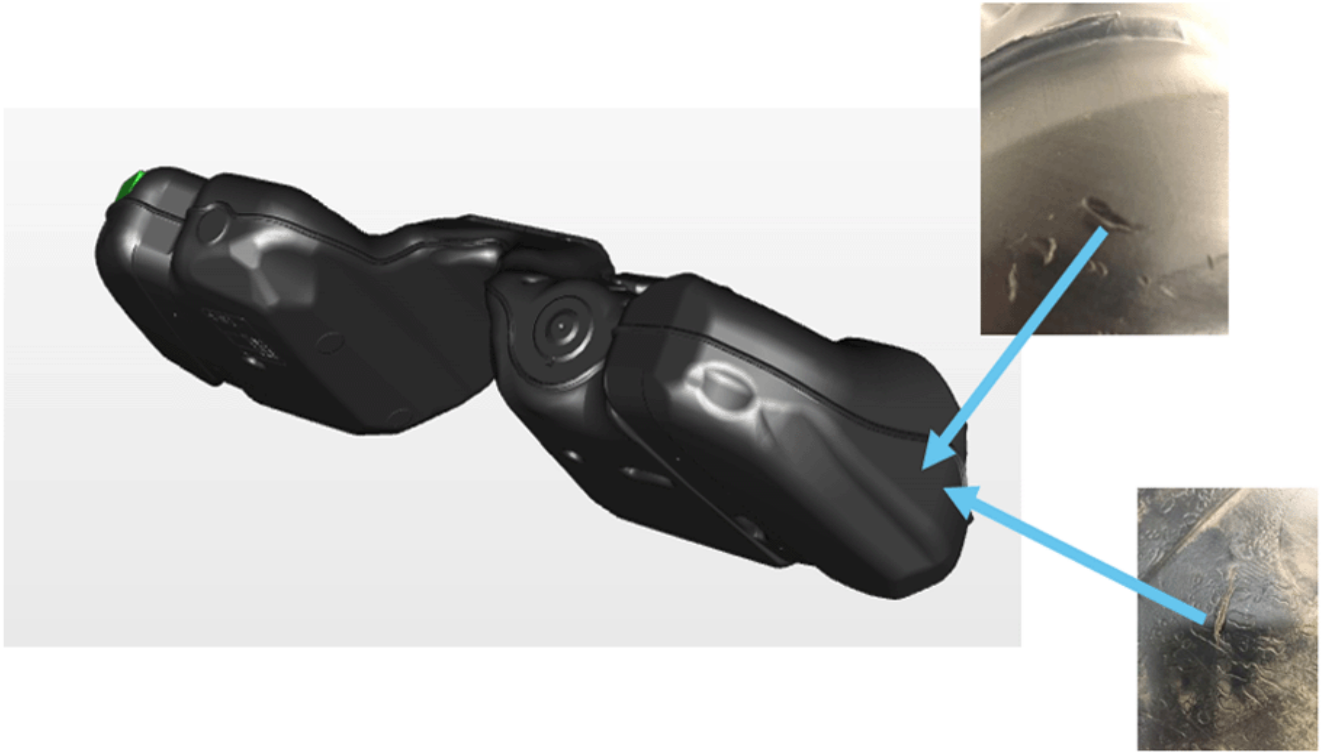
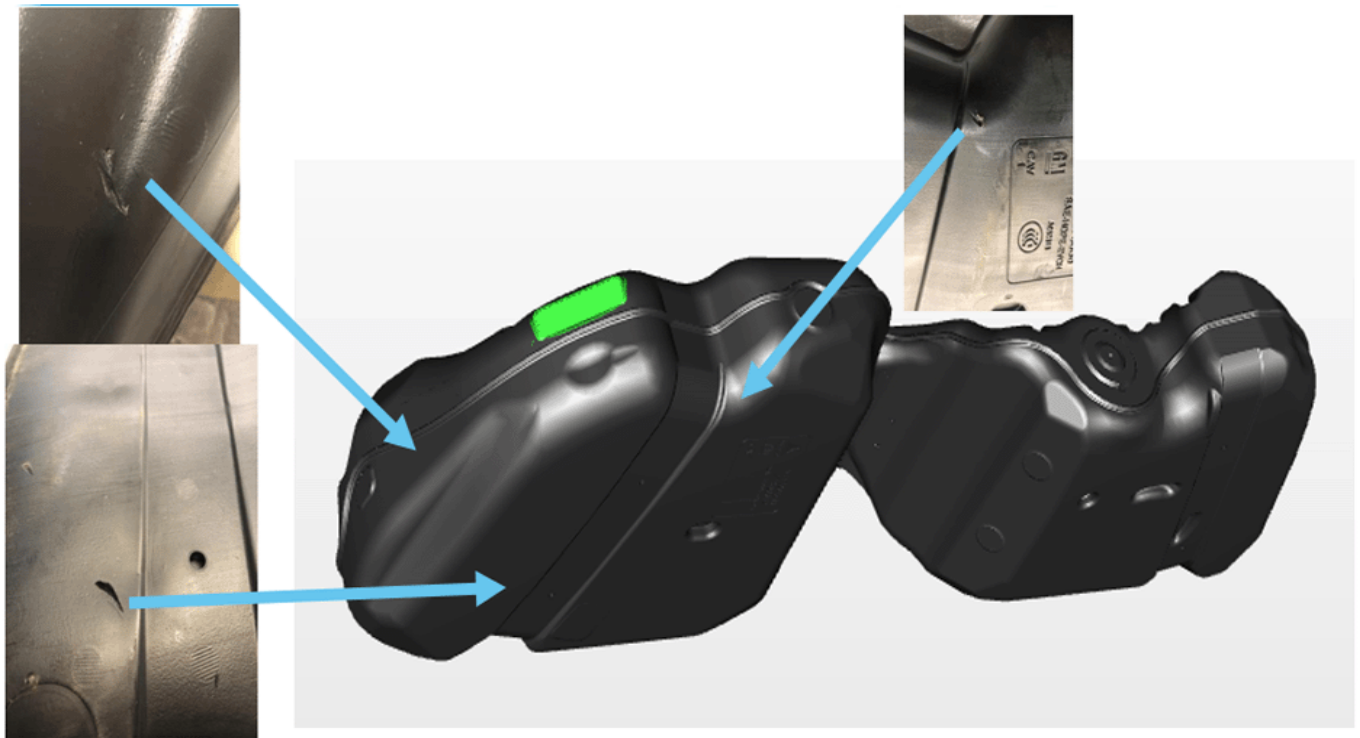
Examples of Scrapes and Gouges

Involved Region or Country	North America and N.A. Export Regions
Condition	During inspection, the customer or technician may comment that the fuel tank shows signs of scrapes and/or gouges. Refer to the pictures below.
Cause	The scrapes and gouges are due to how the parts were loaded into the racks prior to shipping to the vehicle assembly plant.
Correction	Testing of the parts has confirmed the scrapes and gouges are only cosmetic and there is no performance or long term durability concern with the tanks. No further action is required.
