Dealer Service Instructions for:

Customer Satisfaction Notification T13 Manual Transmission Shift Lever

T13

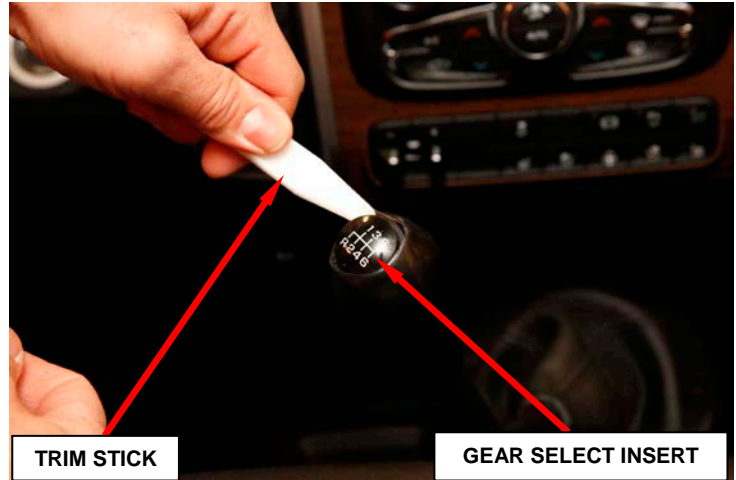
Figure 1 – Gear Select Insert

1. Using a trim stick C-4755 or equivalent, insert the trim stick into the gear shifter knob using moderate force to remove and save the gear select indicator insert (Figure 1).

14. Push the gear select indicator insert into the gearshift lever knob (Figure 9).

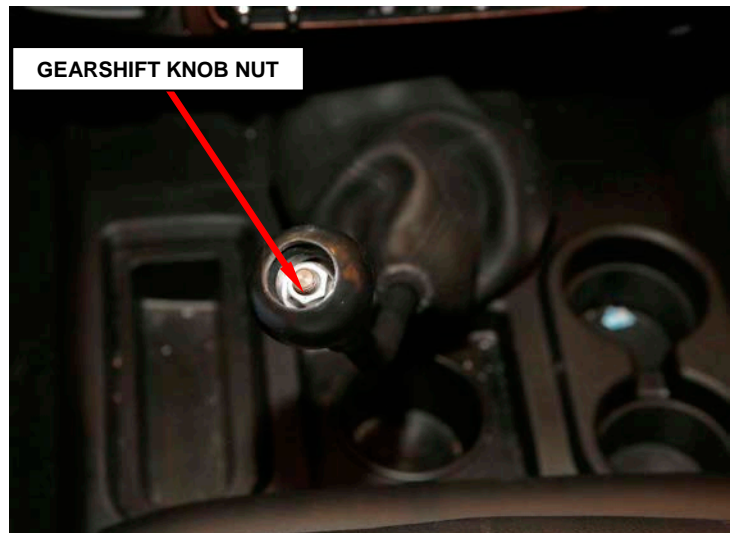
Figure 2 – Gearshift Knob Nut

2. Remove and save the gearshift knob nut (Figure 2).

13. Install the gearshift lever nut and tighten to 27 N·m (20 ft. lbs.) (Figure 2).

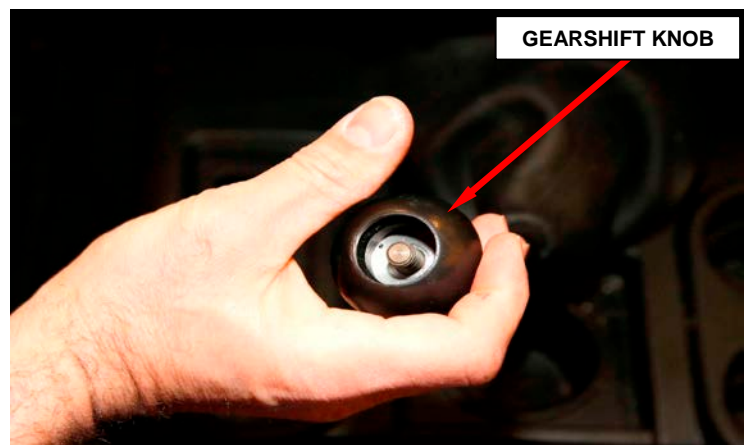
Figure 3 – Gearshift Knob

3. Remove and save the gearshift knob by grasping and rotating the knob in a counter clockwise direction (Figure 3).

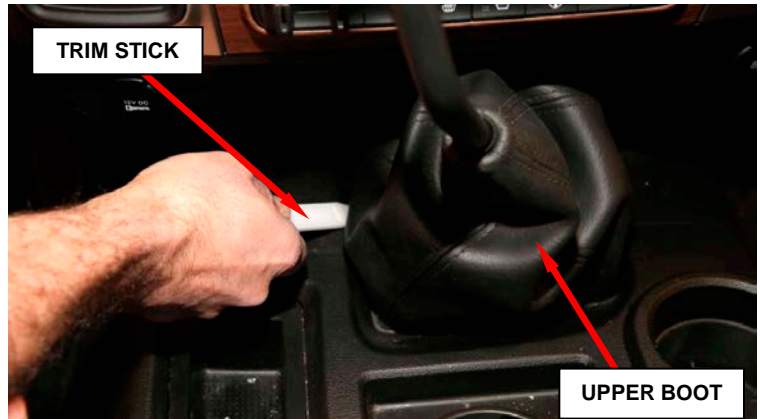
Figure 4 – Gearshift Lever Boot

4. Using trim stick C-4755 or equivalent, moderately pry on lower front edge of gearshift lever upper boot until the front of the boot is released from the center console (Figure 4).

5. Slide upper boot upward and remove from the gearshift lever.

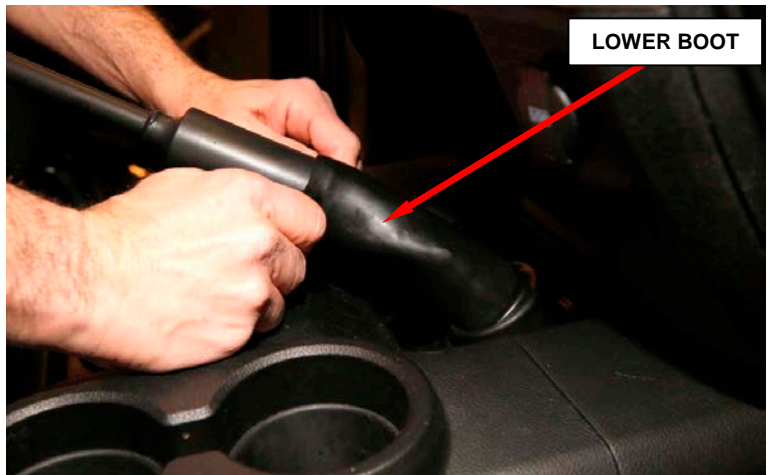
Figure 5 – Lower Shifter Boot

6. Grasp the lower boot sides and peel the lower boot in a downward direction to expose the gearshift attachment nuts (Figure 5).

7. Remove and discard the two gearshift lever nuts and gearshift lever.

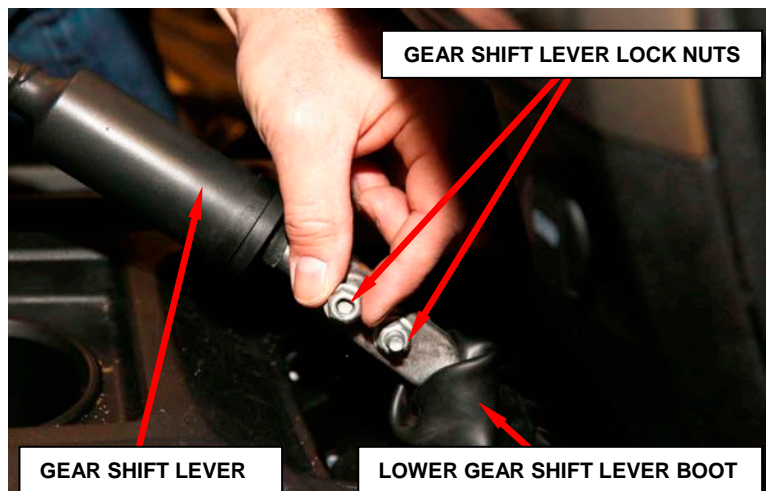
Figure 6 – Lock Nuts

8. Insert the **NEW** gearshift lever into transmission lever and hand start the **NEW** provided lock nuts (Figure 6).

9. Tighten the gear shift lever lock nuts to 20 N·m (15 ft. lbs.).

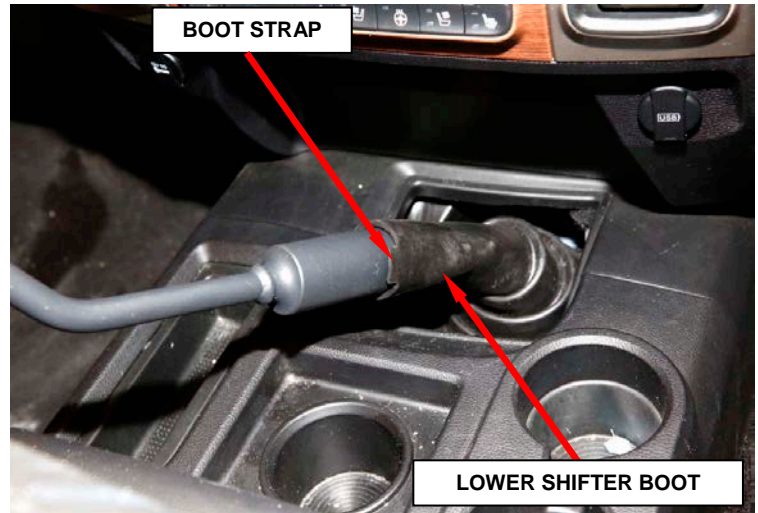
Figure 7 – Lower Shifter Boot

10. Grasp the lower shifter boot side straps and pull in an upward direction to reseat the lower boot onto the gearshift lever (Figure 7).

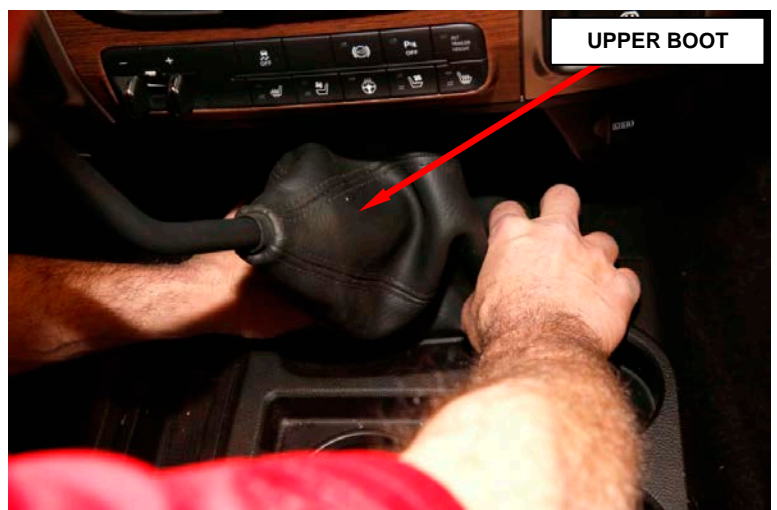
Figure 8 – Upper Shifter Boot

11. Install the gearshift lever upper boot onto the gearshift lever and push on the base of the boot downward to engage the clips to the center console housing (Figure 8).
