Bulletin No.: 00-06-01-026J

Subject: Intake Manifold Inspection/Replacement After Severe Internal Engine Damage

Models: 2018 and Prior GM Passenger Cars and Trucks (Includes Medium Duty Trucks with Gas Engines)

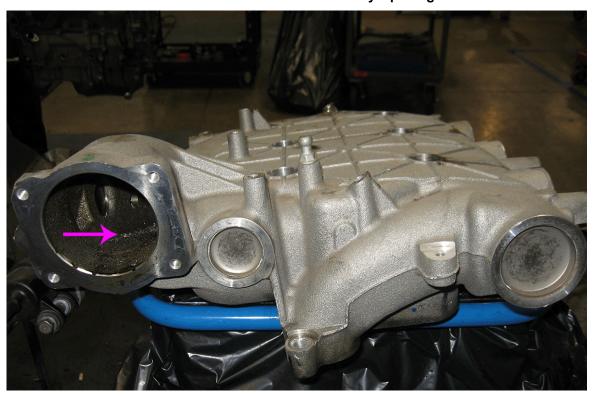
View of Debris in Aluminum Intake Manifold — Throttle Body Opening

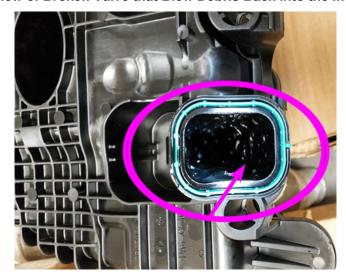
View of Broken Valve that Blew Debris Back into the Intake from the Combustion Chamber

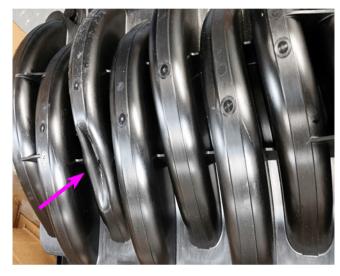
View of Intake from GEN 5 V8 that Experience Lifter Collapse and/or Broken Valve Spring
