## **Service Bulletin**

Bulletin No.: 17-NA-256

Subject: Information on Trailer Brake Controller Blunt End Harness Breakout Connection

Brand:	Model:	Model Year:		VIN:		Engine:	Transmission:
		from	to	from	to		
Buick	Enclave	2018	2018				
Chevrolet	Traverse

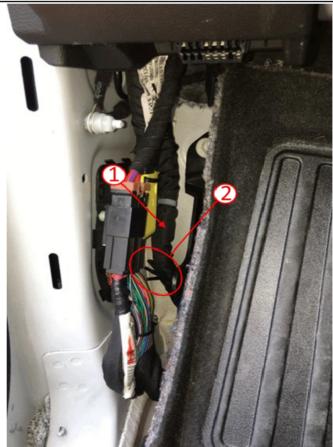
4847349

The trailer brake controller blunt ends (2) is part of the Instrument panel wiring harness and the blunt cut wires are located under the left instrument panel, behind the front side door sill garnish molding trim.

**Note:** This bulletin is to aid the customer in locating the trailer brake controller blunt end wires.

If the customer wishes to have an aftermarket brake controller installed in their vehicle, it would be considered as a Customer Pay option.
would be considered as a Customer Fay option.
