August 2017
FL740A
NHTSA #17V-402
Transport Canada #2017-319
REVISED NOTICE

Subject: Brake Check Valve

Models Affected: Specific Freightliner 108SD, 114SD, and Business Class M2 vehicles manufactured December 16, 2014, through April 27, 2017.

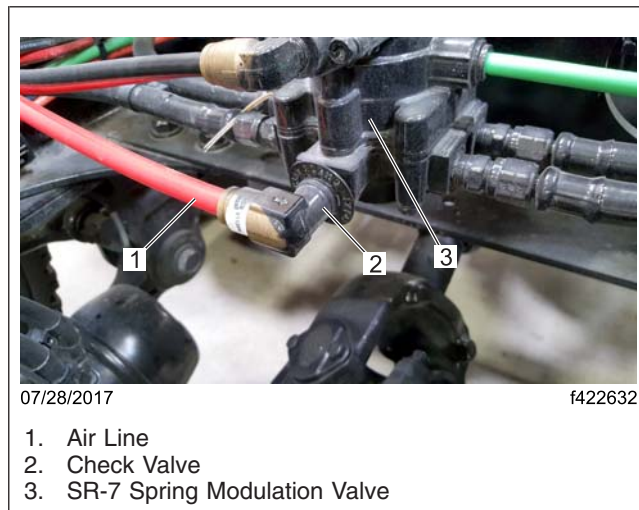
Fig. 1, SR-7 Spring Modulation Valve

Certain vehicles may not have a required check valve installed in one of the ports of the spring brake modulation valve. If a certain check valve is missing, a rapid loss of air pressure in the secondary system could cause a similar rapid loss of pressure in the primary system, which may lead to a sudden application of the parking brakes. This could increase the risk of a crash.

3. Locate the SR-7 spring modulation valve, shown in **Fig. 1**, and inspect the secondary air port for a check valve fitting. The check valve is integral to the fitting and will have the plastic tag that says 'check valve' on it. See **Fig. 2** for an example of the check valve.

1. Drain the air from the system.
2. Disconnect the air line. See **Fig. 1**.
3. Remove the fitting.
4. Install the new check valve fitting. See **Fig. 2**.
5. Connect the air line.
6. Start the truck to build air pressure in the system.
7. Using a solution of soap and water, test the air line for leaks. If bubbles appear, repair the leak as needed.
8. Clean a spot on the base label (Form WAR259). Write the recall number, FL740, on a completion sticker (Form WAR260), and attach it to the base label.
