Recall Campaign

Subject: TBB HDX Heater Hose Plumbing

Models Affected: Specific Thomas Built Buses Saf-T-Liner HDX buses manufactured November 29, 2012, through February 4, 2016.

Work Instructions

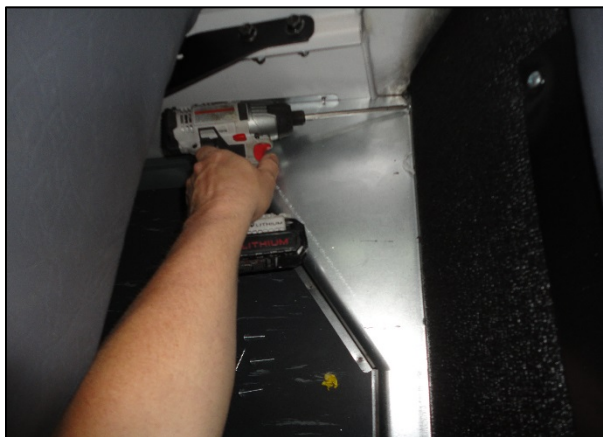
Figure 3, Removal of interior heater hose cover

4. Remove the hose cover located on the curb side of the bus in the corner of the bus body and the davenport. See **Figure 3**. Retain the screws for reinstallation.

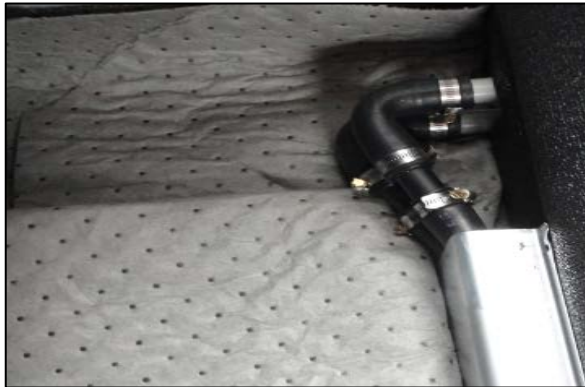
Figure 4, Place absorbent pad under the hoses

5. Place an absorbent mat under the hoses to catch any leftover coolant in hoses. See **Figure 4**.

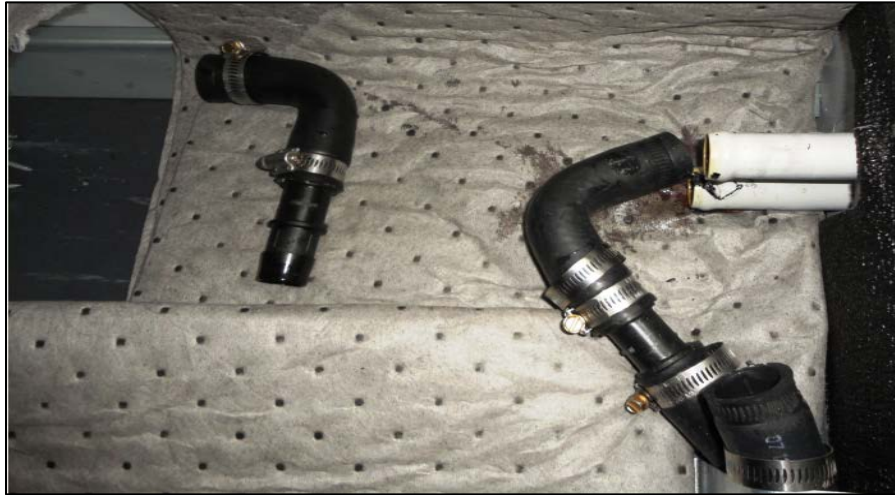
Figure 6, Removal of rubber elbow

7. Remove other side of rubber hose elbow and discard hose, but keep clamps for reuse. See **Figure 6**.

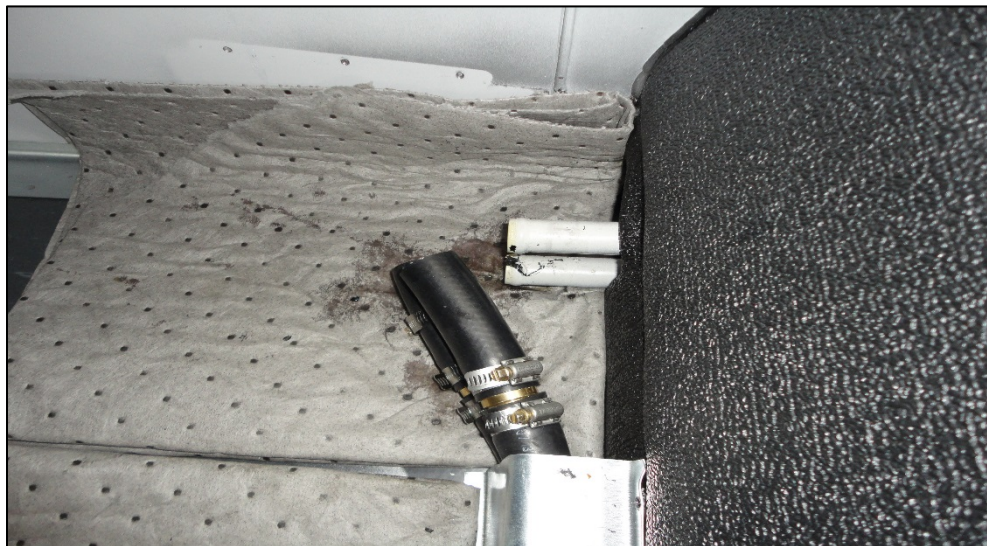
Figure 7, Installation of 4 inch hose and brass fittings

8. Cut a 4 inch piece of the proper type hose, see **Table 2**. Install the straight brass fitting from the kit into the existing hose using clamps. See **Figure .7**

NOTE: The installation of the elbow and straight brass fittings will require additional clamps. They are included in the kit with the elbows and straight brass fittings.

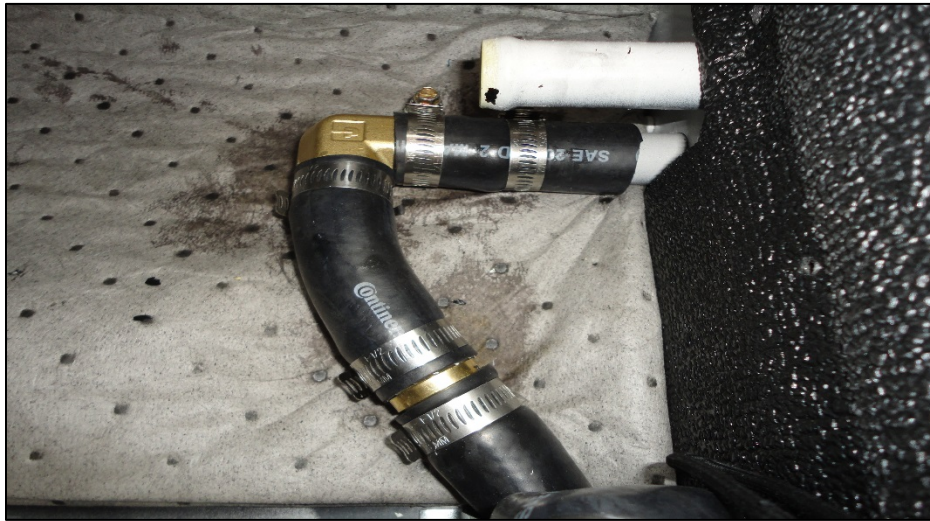
Figure 10, Installation of 4 inch lines onto elbow

11. Slide a clamp onto each 4 inch section of hose then install the hoses (connected earlier) onto the other side of elbows as shown in **Figure 10**, making sure the supply and return lines are installed correctly. Tighten the clamps after adjusting to ensure no kinks in the lines will restrict coolant flow.
