Subject		Market
Precautions regarding usage of A/C stop leak during A/C system service		USA
Service Category	Section	
Vehicle Interior	Heating/Air Conditioning	
Applicability		
Applicable Models With Air Conditioning

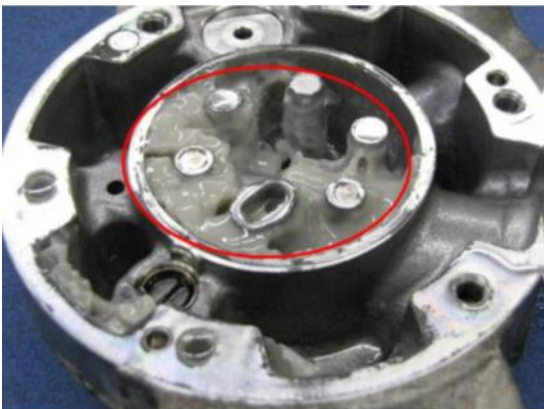
During previous air conditioning service, leakage prevention agent (A/C stop leak) may have been added to the A/C system. Adding stop leak products to the A/C system is not a recommended or approved Lexus repair process. During A/C service, moisture enters the A/C system, and can react with the previously added A/C stop leak, forming a gelatinous substance. The gel substance that forms can cause the A/C compressor to bind and or seize.

- 1) Do not use any A/C stop leak products to diagnosis or repair suspected A/C system leaks.
- 2) Because it's unknown if A/C stop leak has been used for A/C system service in the past, precautions should be taken to ensure moisture does not enter the A/C system. Following these precautions might help prevent gelling from occurring if A/C stop leak is already present in the system.
 - A) Seal disconnected parts with plugs or vinyl tape
 - B) Vacuum purge A/C system
 - C) Confirm leaks are not present
