Subject		Market
<b>Precautions regarding usage of A/C stop leak during A/C system service</b>		USA
Service Category	Section	
Vehicle Interior	Heating/Air Conditioning	
Applicability		
All Models

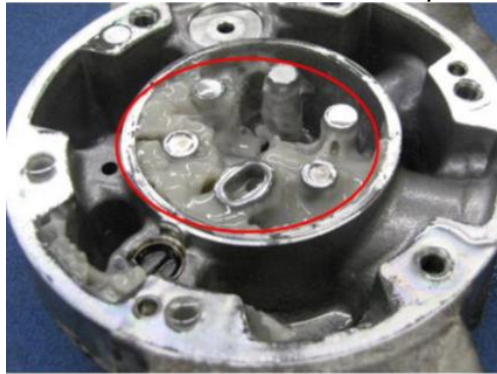
During previous air conditioning service, leakage prevention agent (A/C stop leak) may have been added to the A/C system. Adding stop leak products to the A/C system is not a recommended or approved Scion repair process. During A/C service, moisture enters the A/C system, and can react with the previously added A/C stop leak, forming a gelatinous substance. The gel substance that forms can cause the A/C compressor to bind and or seize.

- 1) Do not use any A/C stop leak products to diagnosis or repair suspected A/C system leaks.
- 2) Because it's unknown if A/C stop leak has been used for A/C system service in the past, precautions should be taken to ensure moisture does not enter the A/C system. Following these precautions might help prevent gelling from occurring if A/C stop leak is already present in the system.
  - A) Seal disconnected parts with plugs or vinyl tape
  - B) Vacuum purge A/C system
  - C) Confirm leaks are not present
