SERVICE ACTION: REPLACE ACTIVATED CHARCOAL FILTER AND NVLD SENSOR HOLDER

This Service Information bulletin replaces SI B16 01 17 **dated February 2017**

F25 (X3)	F26 (X4)
----------	----------

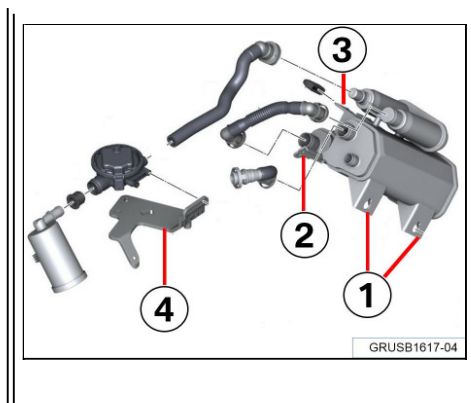
The activated charcoal canister and or NVLD sensor holder may be damaged.

Transportation damage.

<ol style="list-style-type: none"> 1. Inspect the mounting brackets (1-3) in the illustration located on the activated charcoal canister.
--	--

Inspect the NVLD sensor holder (4).

Replace activated charcoal canister and NVLD sensor holder if found damaged.

Refer to repair instruction 16 12 010 "Replace the activated charcoal canister".

2. Replace the activated carbon canister and the NVLD sensor holder if found cracked or deformed.
