SERVICE ACTION: CHECK ROUTING OF FUEL LINE

G12 (740i & 740Li)	G12 PHEV (740e xDrive)	G30 (530i)	
--------------------	------------------------	------------	--

This Service Action involves certain 7 Series and 5 Series vehicles (7,043 cars) produced from 07/30/2015 to 11/25/2016.

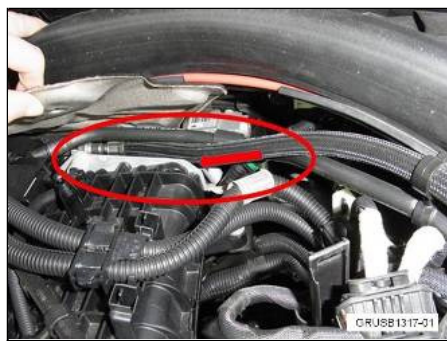
The fuel feed line is not correctly routed behind the tank ventilation line and may conflict with components of the intake system.

Picture shows incorrectly positioned fuel line (in front of the tank ventilation line) contacting the rear bracket of the intake manifold.

This may cause abrasion on the protective fabric coating of the fuel feed line.

Verify the proper routing of the fuel feed line as shown in the accompanying graphic.

1. Remove the engine acoustic cover. Identify the fuel feed line (covered in protective fabric) and the tank ventilation line (not covered in protective fabric).
2. If necessary, move the fuel feed line so that it is routed behind (slide underneath) the tank ventilation line and is not able to contact the components of the intake system.

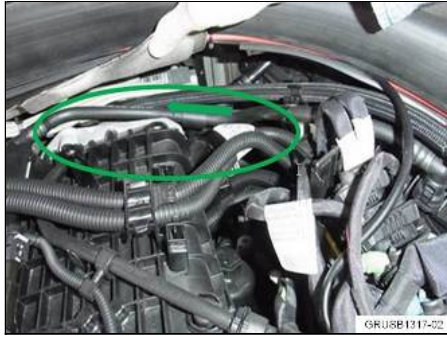
Proper location of the fuel line (behind the tank ventilation hose).
