# Customer Satisfaction Campaign

**CC-17-20-07**

**MODEL: Karma Revero**

**TITLE: PTC Heater Replacement**

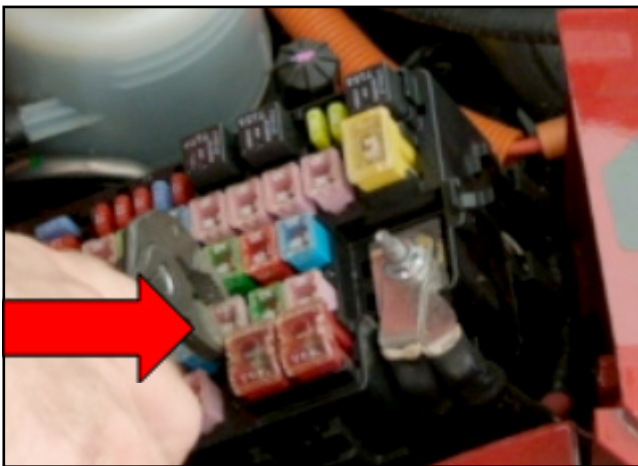
fig.1a

- a. Note- have vehicle unlocked, open all the windows before disconnecting
- b. Remove the 10A solar panel fuse as shown (fig.1a)
- c. Disconnect the 12V harness as shown (fig.1b).

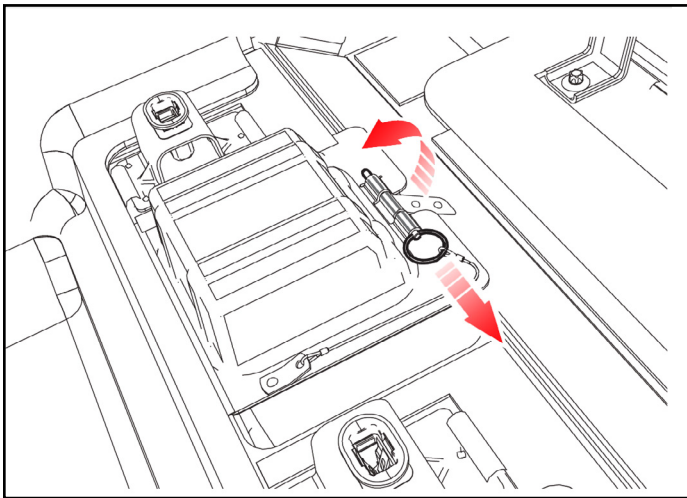
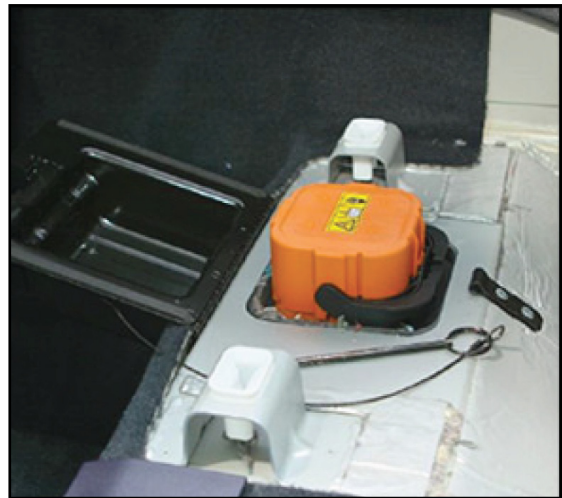
Remove the rear seat cushion to expose the manual service disconnect (MSD). To deactivate the high voltage supply to the vehicle, open the left rear door, lift the lower left rear seat cushion to unlatch it. Under the cushion you will find a boxed cover with a locking pin (fig 2a and 2b).

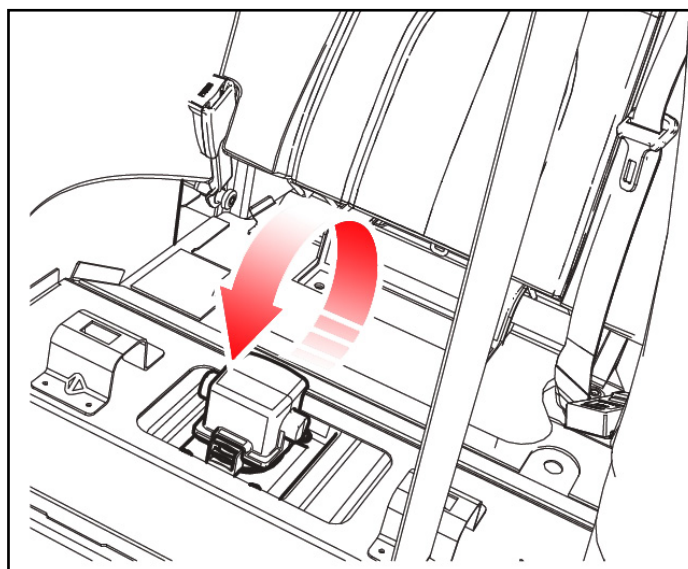
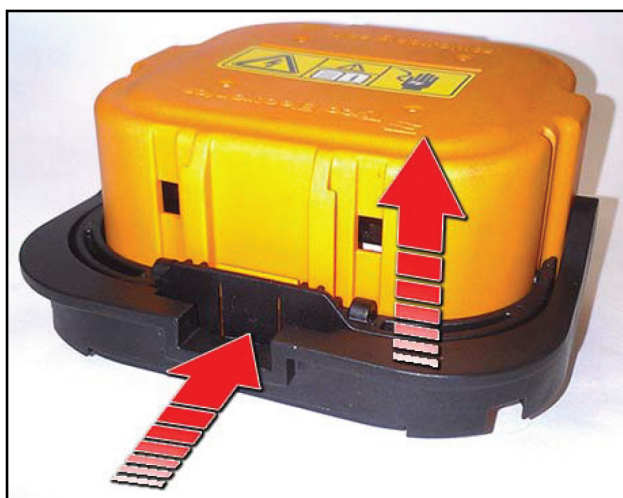
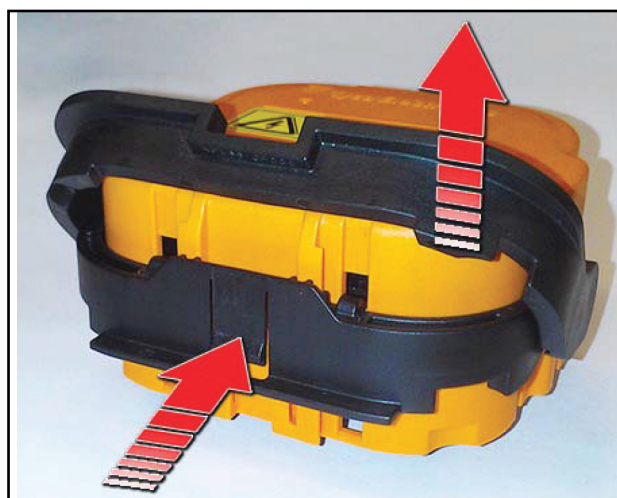
2.1.1 Release the latch pin from the MSD latch (fig.3a,3b,and 3c). Lift cover for access, release clip and remove the MSD from the HV battery

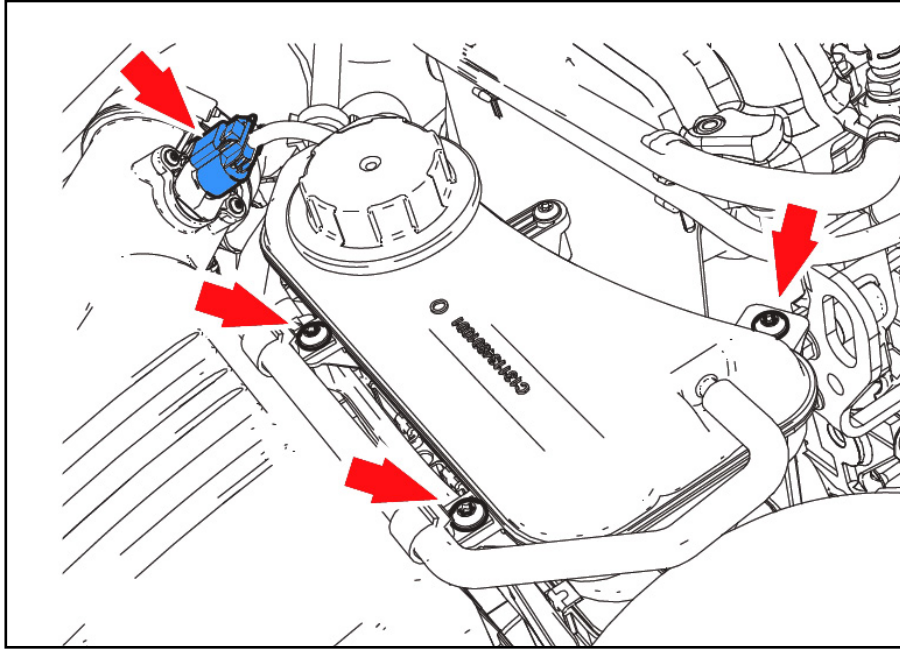
fig.4

3. With the hood open- remove the engine cover and proceed to Disconnect MAF sensor harness connector (blue in fig.4)

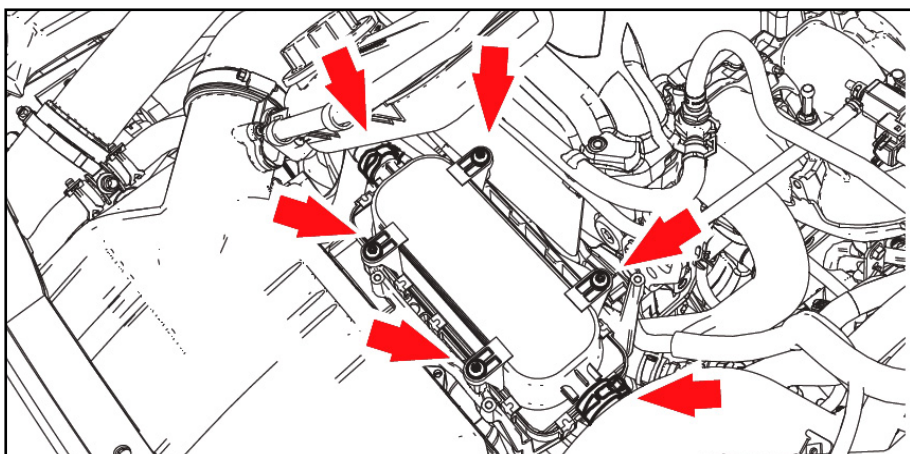
fig.5

4. Remove screws (x3) securing battery low temperature reservoir to PTC mounting bracket
5. Release battery coolant reservoir from mounting and tie aside for access (fig.5)
6. Clamp coolant hoses either side of PTC heater as close to connections as possible

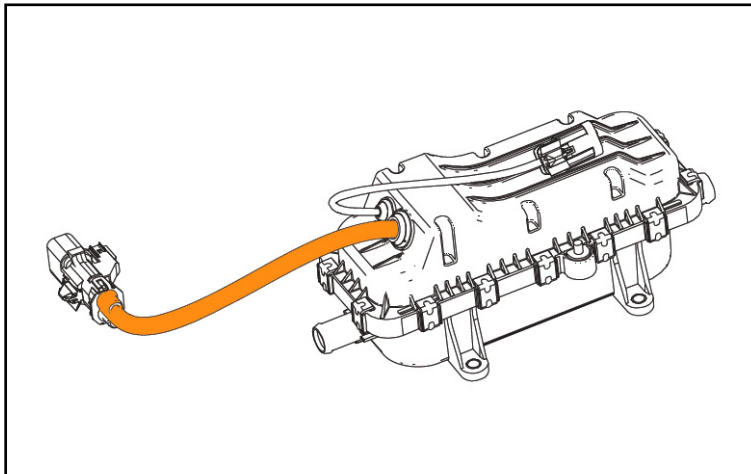
9. Raise PTC heater and disconnect the orange high voltage connector and low voltage harness connectors (fig. 6)

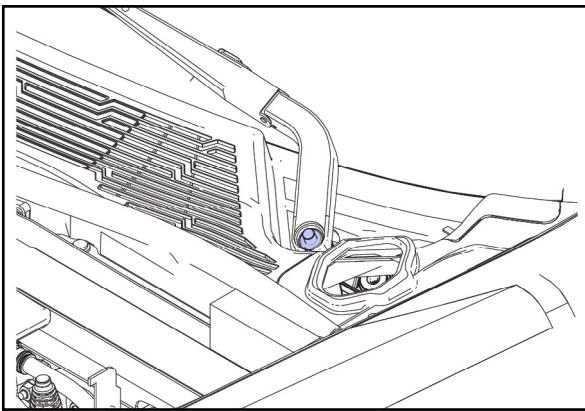
fig.7a

3. Remove the windshield wipers
  - a. Mark the fitted position of the wiper arm to reinstall it at the same park location
  - b. Remove the nut (install torque 25Nm) (fig. 7a)
  - c. Release clip securing the washer nozzle to wiper arm and release
  - d. disconnect hose. (note routing for easier install) (fig. 7b)

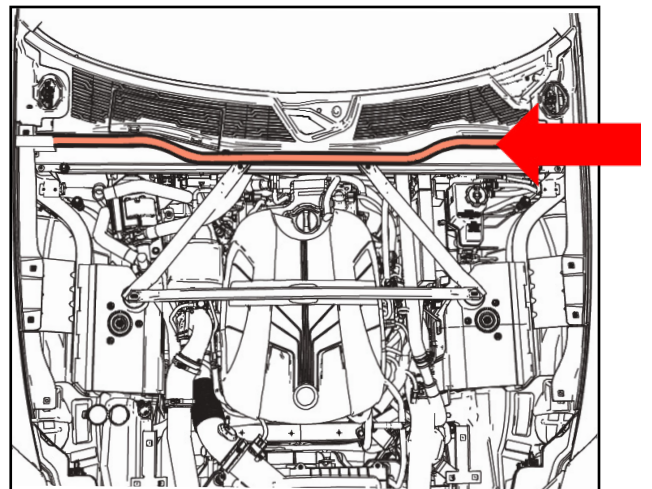
fig. 8a

4. Remove the cowl screen
  - a. Remove the rear hood seal from the cover (fig. 8a)
  - b. Remove the clips (x7) securing the cowl to the body, disconnect the drain tube on LH side
  - c. Remove cowl (indicated by arrow)

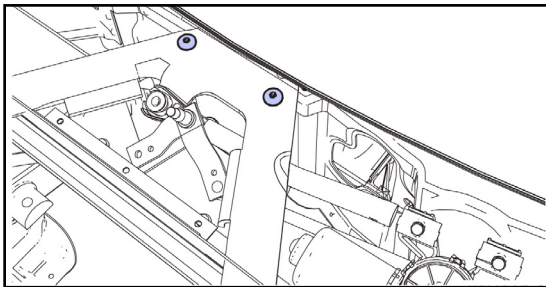
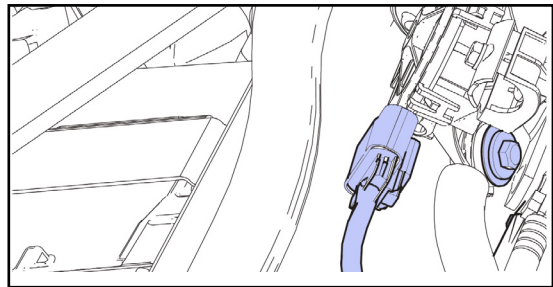
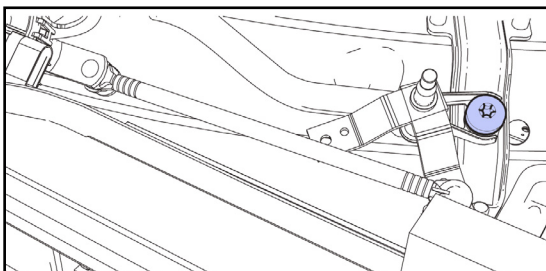
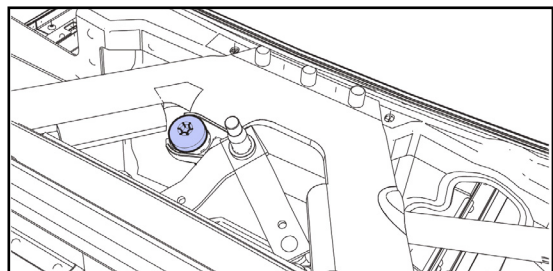
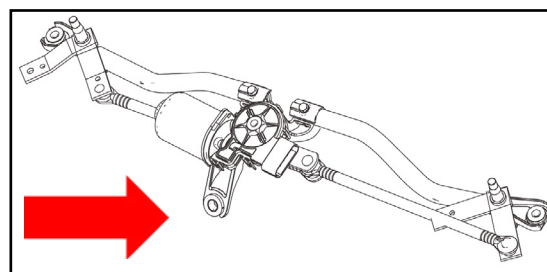
5. Remove the cowl brace and the wiper module -to access the heater hose below.
  - a. Remove screws (x2) securing plenum chamber brace to bulkhead. Torque - 25 Nm (fig.9a)
  - b. Disconnect wiper motor connector (fig.9b)
  - c. Remove screw securing wiper motor to bulkhead. Torque - 25 Nm (fig.9c)
  - d. Remove screw securing wiper motor to bulkhead brace. Torque - 25 Nm (fig.9d)
  - e. Remove bulkhead brace (fig.9d)
  - f. Remove wiper motor assembly, LH mounting screw. Torque - 25 Nm (fig.9e) - there are 2 zipties and 1 bolt underneath the flip up
  - g. Install is reverse of removal

**NOTE:** There is a nut and bolt here, it is not captured, have a magnet ready to capture these as they are loosened.

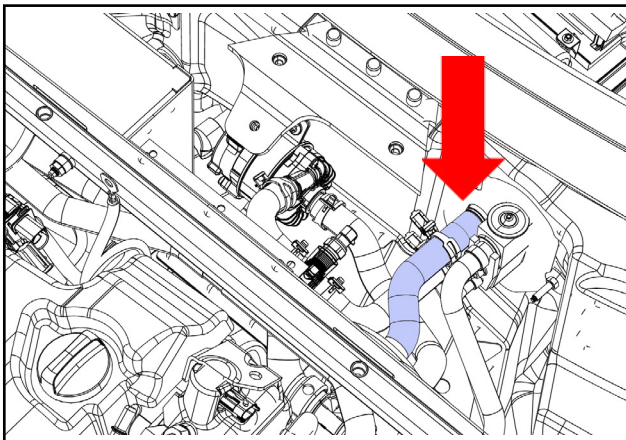
fig. 10a

- a. Remove the clamp from the heater core out hose connection (upper hose not connected to pump- (fig.10a)
- b. Use a soft pry- or 90 degree tool, and gap the hose end off the connector to allow to burp the system (fig.10b)
- c. Have the vehicle in Stealth Mode with the heater enabled Maximum heat is not required to run the pump on high, however max heat periodically will aid in verification that heat is coming out of the vents (this has been successfully performed with vehicle in ACC Mode with Defrost on)
- d. Make sure PTC hoses get hot, this may take several minutes, to bleed at heater core.
