EDGE CORROSION ON THE EXTERIOR FRONT AND REAR DOOR UNDER THE PAINT FINISH

F10 (5 Series Sedan)	Produced through 7/24/16
----------------------	--------------------------

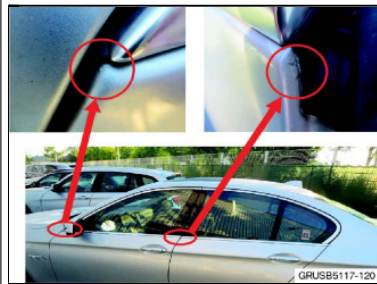
Corrosion of the front door and rear edges is appearing in paint surface near window trim.

Material contamination.

Remove the corrosion, repair the sheet metal and repaint/refinish the affected doors as necessary.

Note: Replacing the complete sheet metal door assembly is not necessary to address this corrosion issue.
