September 2017
FL724A-Q
NHTSA #16V-666 (Non-School Buses)
NHTSA #16V-664 (School Buses)
THIRD REVISED NOTICE

Subject: ICU3S Instrument Cluster Hydraulic Brake Telltale

Models Affected: Specific Freightliner Business Class M2 vehicles and Freightliner Custom Chassis S2 bus and B2 (Thomas Built Buses C2 Saf-T-Liner) school bus chassis manufactured March 3, 2015, through September 8, 2016.

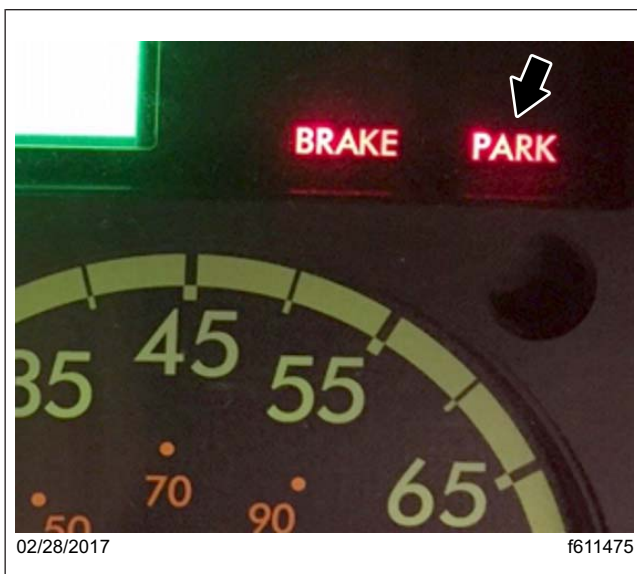
Fig. 1, A "Park" Telltale - Replace ICU3S

1. Check the base label (Form WAR259) for a completion sticker for FL724 (Form WAR260) indicating this work has been completed. The base label is usually located on the passenger-side door, about 12 inches (30 cm) below the door latch (trucks) or over the driver's window (buses). If a completion sticker is present, no work is needed. If a completion sticker is not present, proceed to the next step.
2. Park the vehicle, shut down the engine, and apply the parking brakes. Chock tires.
3. During the bulb check at key-on, inspect the telltales on the ICU3S (affected telltales will be illuminated for three seconds). See [Fig. 1](#) and [Fig. 2](#).

If the ICU3S has a "Park" telltale, continue with the next step.

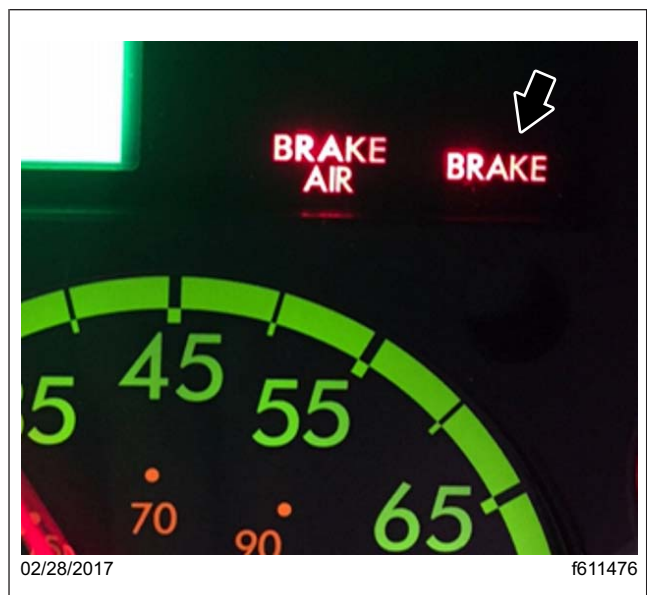
Fig. 2, A "Brake" Telltale is OK - No Replacement

If the ICU3S has a "Brake" telltale, no further work is needed. Clean a spot on the base label (Form WAR259), write the recall number, FL724, on a red completion sticker (Form WAR260), and attach it to the base label.
