# SS 1033223 WST 4700 with Cummins engine: Hood strap wrapping around A/c pressure switch

WST 4700 with Cummins engine

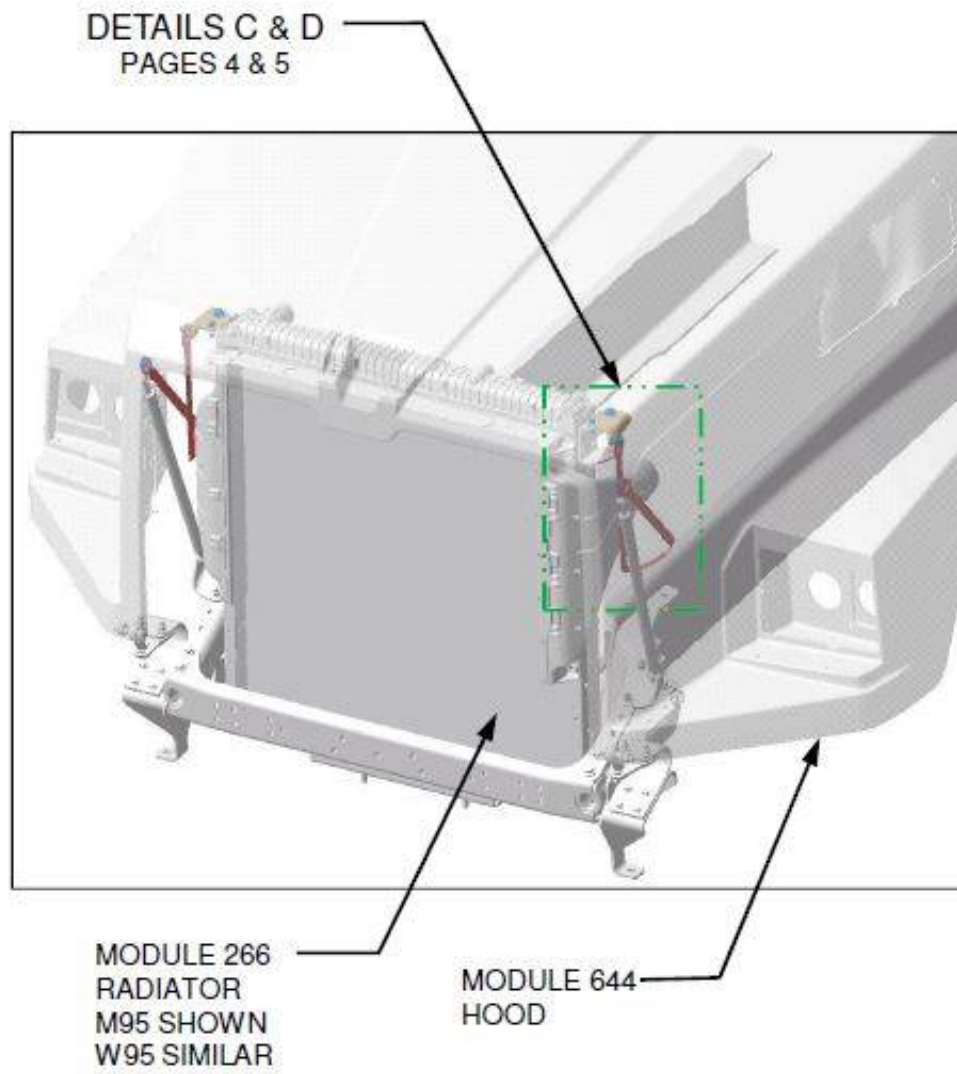
A/C pressure switch broken and/or hood strap wrapped around A/C pressure switch.

The hood strap on 4700s equipped with Cummins engines is liable to be tossed about by wind entering through the grille. The strap is long enough that it able to wrap around the A/C pressure switch as it is tossed in the wind.

Fig 1: hood strap shown in green rectangle

Wrap a spiral wrap hose protector over the strap. This will weigh the strap down, preventing it from being tossed about, as well as helping it roll off the pressure switch if it gets hooked on it.

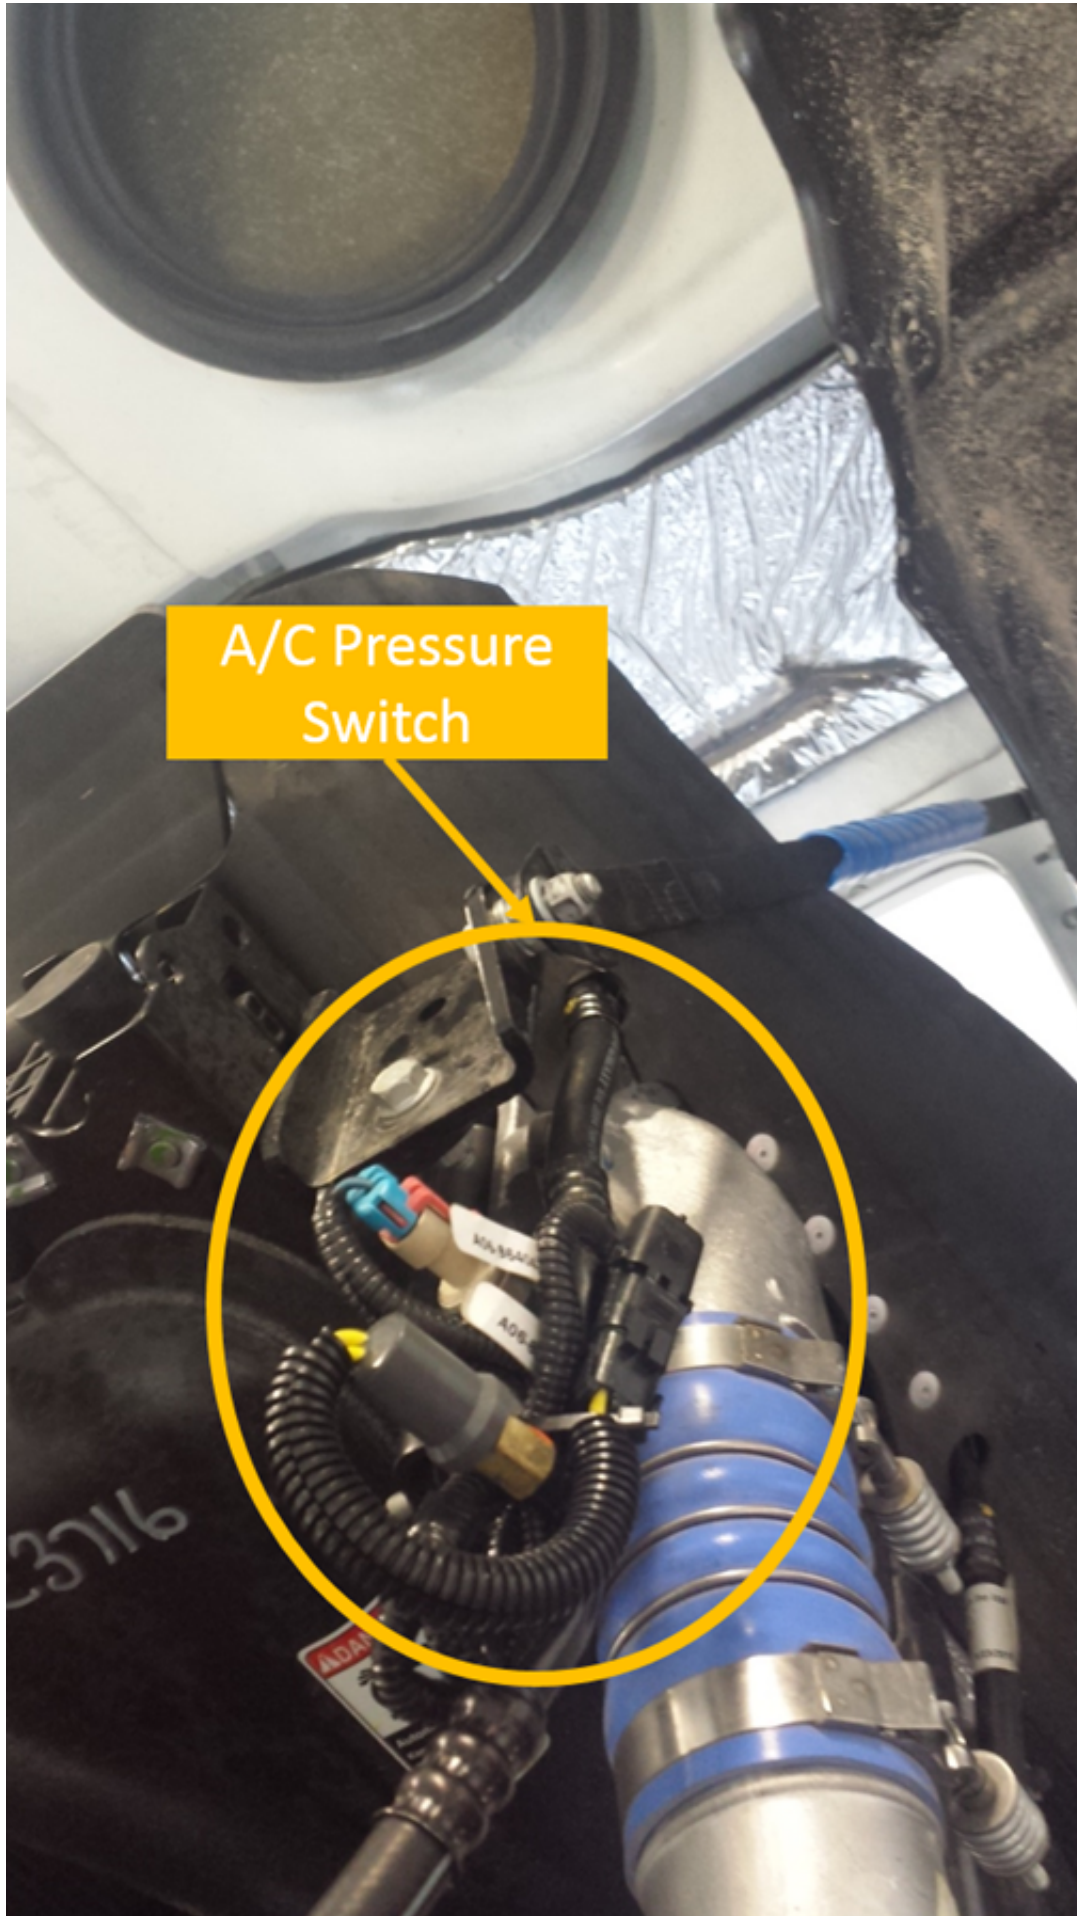
Fig 2: A/C Pressure switch next to strap, with improvement already installed
