## BR190: Exhaust system noises

| Topic number | LI49.10-P-066559 |
| Function group | 49.10 Exhaust pipes, catalytic converter, mufflers |

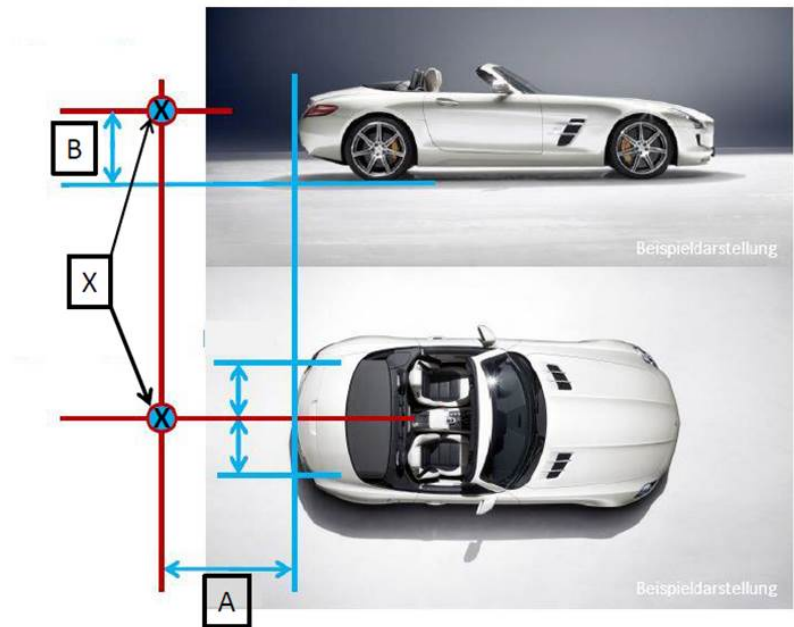
Messpunkt für Soundfile.  
jpg:

Creating a sound recording (see attachment "Measuring point"):

- X = Measuring point (central relative to vehicle)
- A = Approx. 1m behind the vehicle
- B = At height of approx. 1m behind the vehicle
