## Stowage compartment (ashtray compartment) lid does not open or close

| Topic number | LI68.20-P-066987 |
| Function group | 68.20 Center console |
| Validity | BR 205 with code 30P |

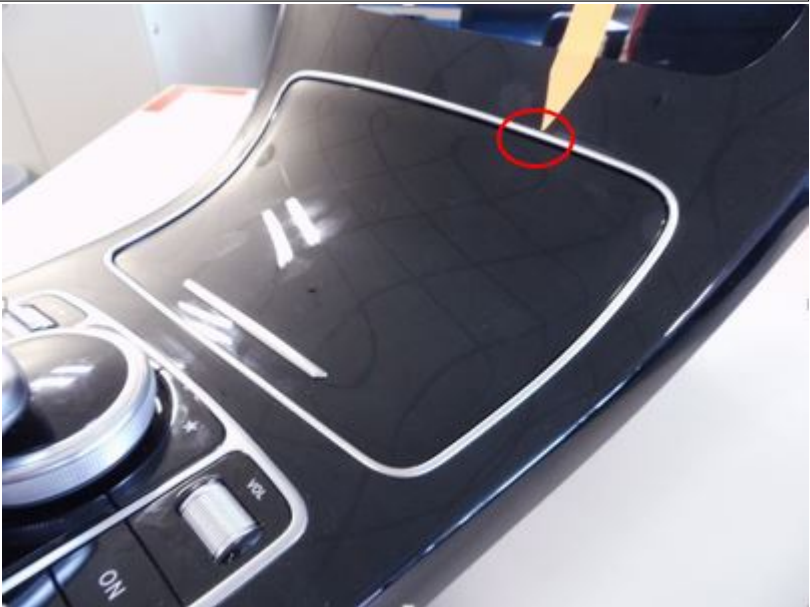
Pic1.JPG:

| Attachments | |
|---|---|
| Pic1.JPG | Position of control rod |

- Overpress the lid slightly (Pic1)
- Insert a piece of wire of  $\varnothing < 1.5$  mm through the lid joint on the left beside the control rod and push the control rod to the right (Pic2 and Pic3).
- When the control rod is pressed to the right, remove the wire and open the lid (Pic4).

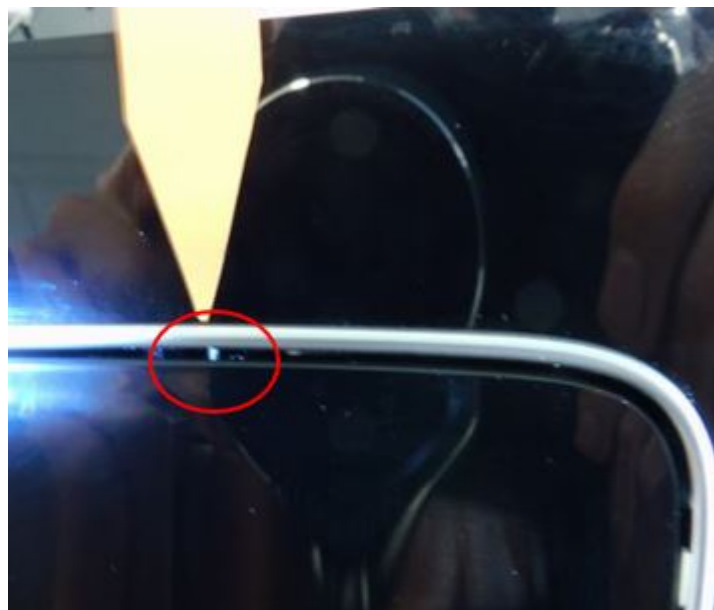
Pic2.JPG:

| Attachments | |
|---|---|
| Pic2.JPG | Position of control rod |

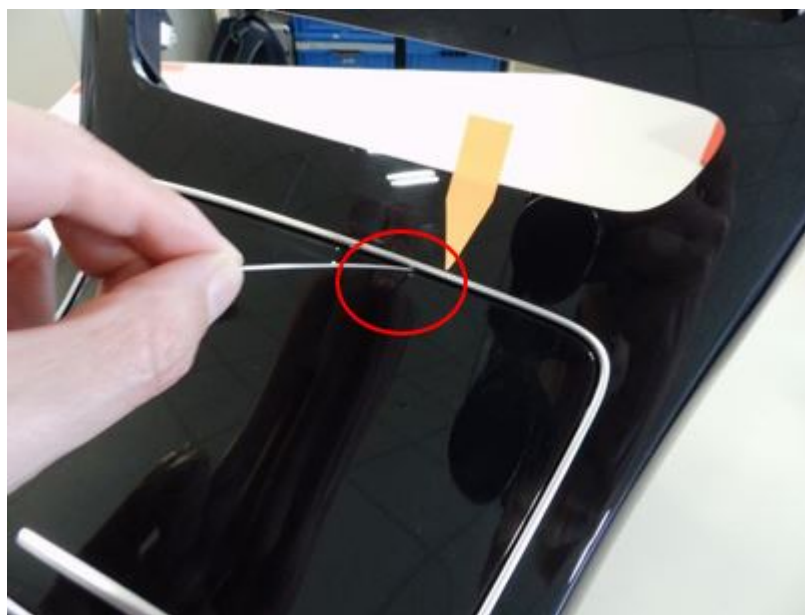
Pic3.JPG:

| Pic3.JPG | Position of control rod |

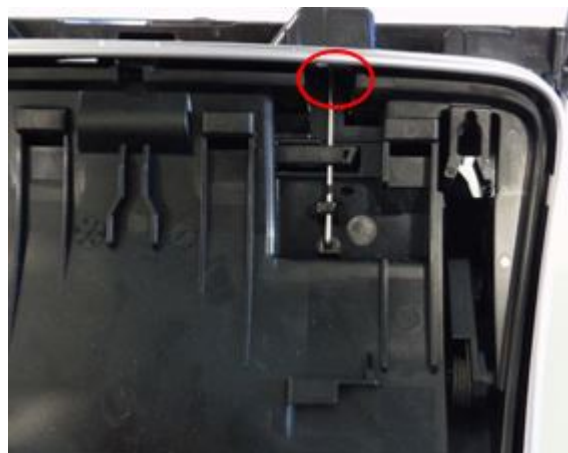
Pic4.JPG:

| Pic4.JPG | Position of control rod. View from behind. |

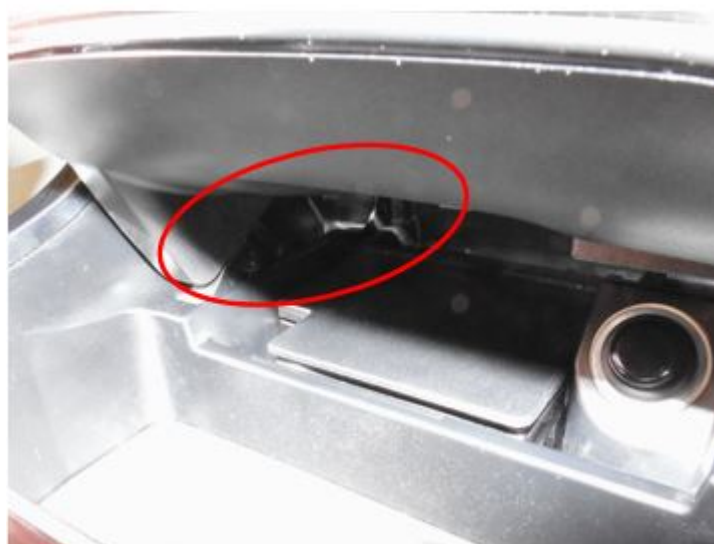
Pic5.JPG:

| Pic5.JPG | Area of kinematics |

- Close the lid slightly and remove any objects from the area of the kinematics. The lid should open automatically (Pic5 and Pic6).
- If the lid still does not open automatically, the stowage compartment must be removed (AR 68.20-P-2350LWA) and the tracks at the side must be checked for objects (Pic7).

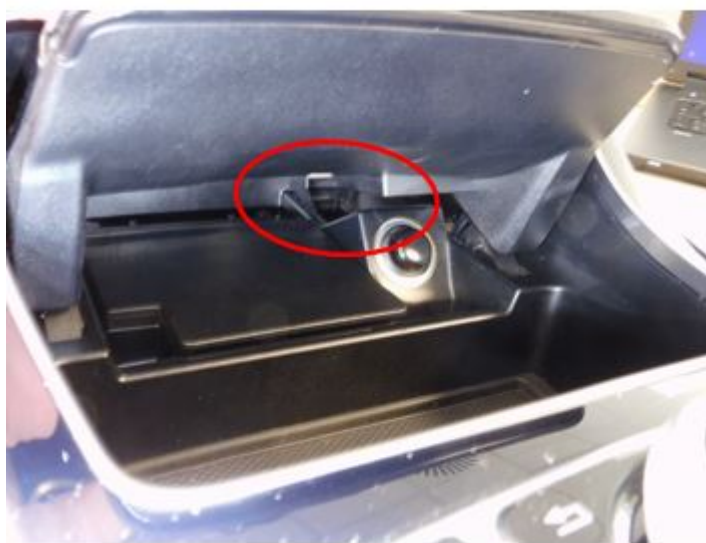
Pic6.JPG:

| Pic6.JPG | Area of kinematics |

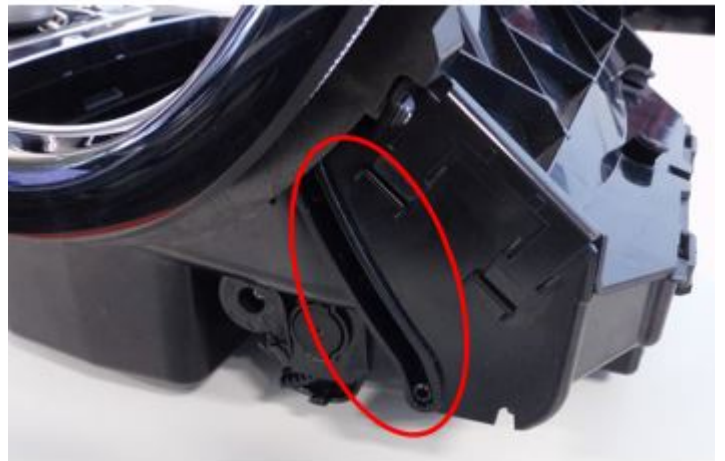
Pic7.JPG:

| Pic7.JPG | Track |

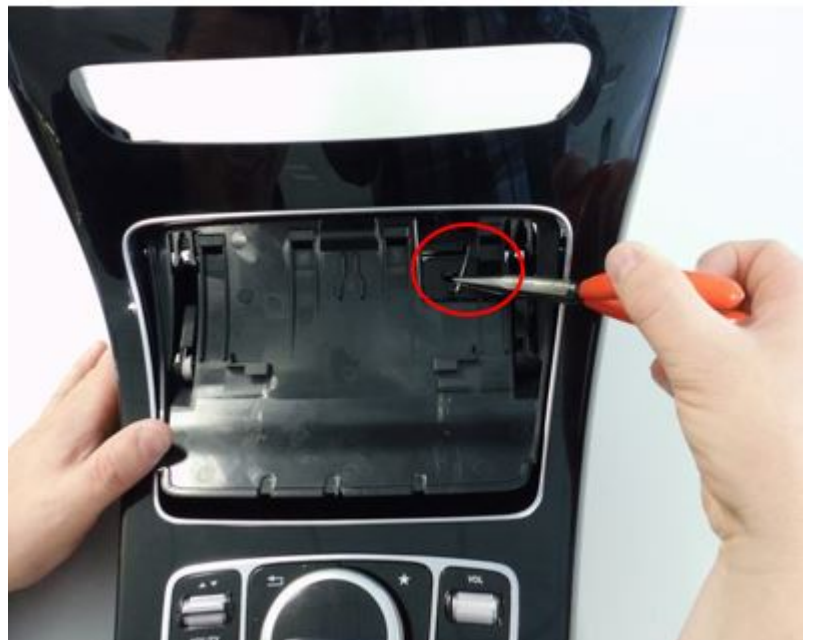
Pic8.JPG:

| Pic8.JPG | Insert control rod |

- Remove the lid and insert the short end of the control rod into the hole (Pic8). Then turn the control rod to the left against a slight resistance (spring-loaded tab) (Pic9). The control rod engages audibly.
- The installed control rod can be turned to the left and right with little effort (Pic 10, orange lines).

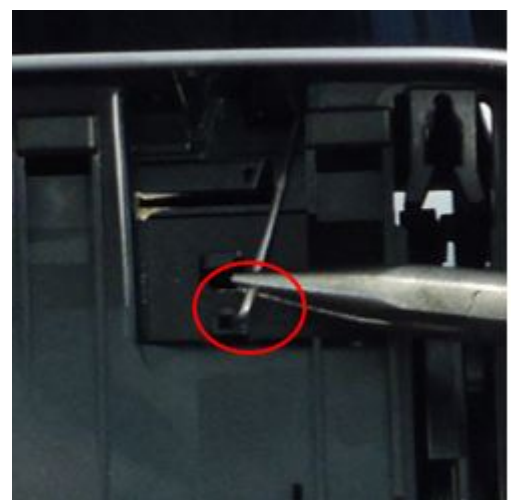
Pic9.JPG:

| Pic9.JPG | Insert control rod |

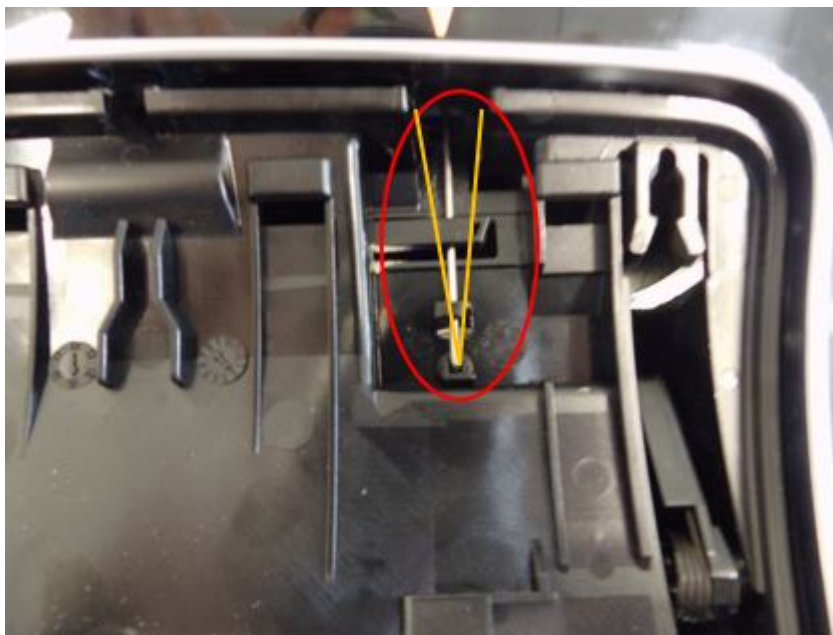
Pic10.JPG:

| Pic10.JPG | Insert control rod |
