Heated seats inoperative

Topic number	LI91.30-P-066988
Version	1
Function group	91.30 Seat heater, seat ventilation
Date	08-31-2017
Validity	A/C 205 with code 873 or 401 up to production date 22.05.2017
Reason for change	
Reason for block

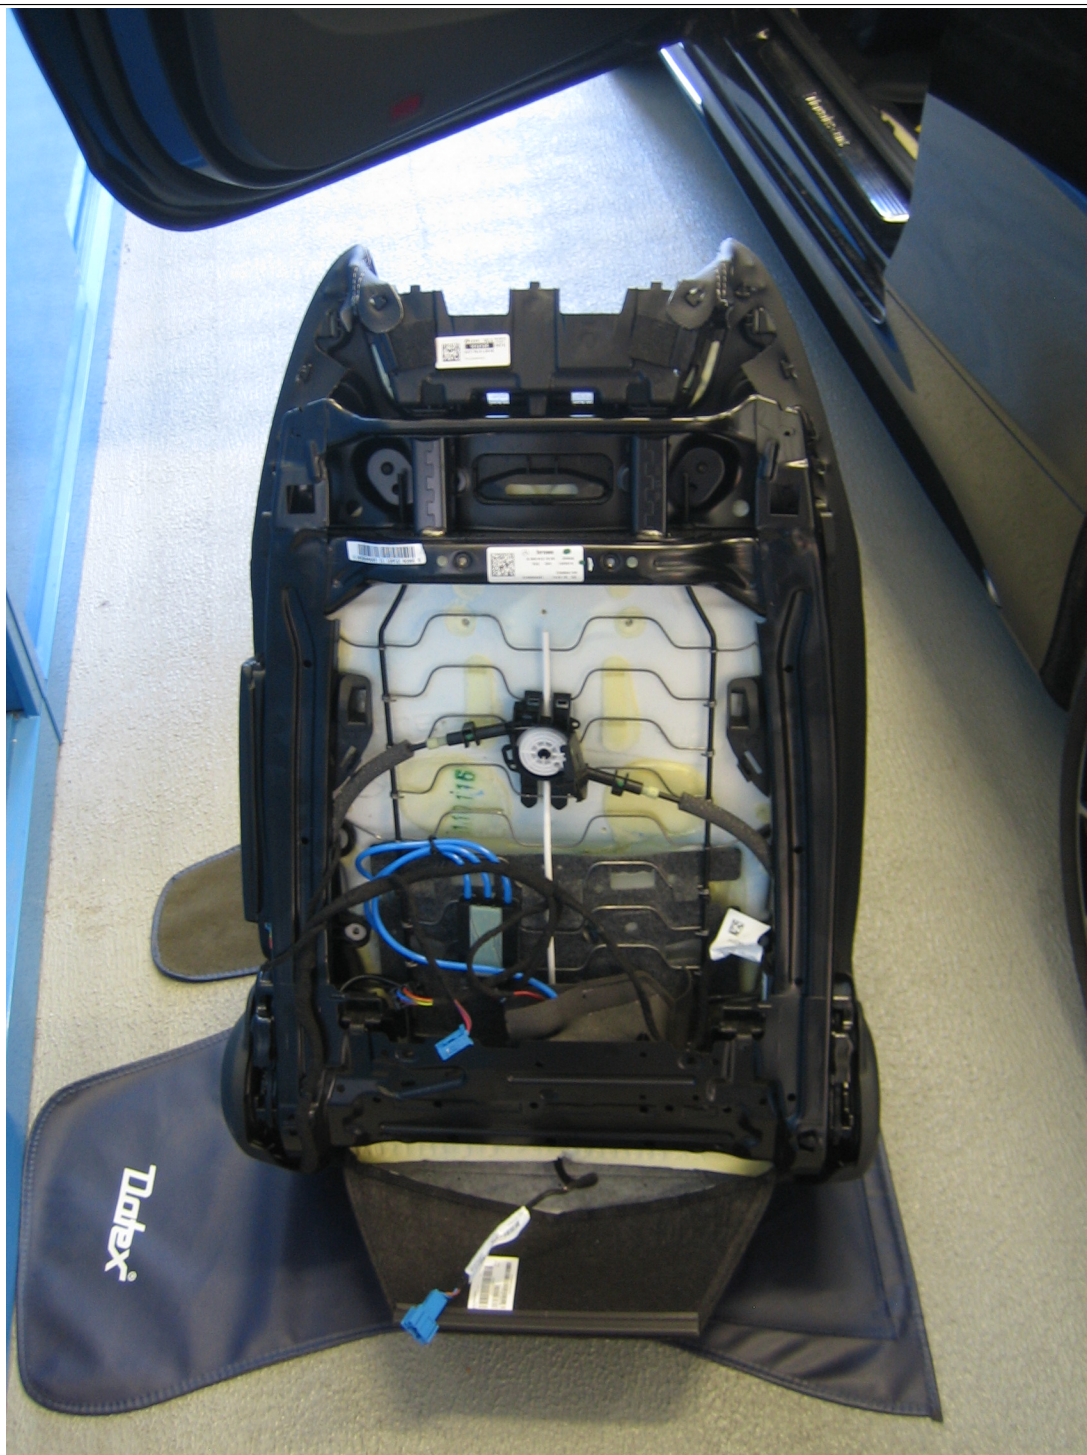
Pic1.JPG:

Attachments	
File	Description
Pic1.JPG	Chafed seat heater wiring harness in driver seat backrest
Pic2.JPG	Chafed seat heater wiring harness in driver seat backrest
Pic3.JPG	Chafed seat heater wiring harness in driver seat backrest

Chafe point on seat wiring harness in driver seat backrest (Pic1, Pic2, Pic3).

1. Remove seat (AR 91.10-O-3310LW)
2. Remove seat-back lining from front seat backrest (AR91.10-P-1910CLW)
3. Detach covering (Pic4 red), release plug and unhook downwards (Pic4)
4. Wrap chafe point with duct tape (A0079890785) in the entire visible area (Pic5) as far as the label on the wiring harness (Pic6).

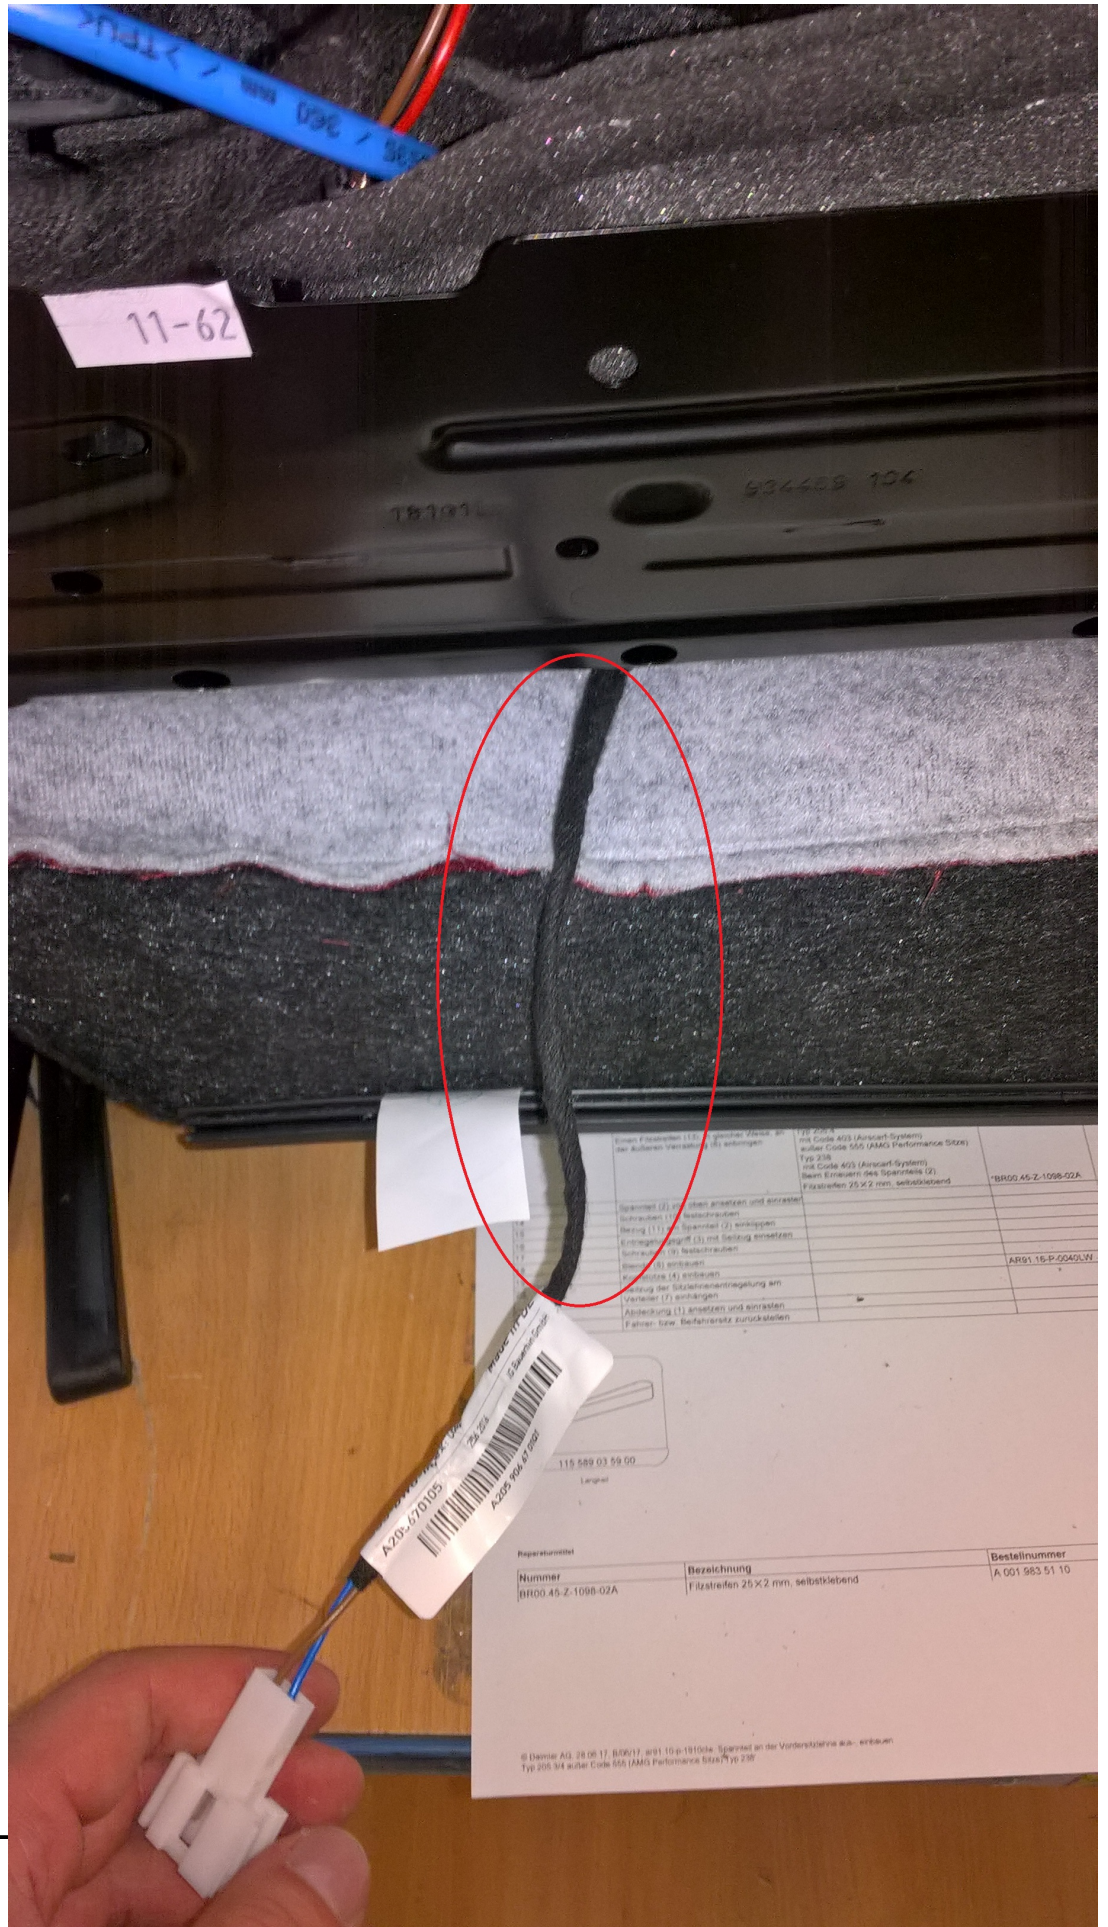
Pic5.jpg:

Attachments	
File	Description
Pic4.jpg	Seat with seat-back lining removed
Pic5.jpg	Wiring harness to be wrapped.
