Emissions Recall

Code: 23U4

Subject	2.0L TDI Engine (GEN 2 – Automatic Transmission) Emissions Modification – Customer Only (Retail Sold) <u>USA ONLY</u>
Release Date	June 01, 2017
Repair Applicability	The ONLY Vehicles eligible for repair under this action are: <ul style="list-style-type: none">• Customer owned automatic transmission vehicles only
Affected Vehicles	U.S.A. ONLY: 2012-2014 MY Volkswagen Passat 2.0L TDI (Automatic Transmission only) <i>Check Campaigns/Actions screen in Elsa on the day of repair to verify that a VIN qualifies for repair under this action. Elsa is the <u>only</u> valid campaign inquiry & verification source.</i> <ul style="list-style-type: none">✓ Campaign status must show “open.”✓ If Elsa shows other open action(s), inform your customer so that the work can also be completed at the same time the vehicle is in the workshop for this campaign.
Problem Description	The Environmental Protection Agency and California Air Resources Board have determined that Volkswagen vehicles equipped with a 2.0L 4-cylinder TDI engine do not comply with applicable emissions regulations. The emissions control systems on the vehicles will not control emissions under off-cyc

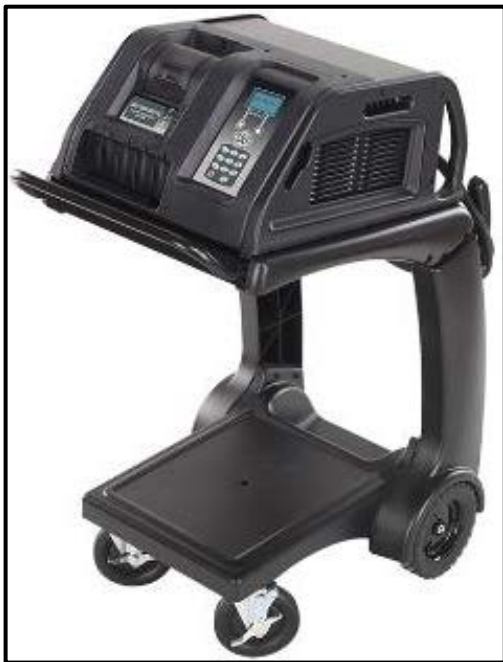
- GRX3000VAS – Battery Tester/Charger (or equivalent)

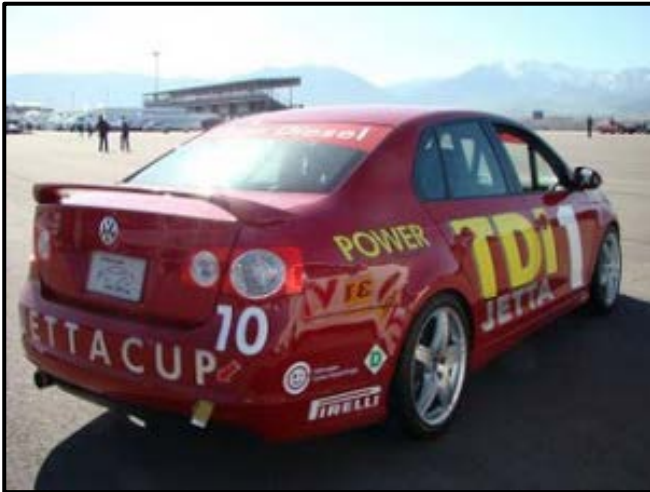
- Check for vehicle modifications from original equipment.
 - If vehicle modifications from original equipment related to emissions components are found, STOP, create a VTA ticket and contact the Volkswagen Technicians Helpline.
 - If vehicle modifications from original equipment related to emissions components are not found, continue work procedure.

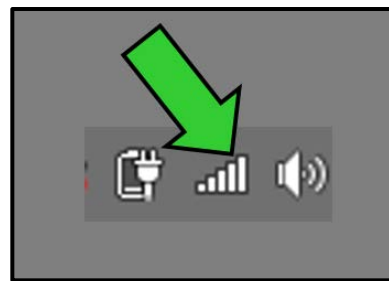
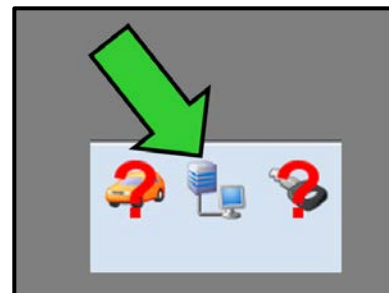
- ✓ **Within the Connection Tab, verify that the Connection type(s) display “Internet” <as shown>.**

- ✓ **Start a connections test <arrow> and verify that all connections pass.**

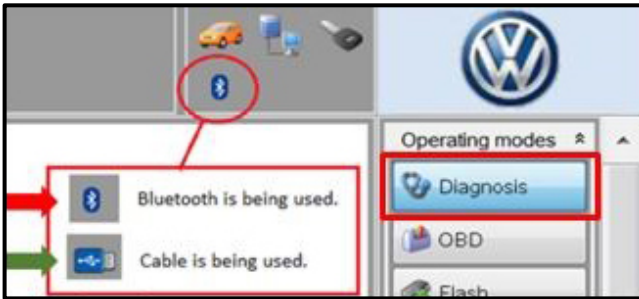
- Open the hood.
- Open the battery cover.
- Attach the GRX3000VAS Tester/Charger (or equivalent) to the vehicle battery.
- Switch the ignition on.
- Apply the parking brake.
- Switch the headlights off.
- Connect the VAS6150X Diagnostic Tester (or equivalent) to the vehicle.
- Start the ODIS program.
- Confirm that scan tool is communicating with the diagnostic head by USB <Green Arrow>.
 - If the Bluetooth symbol is shown <Red Arrow> then disconnect the diagnostic head from the vehicle and reconnect the USB cable to the diagnostic head and then reattach to the vehicle.
- Upon ODIS startup, verify the "Diagnosis" operating mode is selected <as shown>.

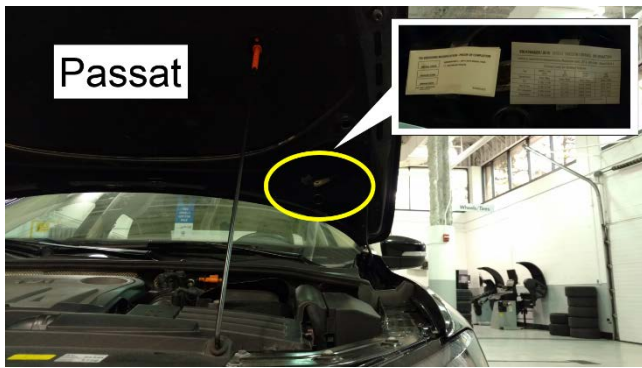
- Open the hood.
- Clean the surface where the label is to be installed <circle>.
- Install the supplemental Vehicle Emissions Control Information label, 03L 010 005 H, in the location shown <circle>.

- The surface where the label is to be installed must be clean, dry, and free from oil residue prior to installing the label.
- Label must NOT cover any existing label(s).
- Label must be installed in location shown.
- Photo documentation of label installed is required.
