Technical Bulletin

13 17 03 September 13, 2017 2044350 Supersedes Technical bulletin 13-17-02 (V131601) dated July 13, 2017 to include additional model year applicability and tool information.

Sealing Flange Installation

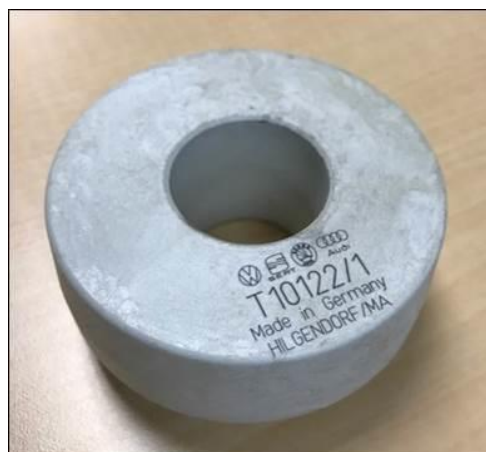
Figure 1. Guide Piece T10122/1

- Obtain Guide Piece to Crankshaft Seal Install Kit – Guide Piece T10122/1 and Crank Shaft Seal Installer – Guide Piece T10122/6A (Figures 1 and 2).

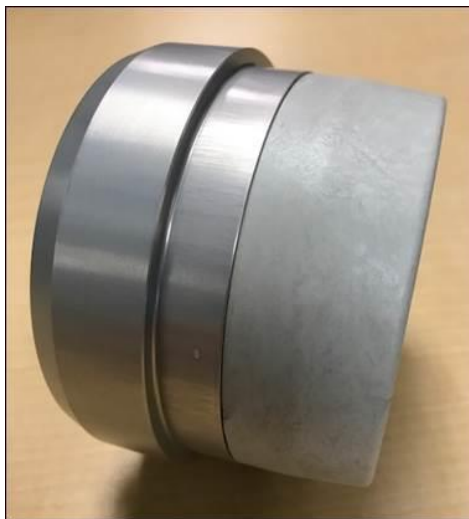
Figure 3

Assemble Tool Guide Piece T10122/1 and Guide Piece T10122/6A (Figure 3).

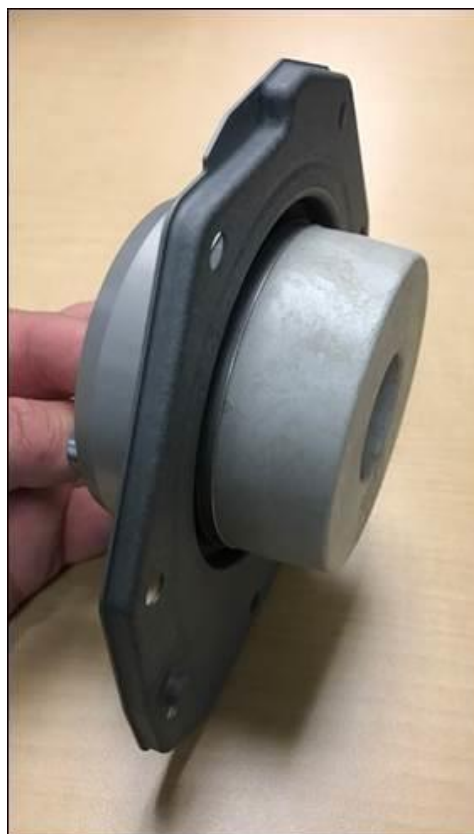
- Install the sealing flange onto the assembled tools (Figures 5 and 6).

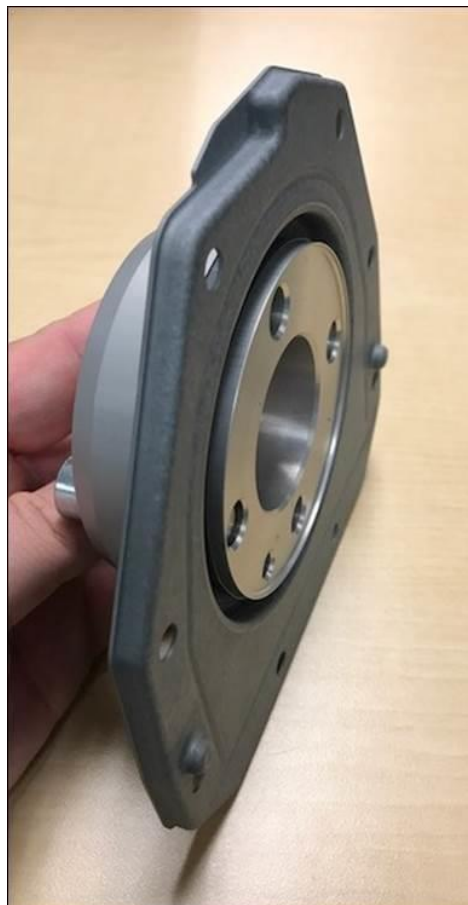
Figure 7

- After installing sealing flange onto tool, remove T10122/1 from T10122/6A as seen in Figure 7.
