# Technical Bulletin

**57 17 03** September 20, 2017 **2041749** Supersedes Technical Bulletin V571506 dated December 16, 2016 to include updated production solution and additional repair instructions.

### Front or Rear Door Arrester (Door Check Rod/Door Check Strap) Noisy or Defective

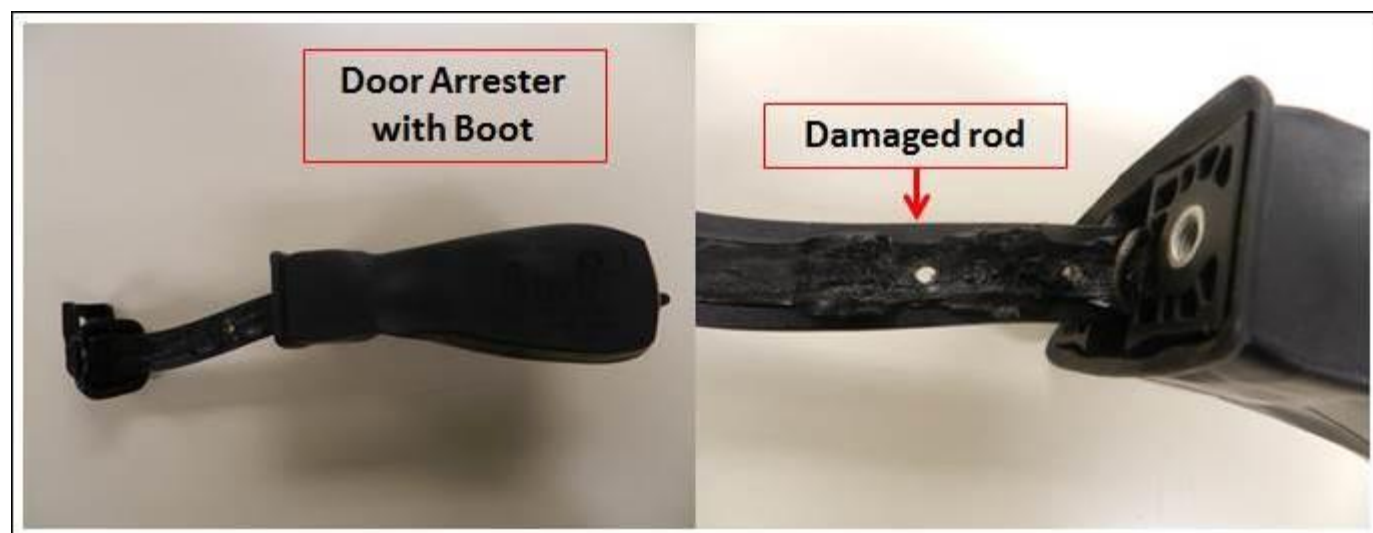
Figure 1.

The condition is caused by water ingress into the door arrester that accumulates in the arrester cover (boot) and freezes during cold weather conditions. The ice built up around the door arrester slider spring prevents it from compressing during door opening and closing operation and the spring will eventually wear through the plastic slider and damage the check rod.

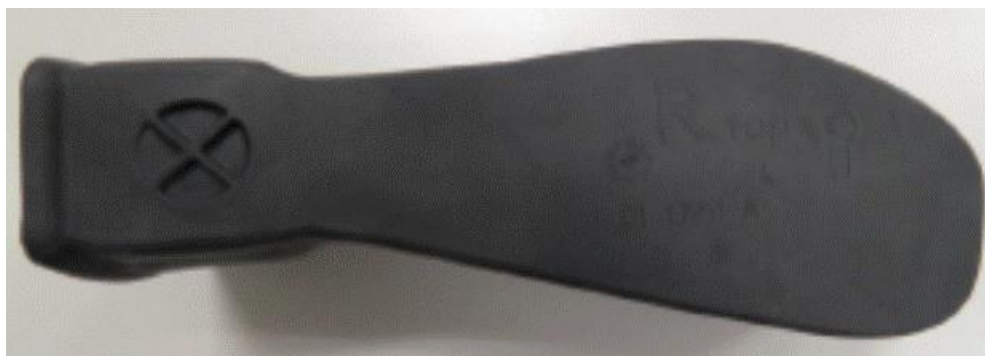
- **Figure 2. Example of door arrester cover for left door.**

If the arrester cover is damaged, it must be replaced according to the parts catalog. If the cover is undamaged, clean and reuse the part.

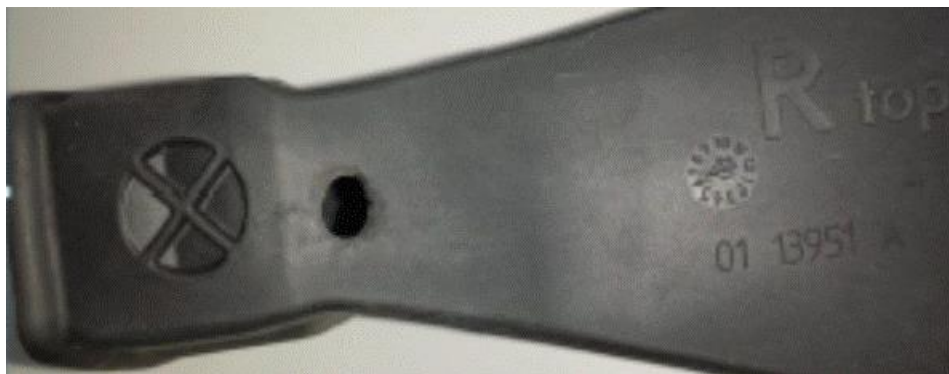
Figure 3. Example of door arrester cover with water drain hole for left side of the vehicle ("R top")

Use a metal drill bit (diameter 8 mm) to drill a water drain hole (Figure 3.) in the door arrester cover as follows.

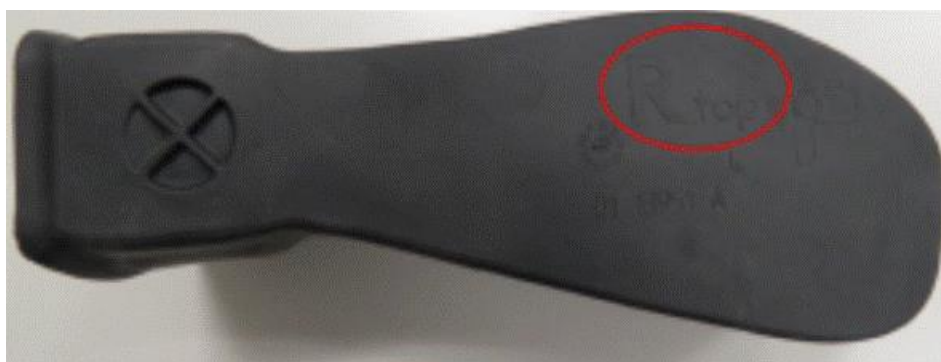
Figure 4. Door arrester cover for left side of vehicle

- On the left side of the vehicle the hole must be drilled on the side of the cover where it says "R top" (Figure 4. red ellipse).

On the right side of the vehicle the hole must be drilled on the side of the cover where it says "L top".

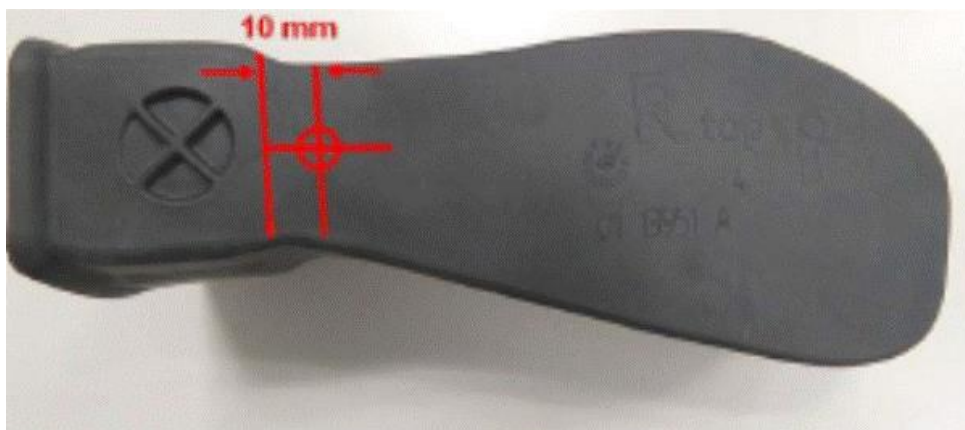
**Figure 5. Reference point of water drain hole**

- Drill a water drain hole at a distance of 10 mm in the door arrester cover, measured from the crease in the cover as shown in figure 5.

When the door arrester is installed in the door, the water drain hole must be pointing down towards the bottom of the door.
