Cascadia Radiator Strut Rod Rubbing on Upper Radiator Hose

20-78

**Freightliner
Service Bulletin**

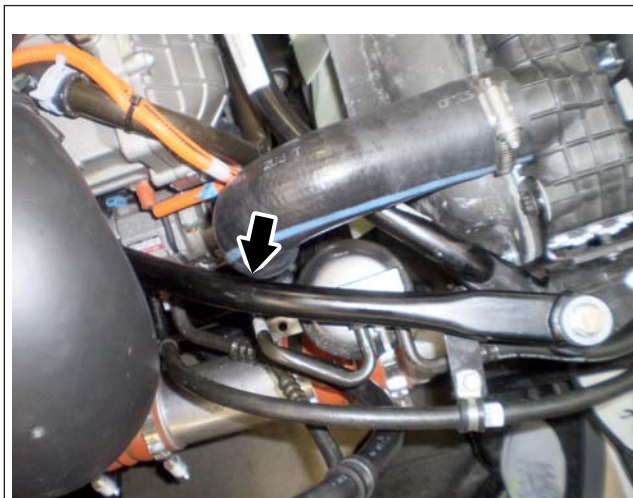
Fig. 1, Hose Rubbing Area, DD13 Engines

On vehicles with DD13 engines, rubbing will show near the right-side strut rod. See **Fig. 1**.

Check for rubbing on the hose at the right-side strut rod.

If there is evidence of rubbing, replace the hose and install a new strut rod. Refer to **Table 1** under "Parts" for replacement strut rods by vehicle configuration.

NOTE: If the installed strut rod is already the replacement part listed in **Table 1**, replace the hose only. Make sure that the hose is installed so that it will not rub.

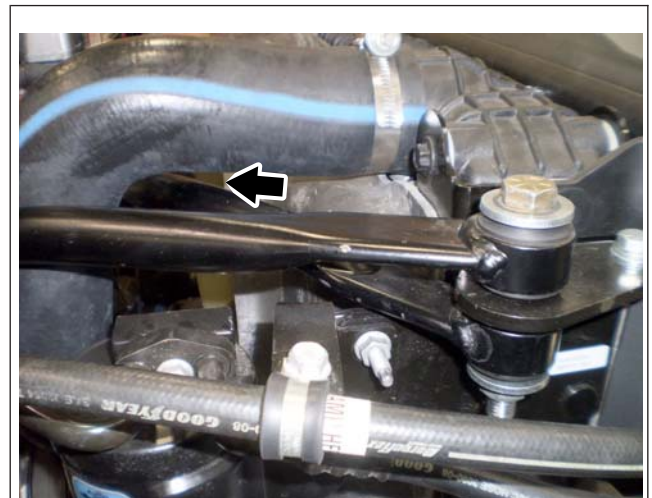
Fig. 2, Hose Rubbing Area, Cummins ISX Engines

On vehicles with Cummins ISX engines, rubbing will show near the bias strut rod. See **Fig. 2**.

Check for rubbing on the hose at the bias strut rod.
