## Vehicle drops at rear axle, vehicles with electronic rear axle level control or AIRmatic

| Topic number | LI32.22-P-048597 |
| Design group | 32.22 Air suspension |

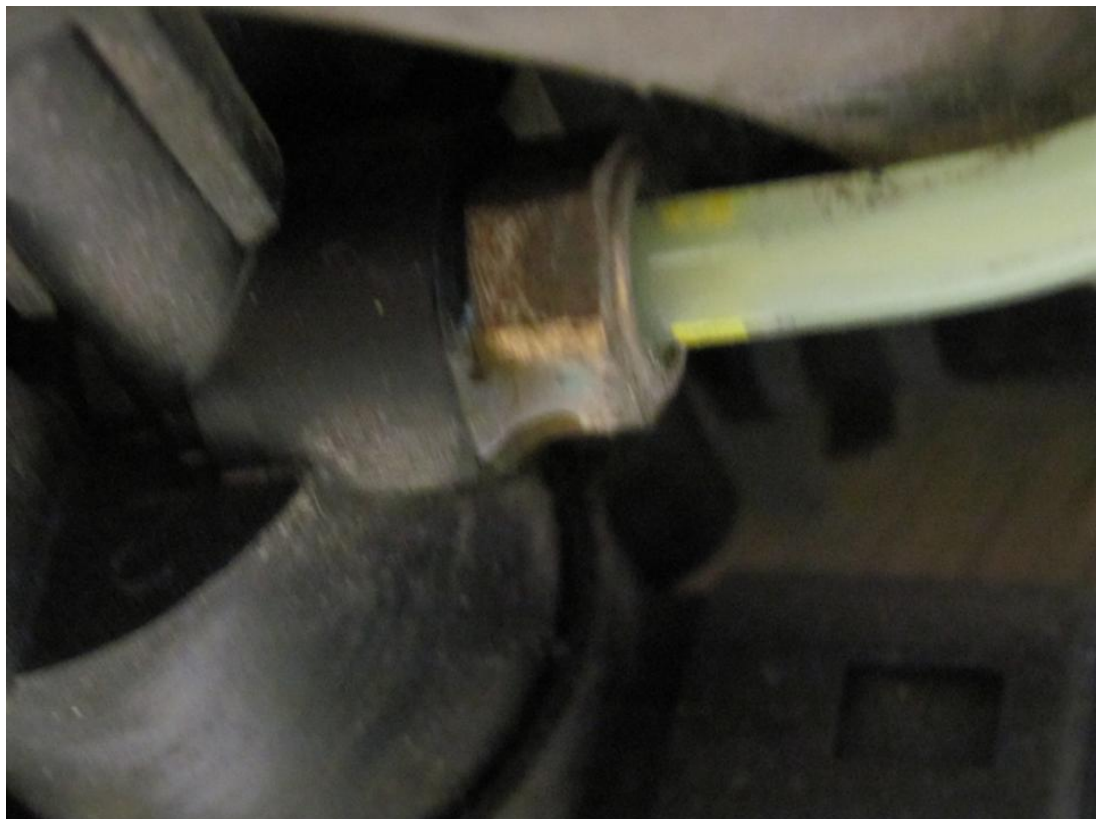
1.JPG:

| Attachments | |
|---|---|
| 1.JPG | Figure 1 |

- Unscrew AIRmatic pressure line between compressor and valve unit.
- If water emerges (Figure 1), or if there are visible water droplets at the connection of the pressure line of the compressor or valve unit (Figure 2), the compressor, the valve unit and the air filter of the intake hose must be replaced. If no water is visible, actuate compressor with XENTRY. If water runs out of the connection on the compressor, the compressor, the valve unit and the air filter of the intake hose must be replaced.

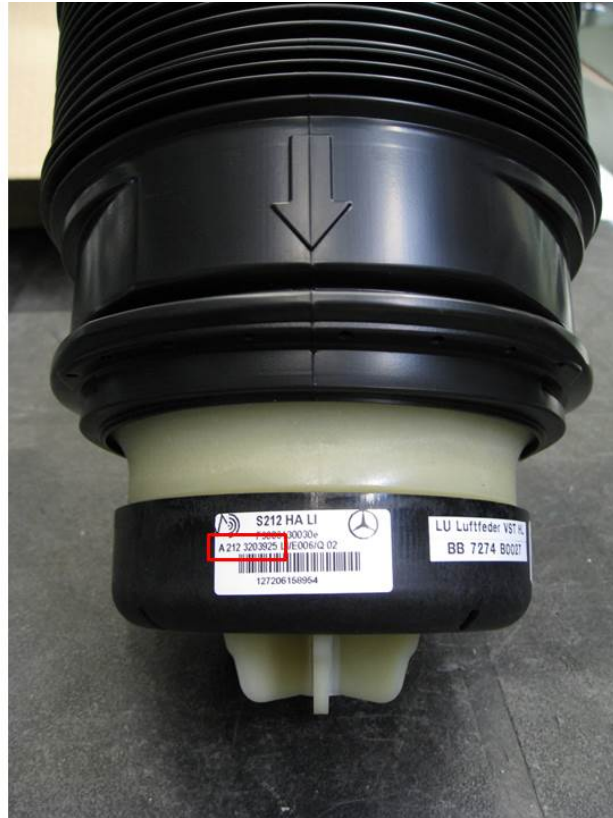
3.jpg:

| Attachments | |
|---|---|
| 3.jpg | Figure 3: Latest air spring bellows with black ring and current part number |
