# Service Campaign Bulletin

Campaign No. 2017030010, July 2017

SUBJECT: **Models 166 and 292, Model Years 2016 and 2017**  
**Check Roll Stabilization Hydraulic Line**

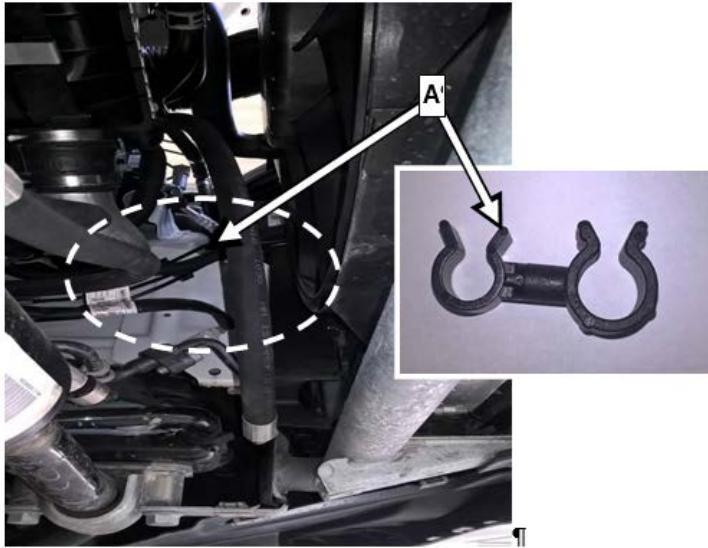
Figure 1

Check whether plastic retaining clips (A, Figure 1) are installed on the hydraulic line of the roll stabilization in the marked area.

**Note:** The clips (A) must be removed and may not be installed again.

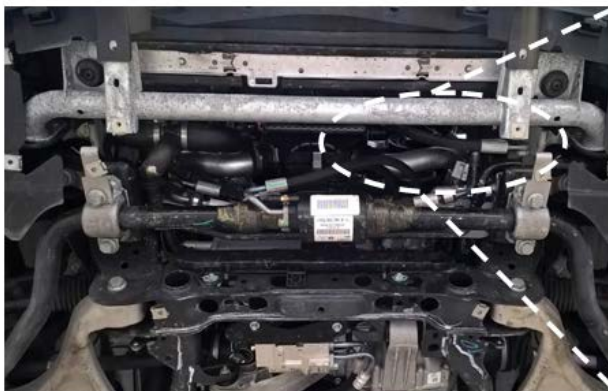
Figure 2

3. Check distance (B, Figure 2) between hydraulic line of roll stabilization and fan.

**Note:** Distance (B, Figure 2) **must be 25 mm**.

- If distance between hydraulic line and fan is **at least 25 mm (OK)**: Procedure is complete.

- If distance between hydraulic line and fan is **too small (NOT OK)**: Proceed to Subject B.
