Cracking noise at limit stop of electric steering

Topic number	LI46.35-P-067121
Version	1
Function group	46.35 Electrical steering
Date	10-09-2017
Validity	Model 156 up to 31.06.2017
Reason for change	
Reason for block

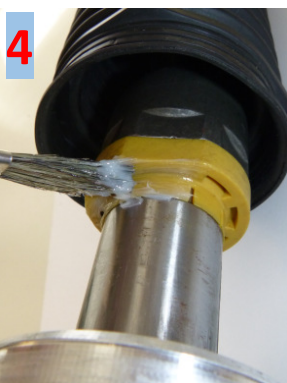
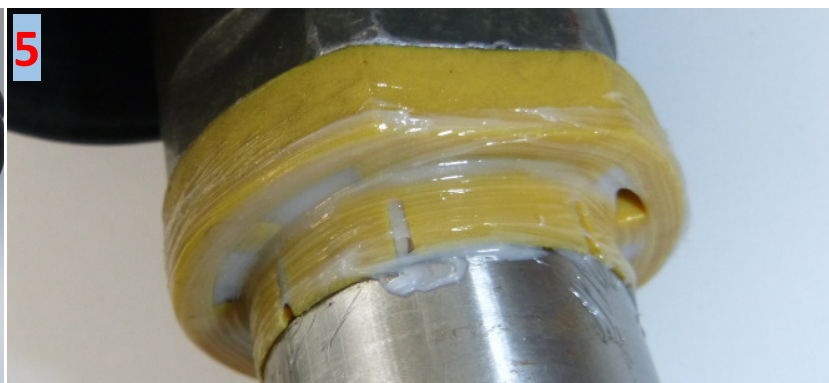
1. Remove steering (picture 1).
2. Open clamps (a-b) and slide boot outwards (pictures 2-3).
3. Grease yellow end stopper ring (pictures 4-5).

Note: Here, a thin layer of grease is more than enough.

Grease end stopper ring in electric steering.
