## Creaking or knocking noise in left or right front seat backrest with equipment code 403 - Airscarf head area heating

Topic number	LI91.29-P-065542
Version	3
Function group	91.29 Seats - electrical system
Date	10-16-2017
Validity	A205, A238 with code 403
Reason for change	BR238 added, creaking noise added
Reason for block

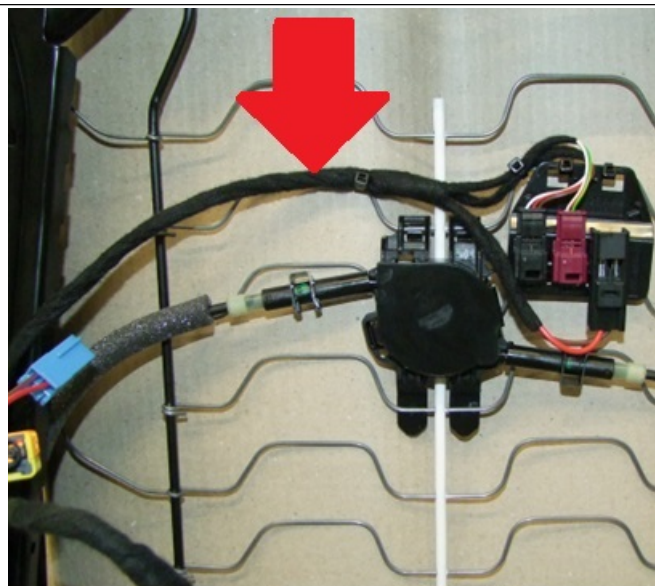
1.jpg:

Attachments	
File	Description
1.jpg	Pic. 1: Line (driver's seat, left)
2.jpg	Pic. 2: Line (driver's seat, right)
3.jpg	Pic. 3: Retaining plate (driver's seat, left)
6.jpg	Pic. 6: Fix connector in place using cable tie
7.jpg	Pic. 7: Connector assembly on Bowden cable (driver's seat, left)
8.jpg	Pic. 8: Connector assembly on Bowden cable (driver's seat, right)
9.jpg	Pic. 9: Line routing (driver's seat, left)
10.jpg	Pic. 10: Line routing (driver's seat, right)
4.jpg	Pic. 4: Retaining plate (driver's seat, right)
5.jpg	Pic. 5: Felt

1. Dismantle backrest trim (see AR91.10-p-3310lw)
2. Unfasten lines from spring-mounted mat (Pic. 1 (left seat), Pic. 2 (right seat))
3. Remove retaining plate (Pic. 3, Pic. 4)
4. Felt strip (A 001 983 23 10 - Cut felt strip 40X2) to length of 80 mm and stick onto spring mounting (Pic. 5)
5. Use cable tie to bind connector assembly together (Pic.6)
6. Fix connector assembly into place on mounting for Bowden cables using cable tie (Pic. 7, Pic. 8)
7. Route lines (Pic. 9, Pic. 10) and fix in place with cable tie
8. Mount backrest trim (see AR91.10-p-3310lw)

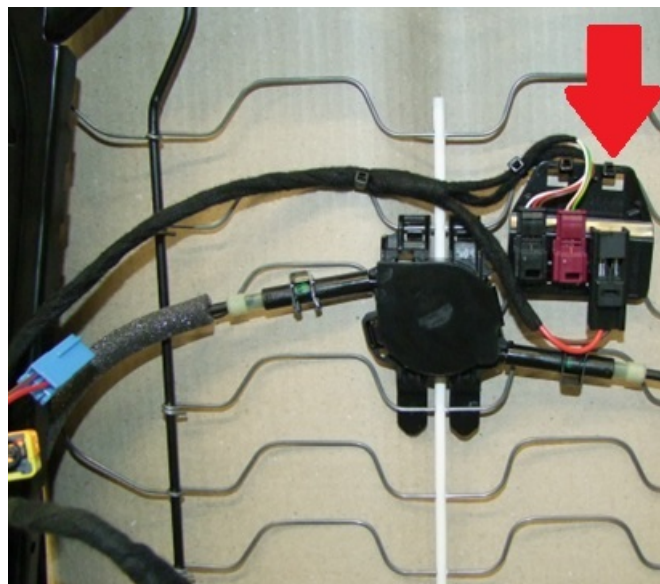
3.jpg:

Retaining plate for electrical lines or connectors may come into contact with the backrest's spring mounting when driving.
